# Historic Structure Assessment

## Cortez Cultural Center

25 N Market St., Cortez, CO 81321

SHF Project # 2019-HA-001

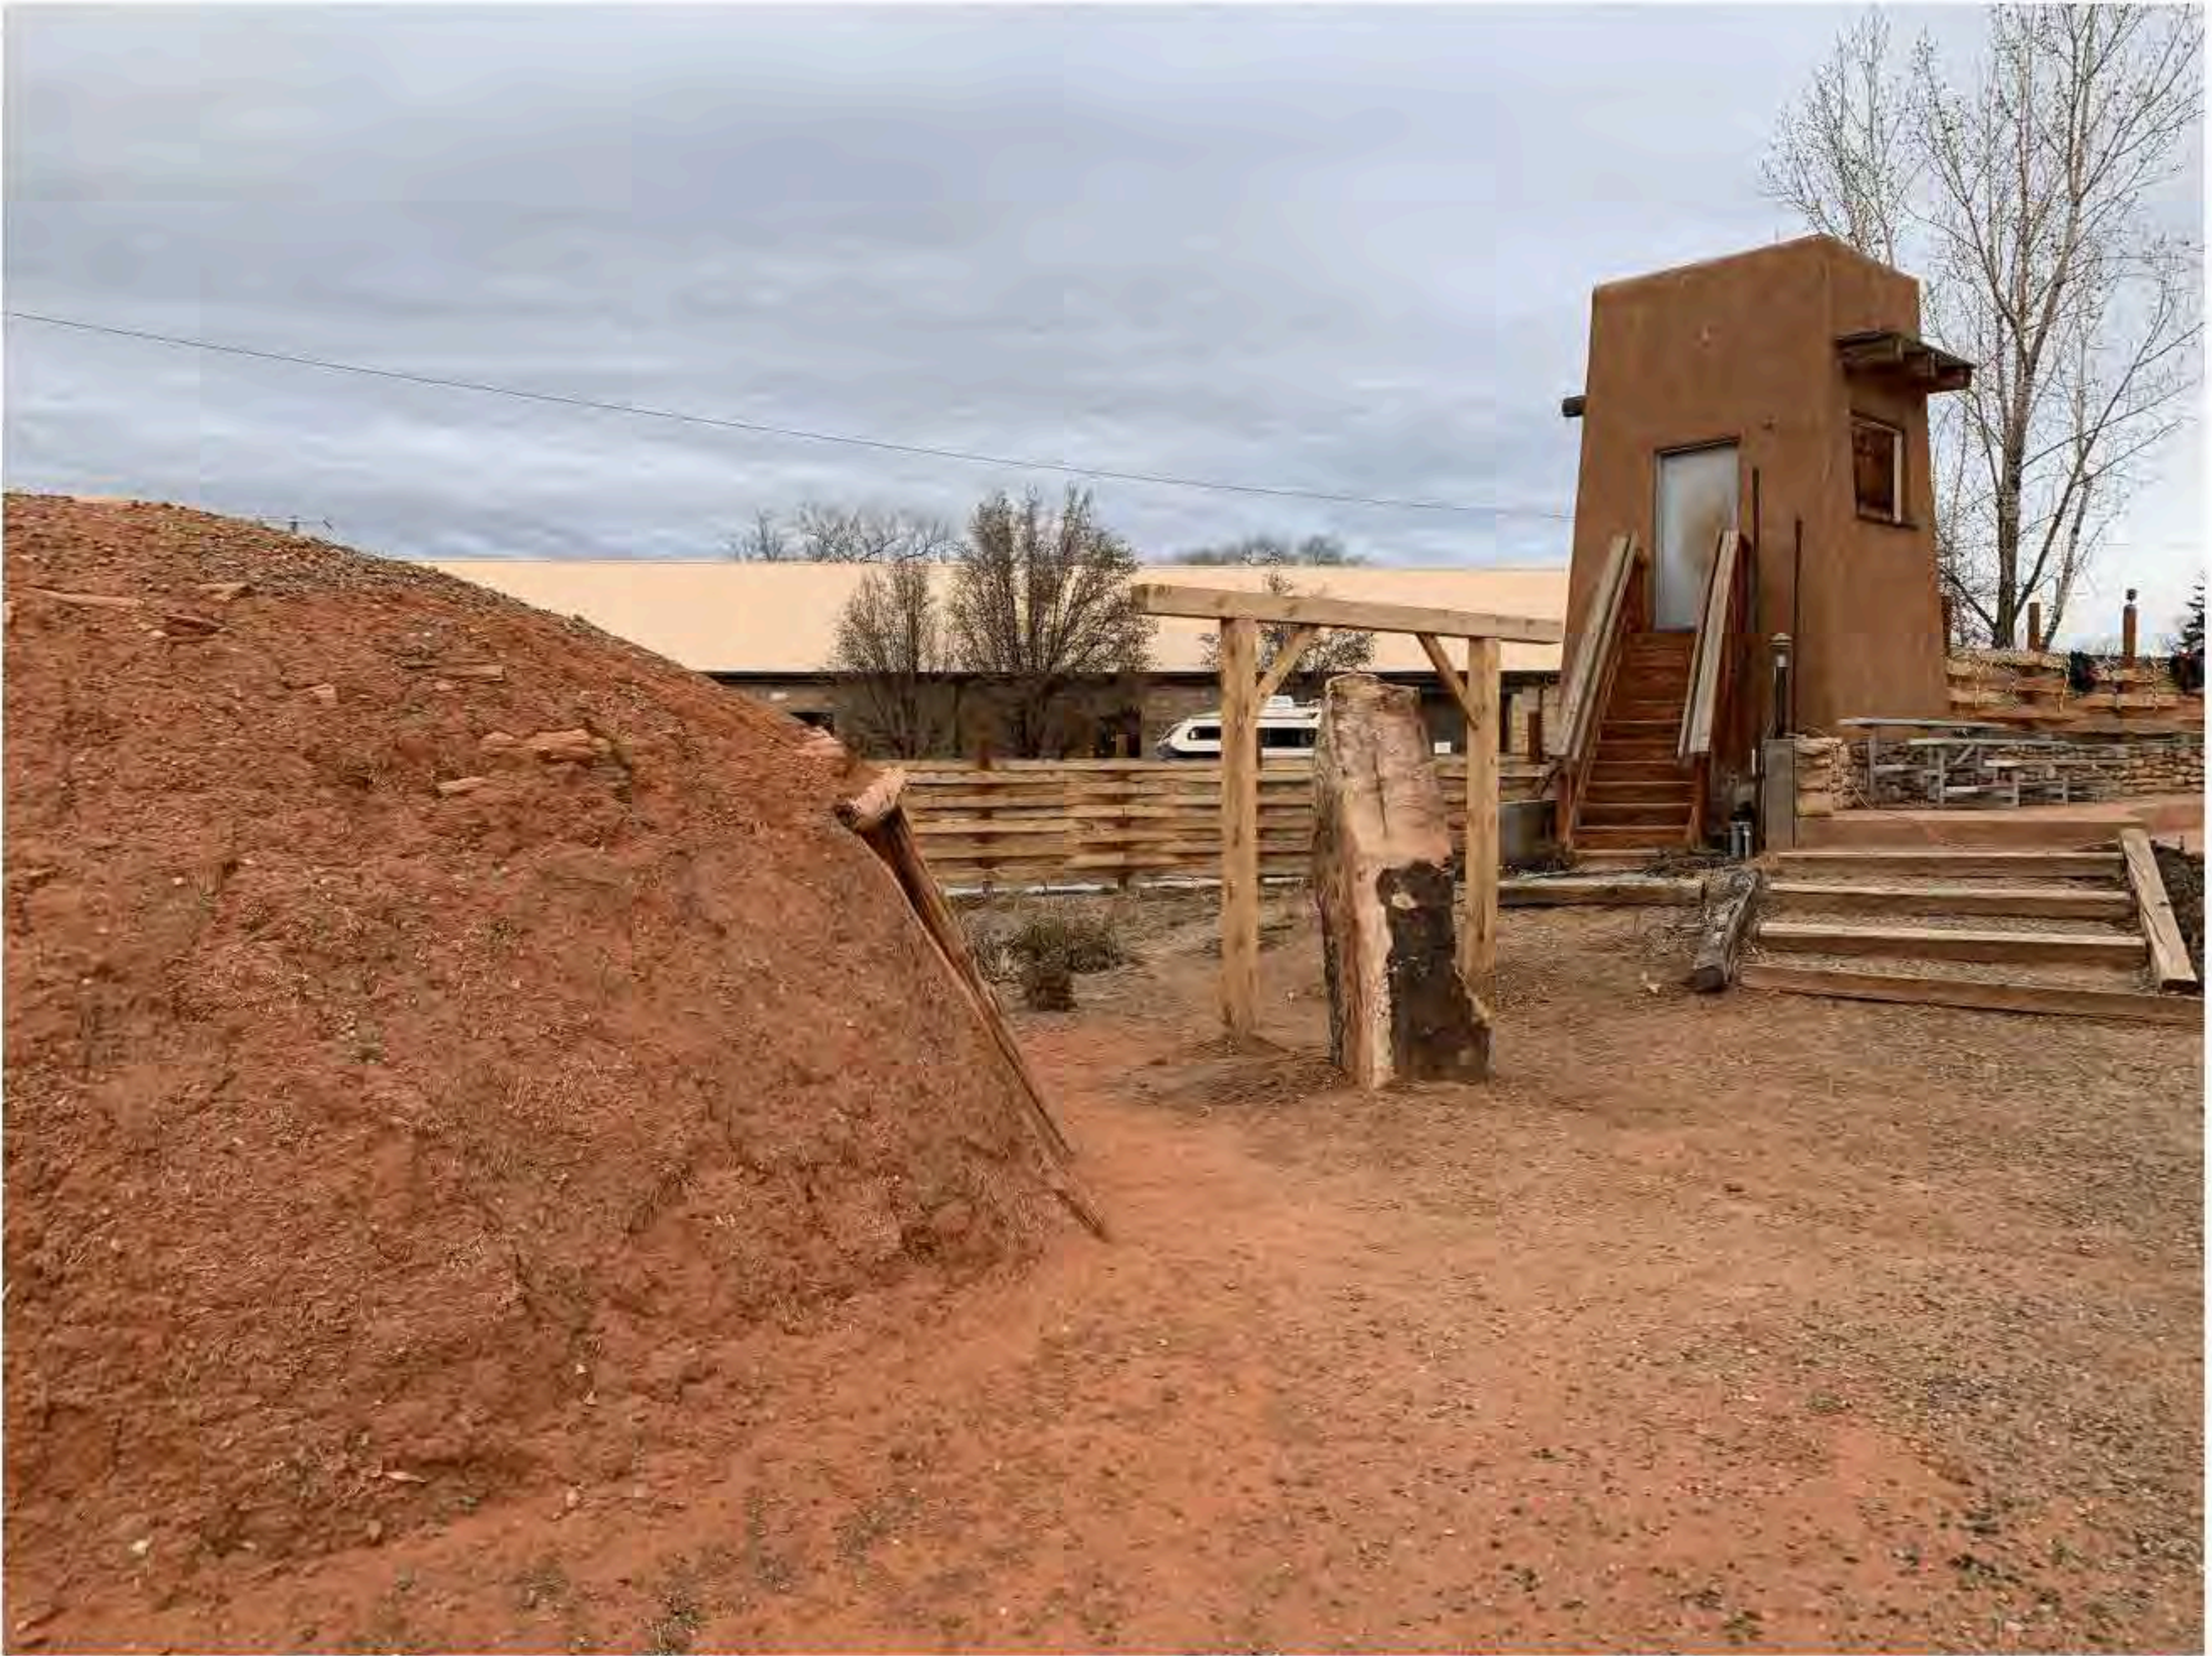
Figure 3.1-3: Tower and Hogan

Constructed features such as the amphitheater tower and hogan are in Fair condition. The Hogan is in need of the typical maintenance re-plastering and evaluation of the roof beams, some of which are sagging. The amphitheater tower wood work such as the stair, trim, sills, and vigas, and railroad tie steps need maintenance or replacement.

- The amphitheater drainage issues should be remedied as soon as possible. If drainage issues got bad enough and there was enough moisture, flooding could effect the building. A plumber and/or other qualified consultant should determine the cause of the blockages, inadequate slope, flow, etc. and design a solution that could be bid upon and executed by a qualified contractor (Serious).
- It is recommended that the back maintenance on the tower woodwork be performed as soon as possible to prevent further degradation and increased future maintenance costs (Serious).
- The hogan should be evaluated structurally and repaired and re-plastered as required (Minor).

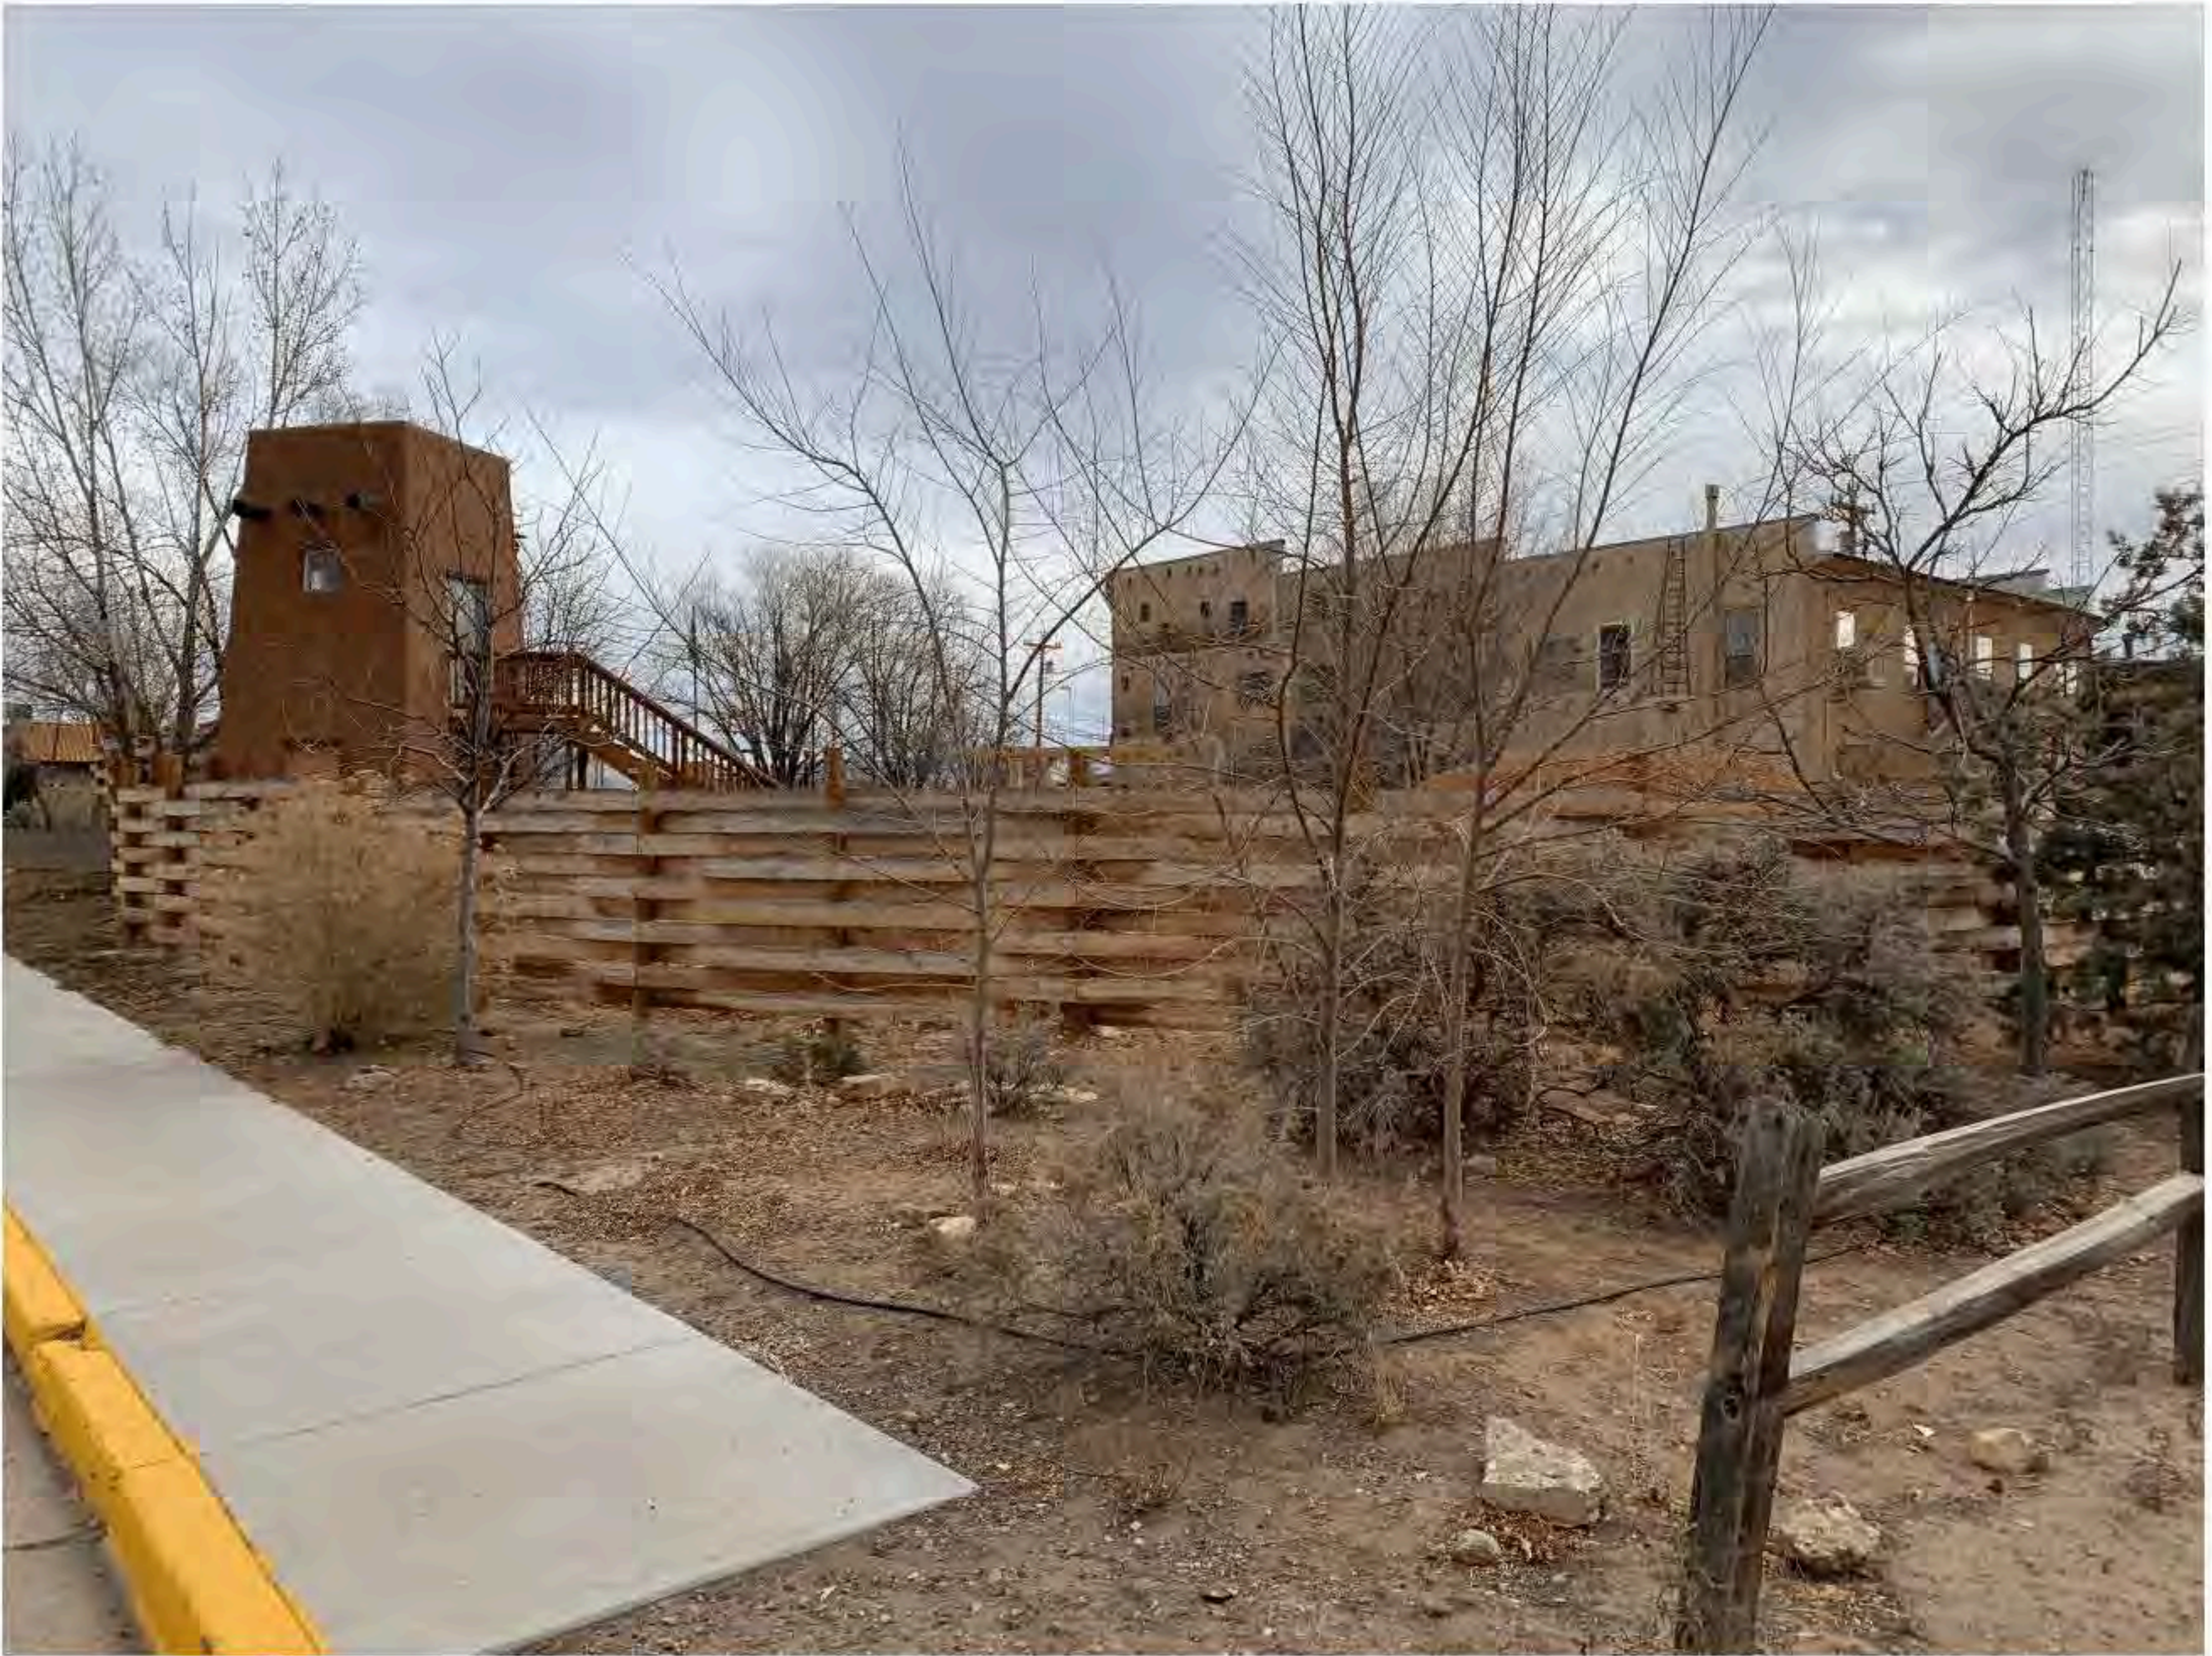
Figure 3.1-4: Amphitheater and Tower

The amphitheater itself is generally in Good to Fair condition. The amphitheater concrete surface is spalling. At times of heavy rain or snowmelt, the amphitheater drain back's up and will accelerate long term water damage if not addressed. The amphitheater drainage system is in Poor condition.

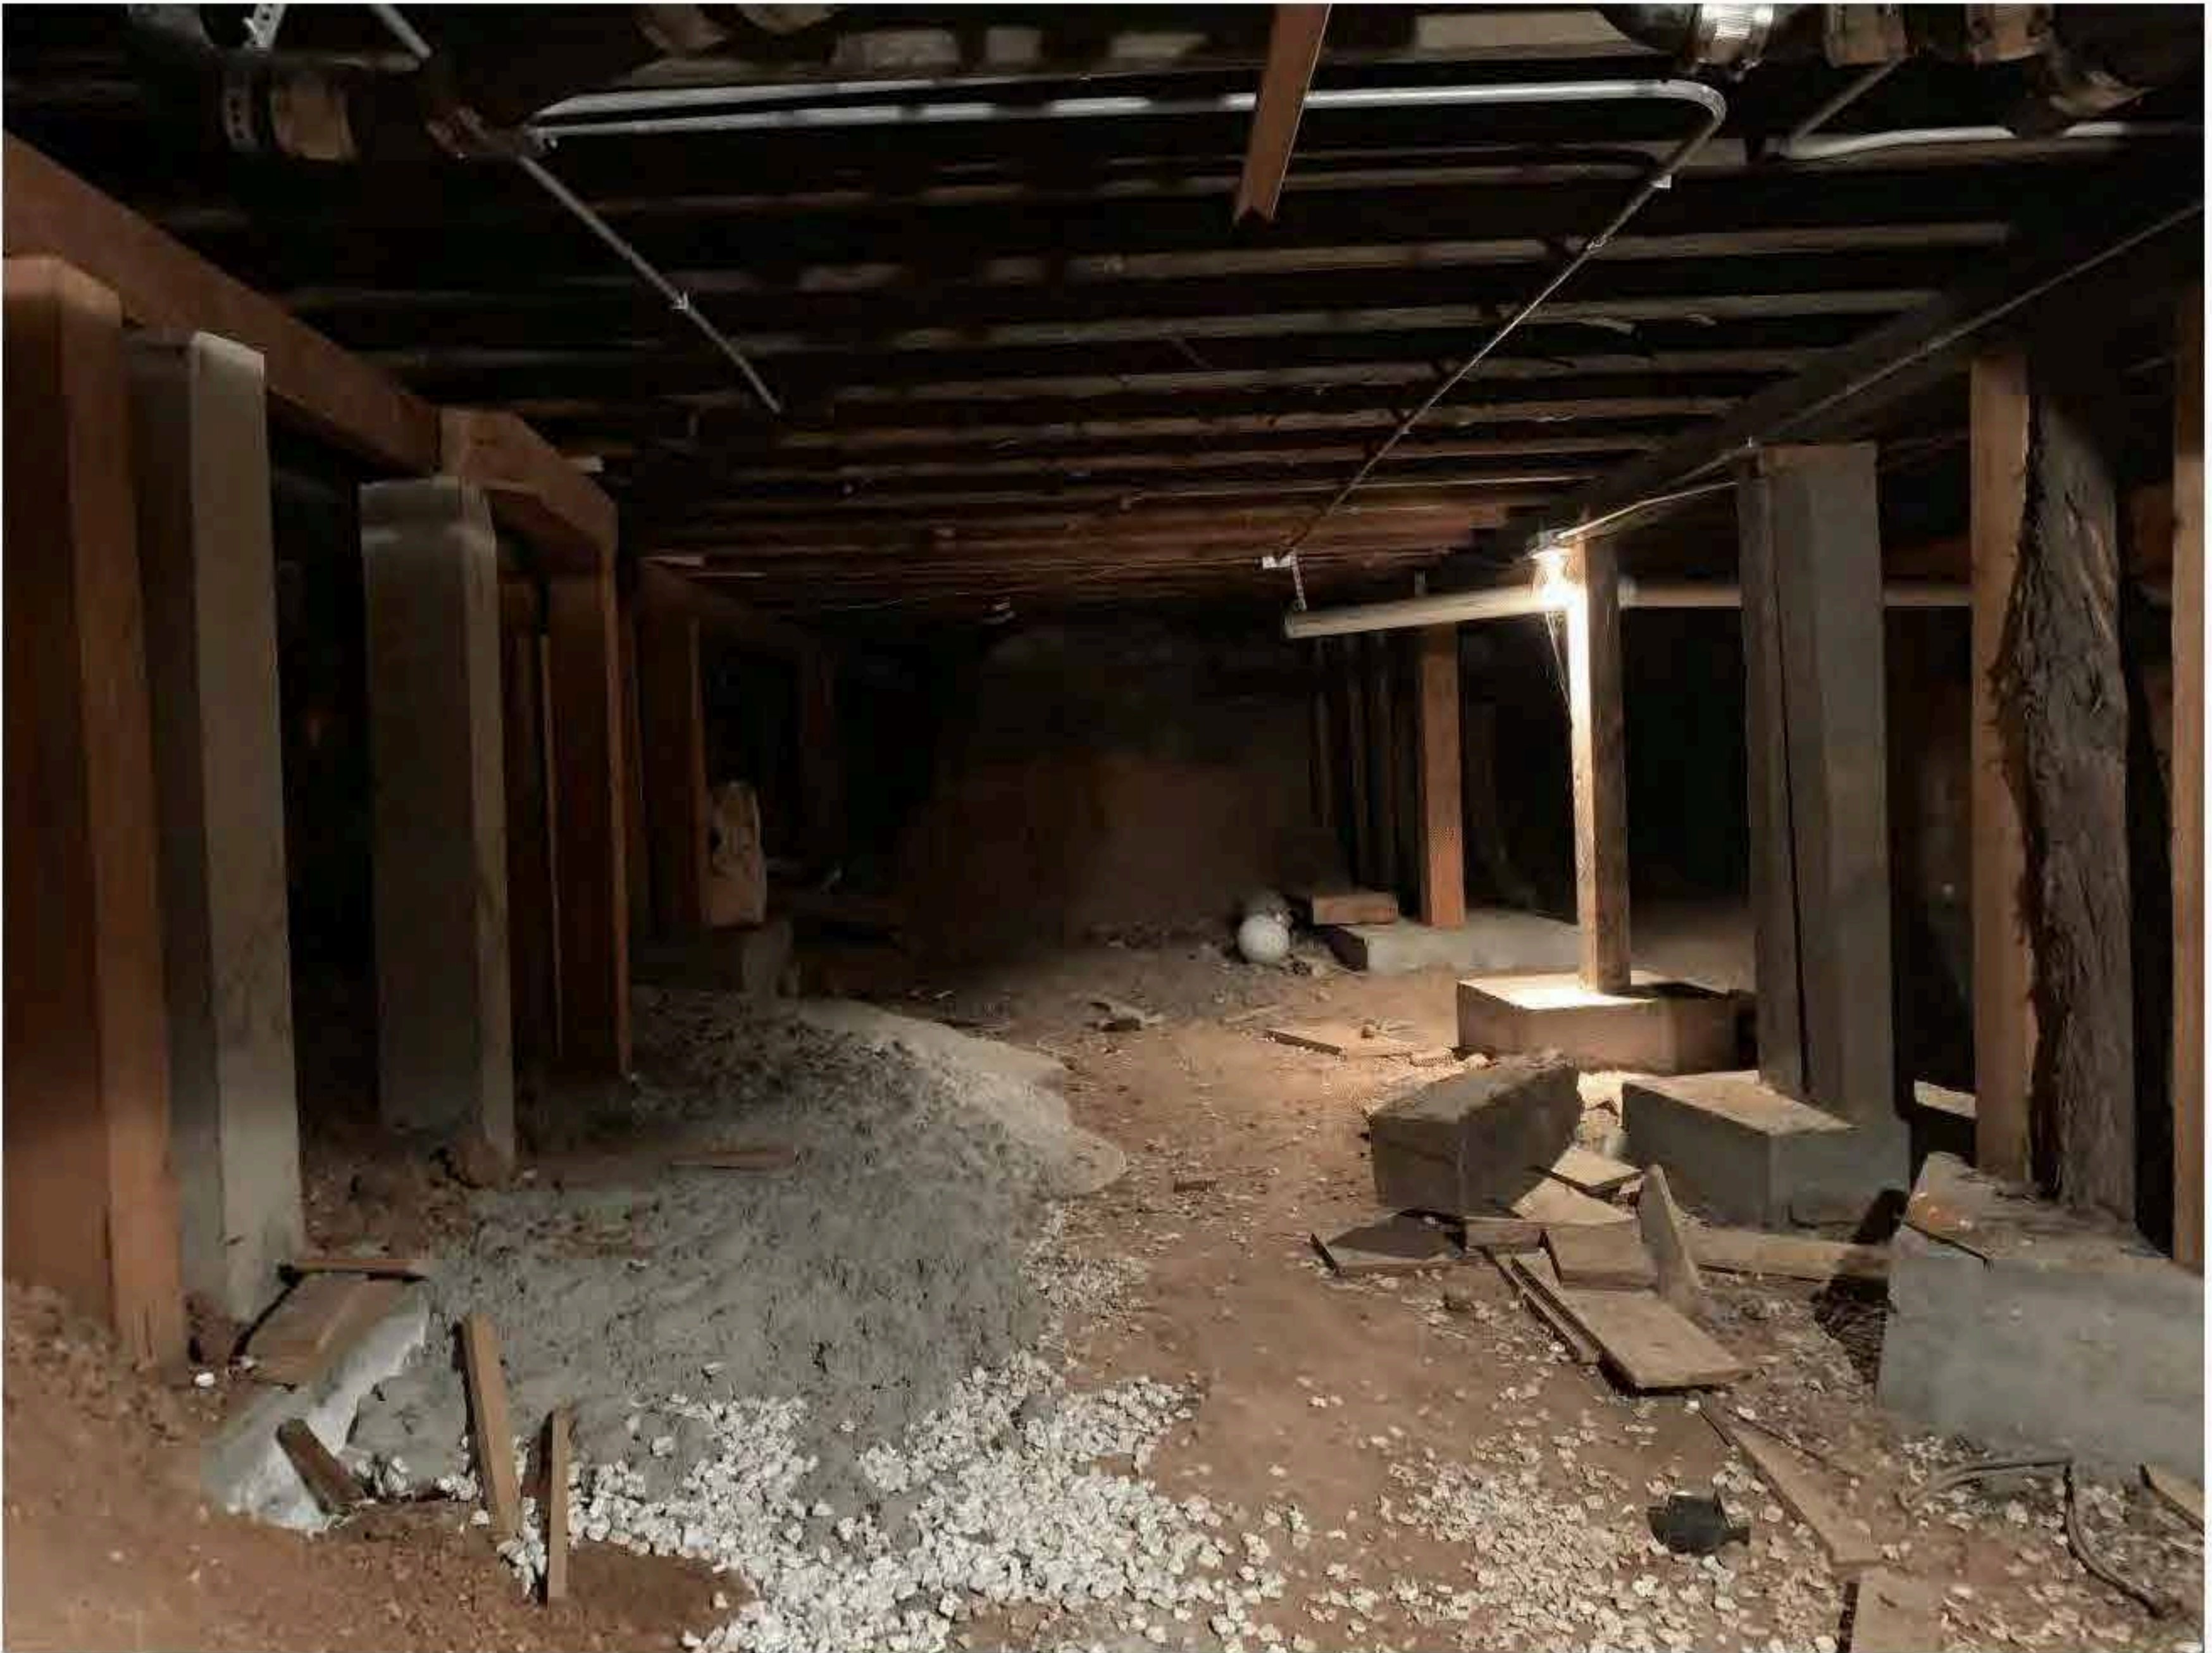
Figure 3.2-1: Earthen basement

The partial basement is excavated earth with approximately 5' floor from the earthen floor to the bottom of the joists. (Figure 3.2-1) The main floor joist spans are supported by a wood beam system of varying ages and sizes. These are supported with heavy timber columns that currently rest on poured concrete footings. There have been successive reinforcements of this part of the floor structure. The most recent was per undated drawings by Charles A Hubbard (See Appendices), though they were not precisely followed, with the PT Timber footings specified being replaced with concrete and the timber posts and beams described being substituted with a variety of scabbed on and replaced LVLs, timbers, and sawn lumber. On the South a poured concrete retaining wall was placed along with additional columns and beams to shore up the earth wall, as well as provide additional floor support.

Some areas of the excavated basement have partially collapsing walls that are gradually sloughing off soil. These are not directly supporting bearing conditions.

Although the basement structure assumably was evaluated by the architect at the time of the latest shoring plans (see Appendices), since a full structural analysis is beyond the scope of this report, and there are no engineering or assessment details of the structural system as a whole from those plans or any other, and there are leaks and periodic flooding in the basement, it is highly recommended that a qualified structural engineer prepare a full structural analysis of the building, with particular emphasis paid to the foundations, basement and main floor framing (Serious).

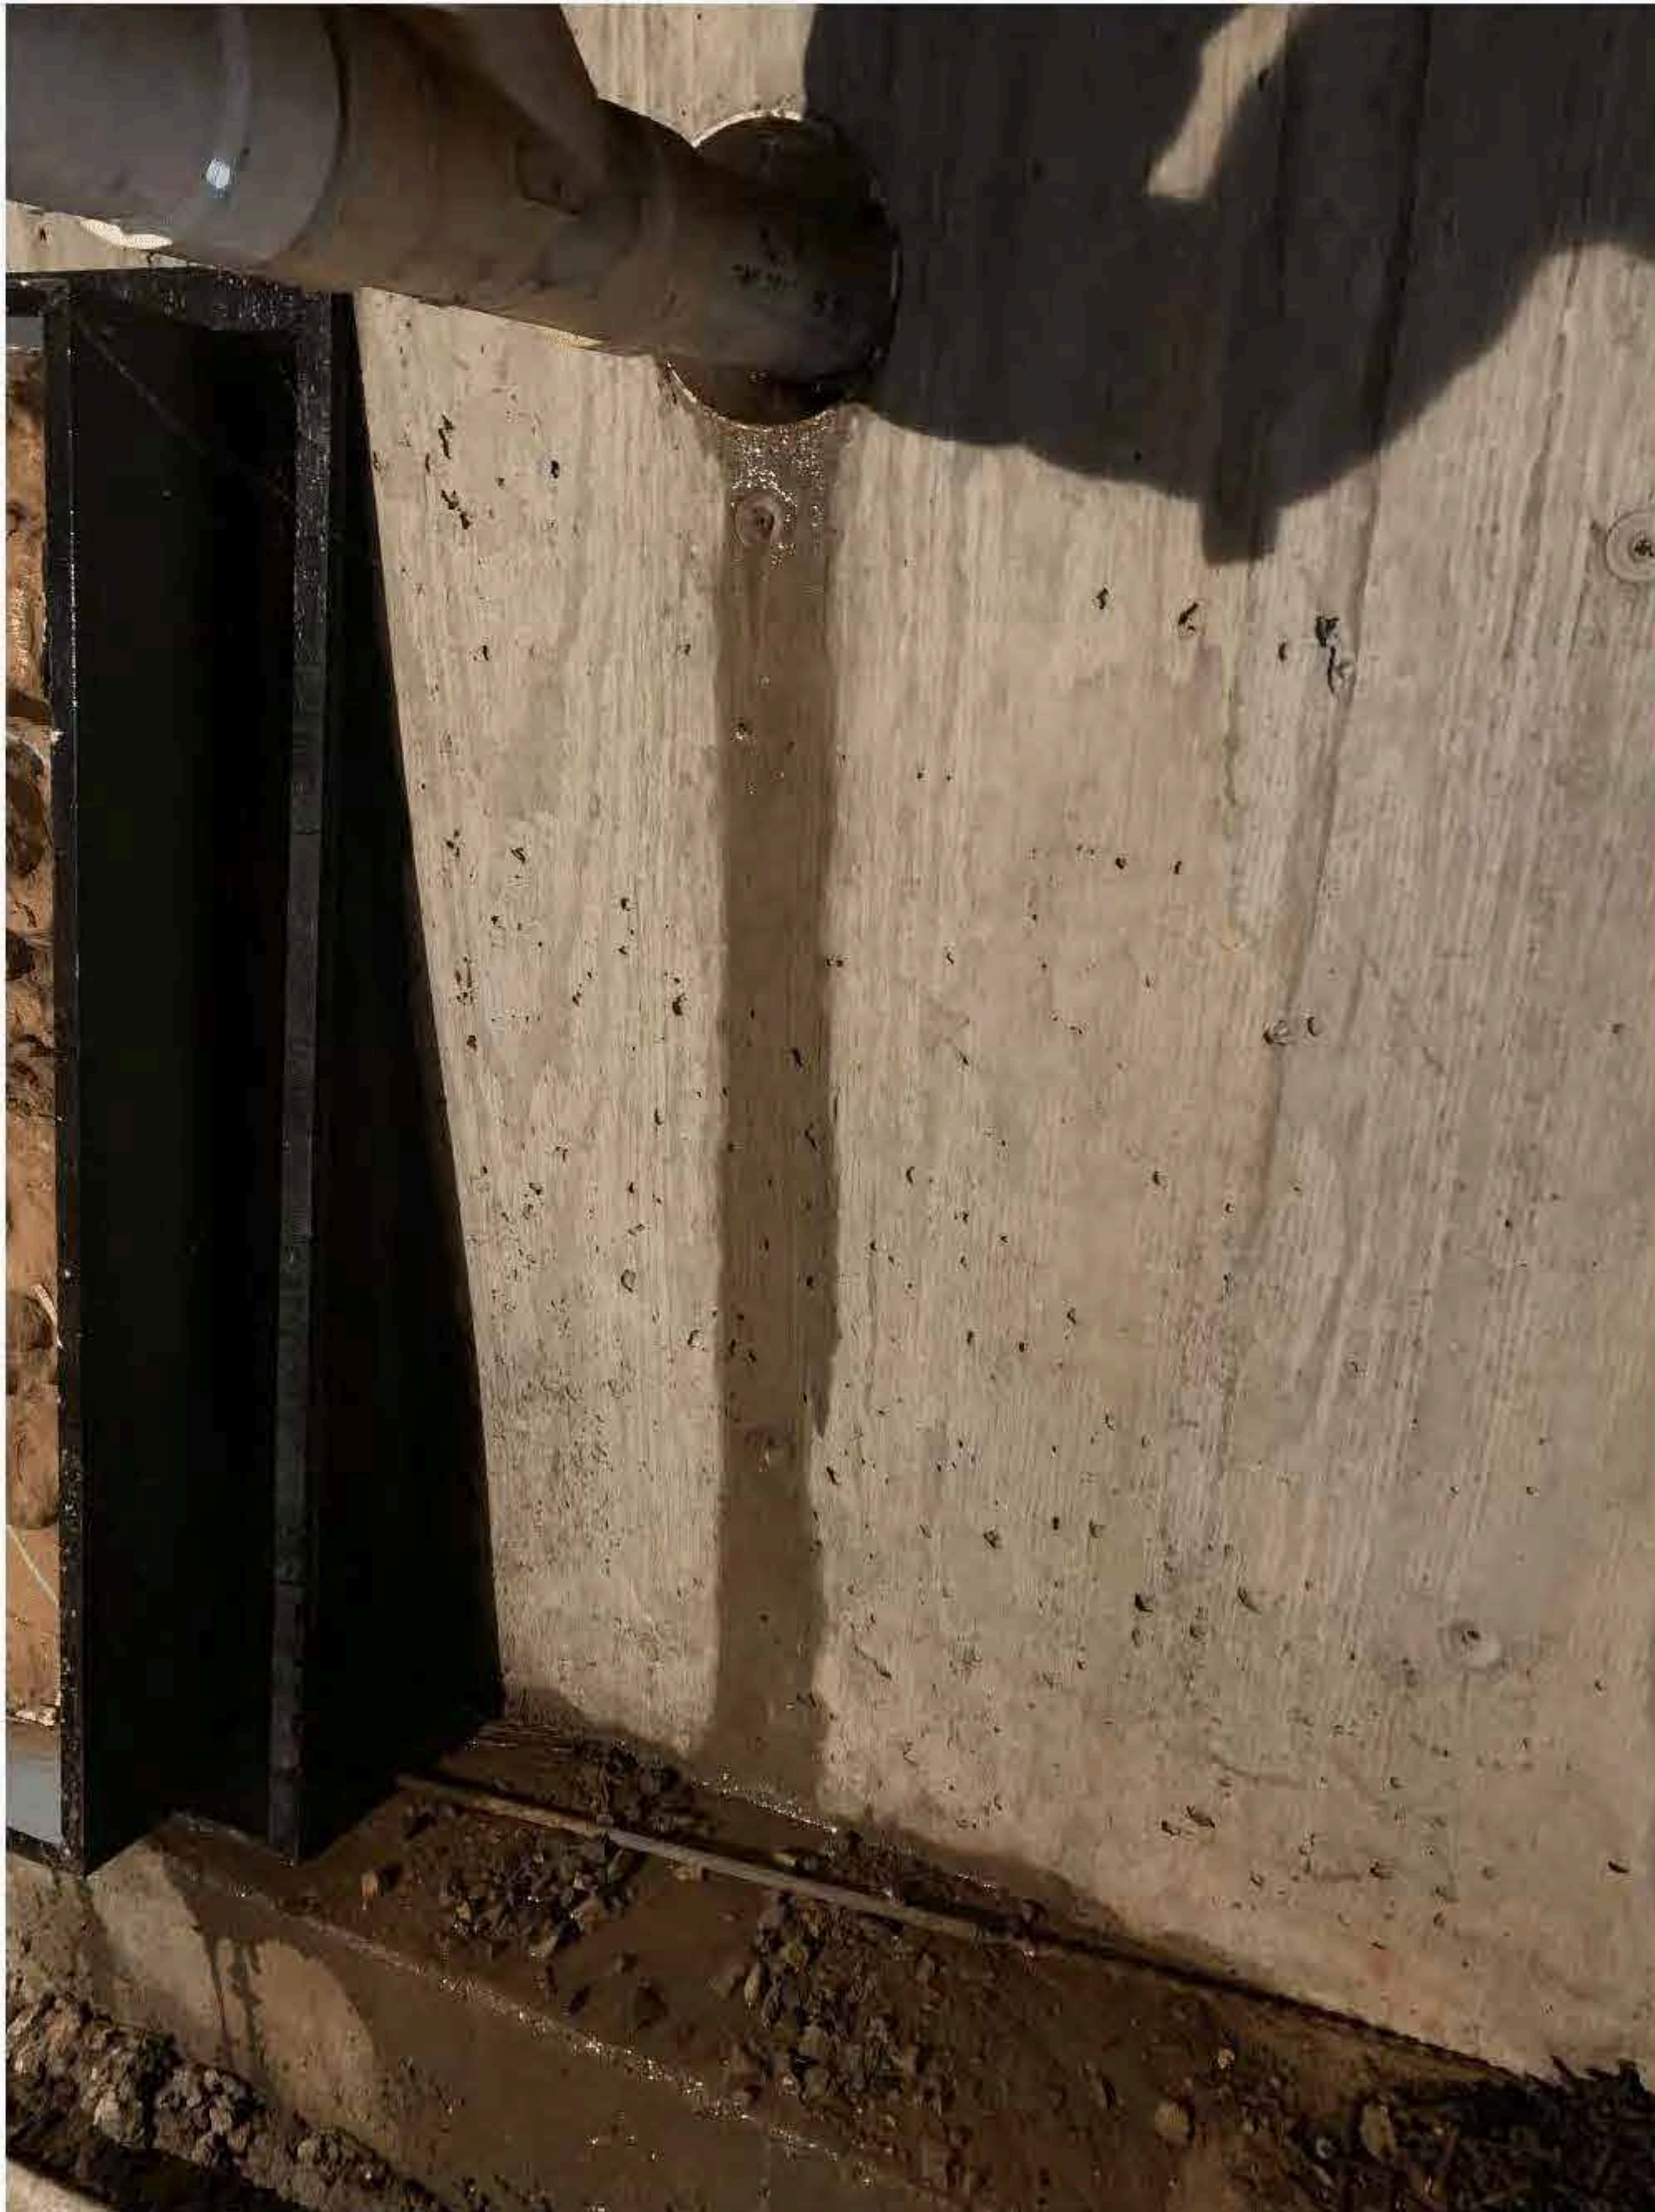
Figure 3.2-3: Leaking sleeve at basement retaining

There are leaks from two spots that cause the basement to flood periodically, which requires a sump pump to mitigate. One is at a drain pipe sleeve at a retaining wall. (Figure 3.2-3) The other appears to be leakage from the exterior at ground level.

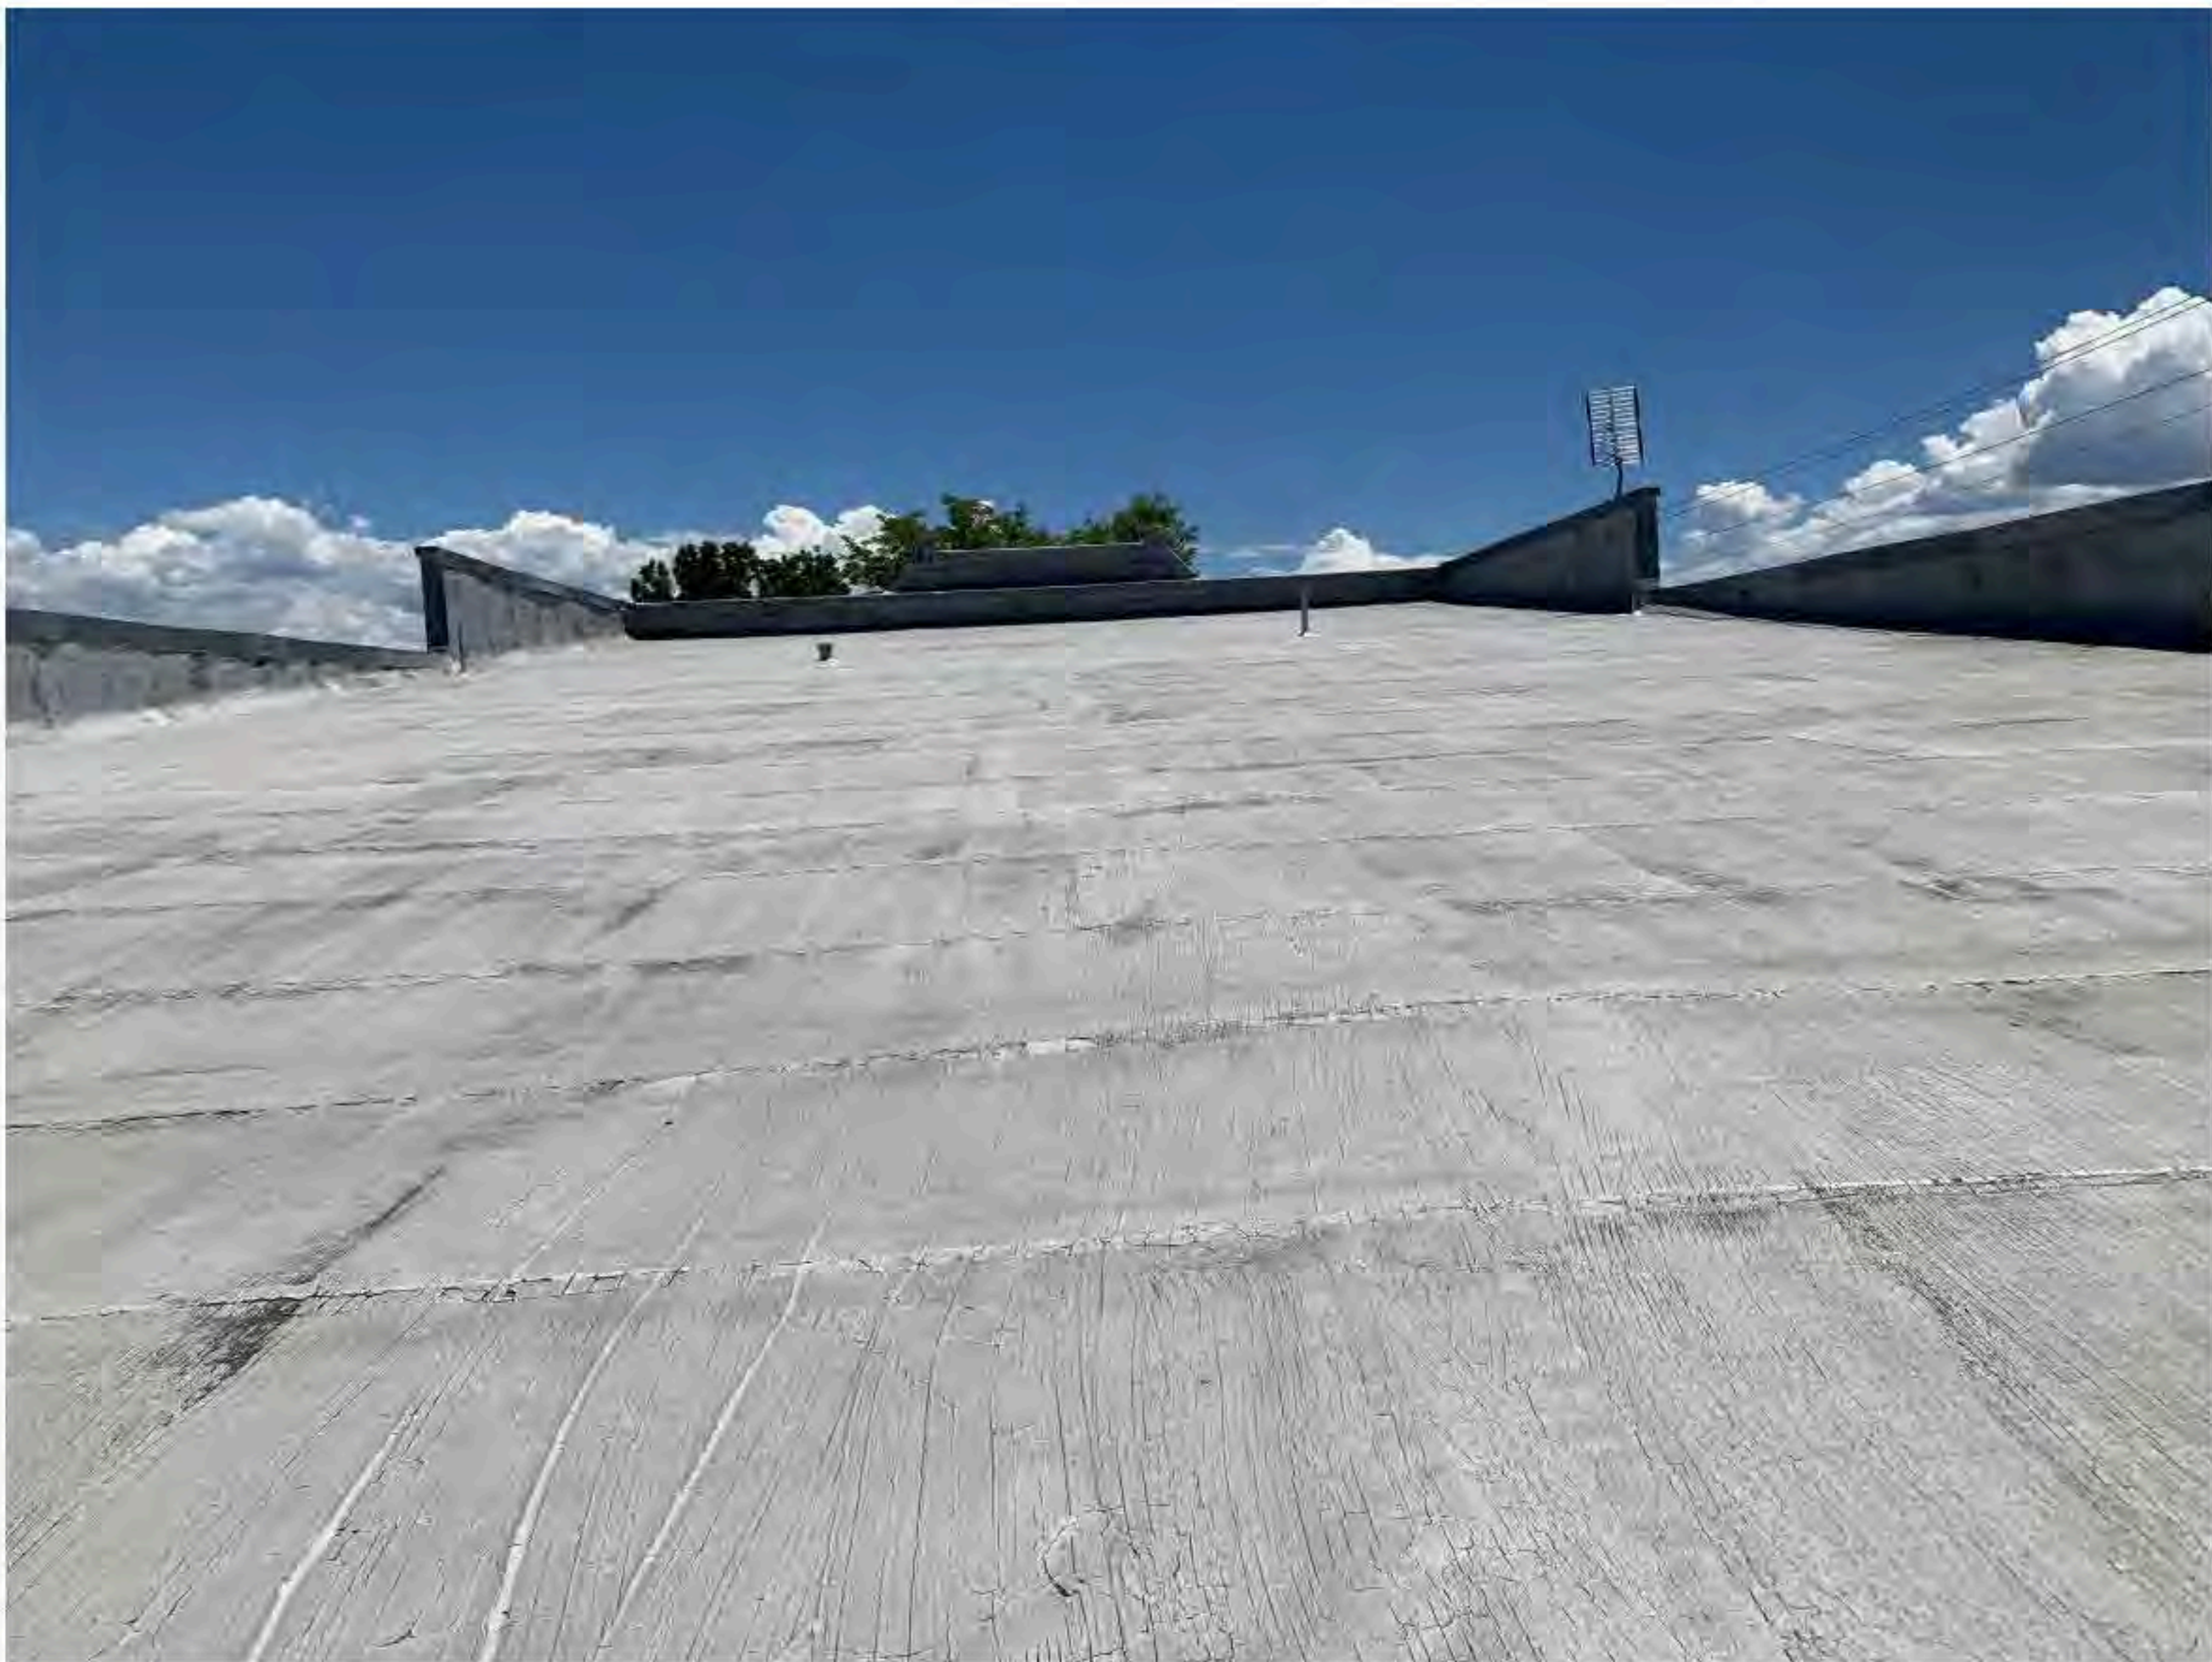
Figure 3.4-1: Main roof

The main roof is a lapped rubber sheeting with an older silver reflective paint coating (Figure 3.4-1), its age is unknown, as is the age of the coating. It wraps at the roof edges up the parapet walls and terminates under galvanized steel parapet cap flashing. The substrate is rough sawn 1x lumber as observed from crawl space access hatches on the upper level.

The main roof covering is in Fair to Poor condition with no known interior leaks. Overall the age of the coating and roof covering appears old and nearing the end of its service life. The drip edge is not adhered to the flashing and water is likely making its way back behind the flashing.

A qualified roofing professional should evaluate the drip edge condition and determine and implement a course of repair. Routine examination and maintenance of the main roof should then continue to ensure that it continues to function properly and remain leak free. (Critical)

The roof will likely need replaced within 5 years. At this time, all flashings, termination bars, roof jacks / penetrations, etc. should be replaced per roofing manufacturer / architects details. Particular attention should be paid to ensure that new cap flashings and any other visible flashing / hardware does not damage or interfere with the Masker facade, parapet etc. Any visible portions should have a matte finish that is harmonious with the facade. (Serious)
