# Historic Structure Assessment

## Cortez Cultural Center

25 N Market St., Cortez, CO 81321

SHF Project # 2019-HA-001

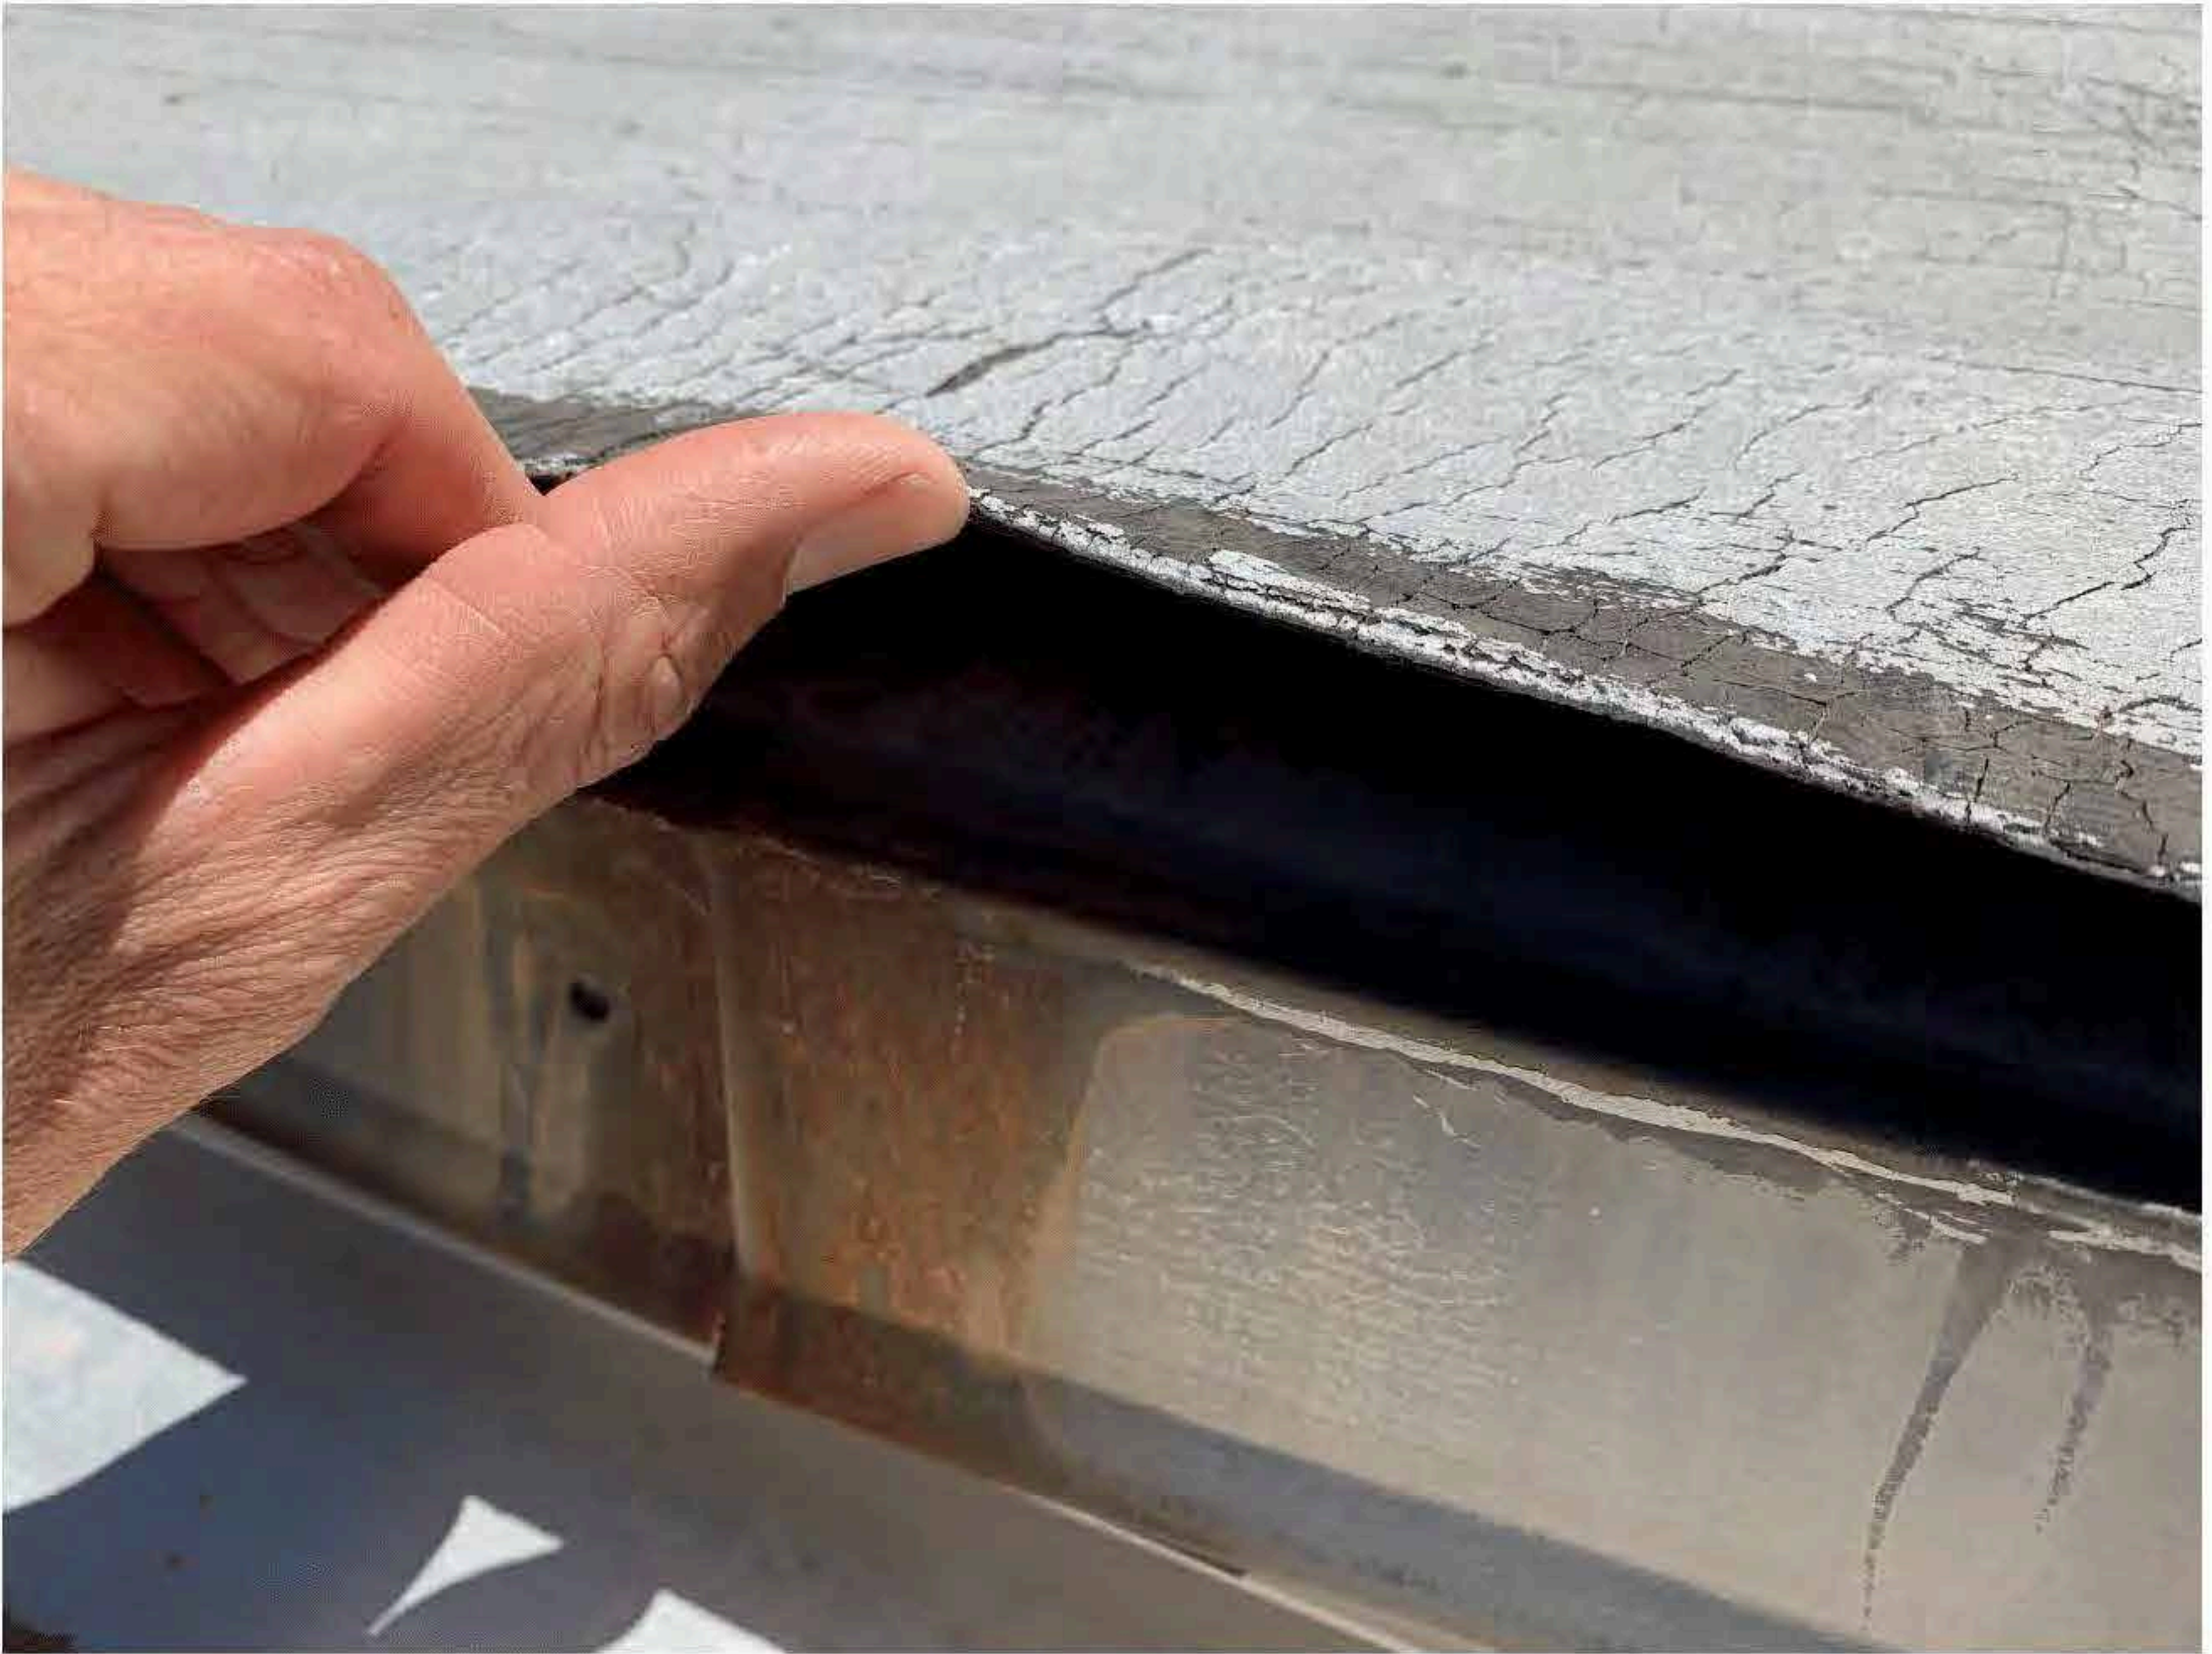
Figure 3.4-4: Drip edge flashing roofing delamination

The main roof covering is in Fair to Poor condition with no known interior leaks. Overall the age of the coating and roof covering appears old and nearing the end of its service life. The drip edge is not adhered to the flashing and water is likely making its way back behind the flashing.

A qualified roofing professional should evaluate the drip edge condition and determine and implement a course of repair. Routine examination and maintenance of the main roof should then continue to ensure that it continues to function properly and remain leak free. (Critical)

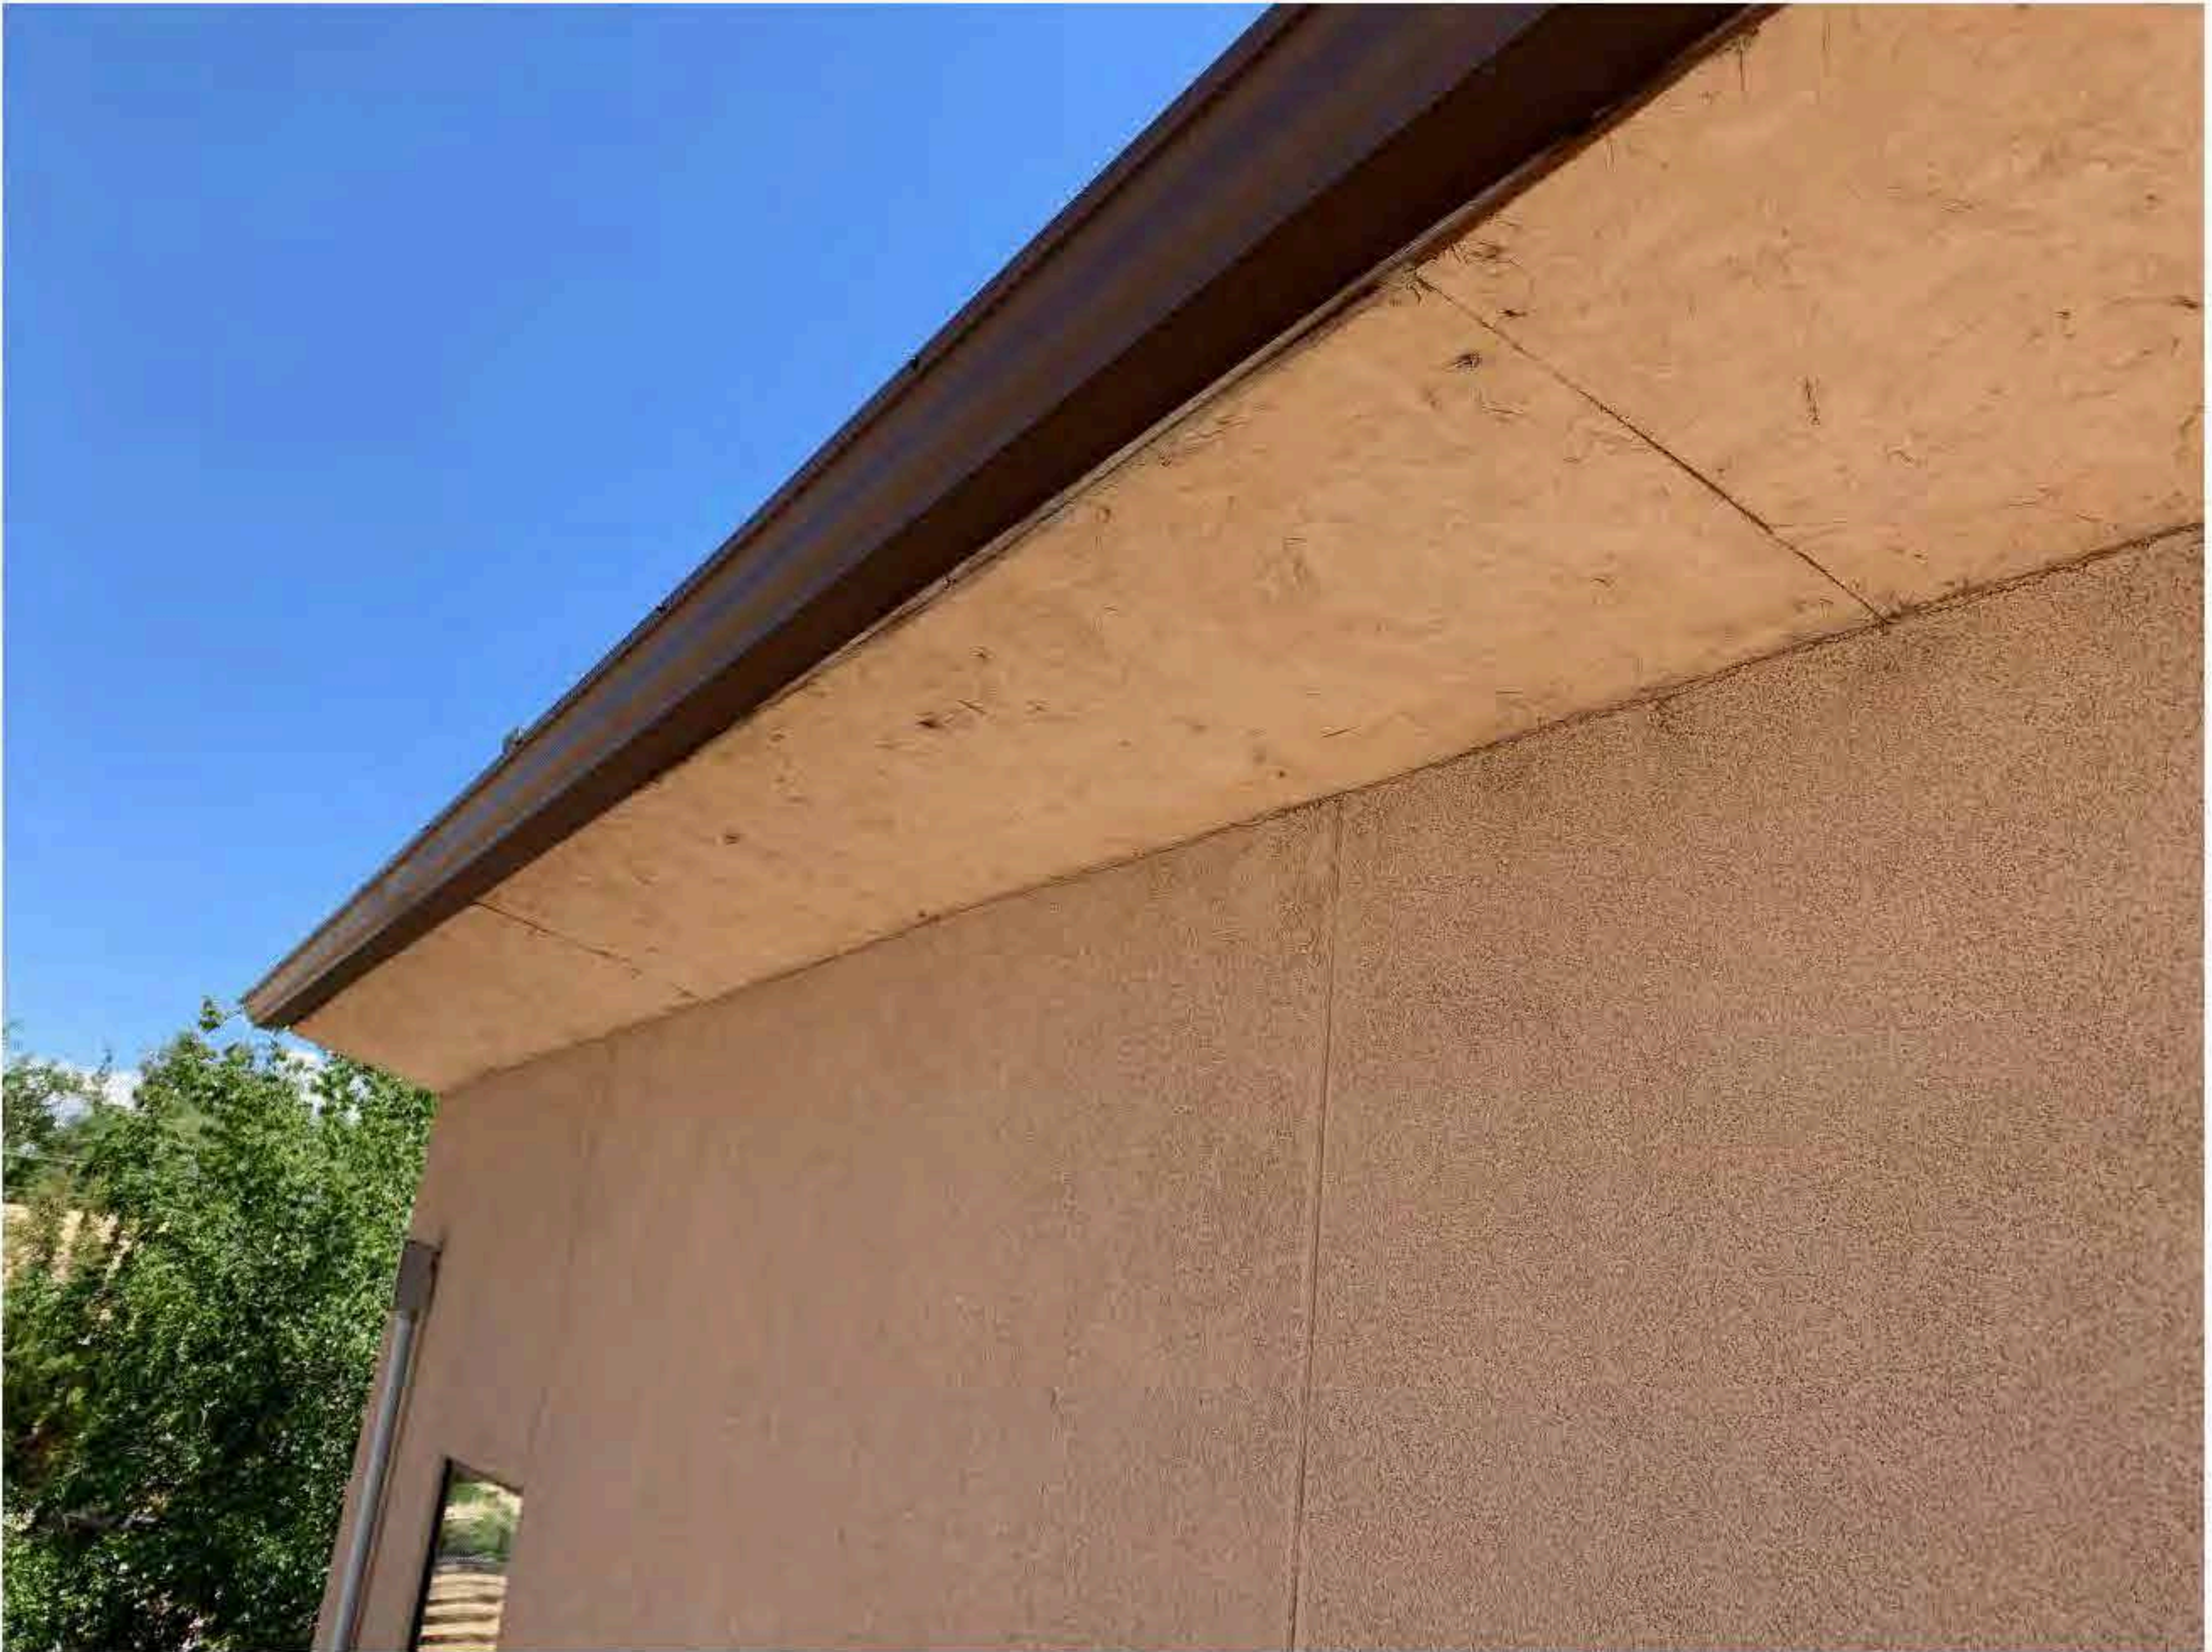
Figure 3.4-7: New OSB soffit

The rear soffit was replaced, presumably at the time the rear wall was re-stuccoed, with OSB which has only a light paint covering on it (figure 3.4-7).

The soffit should be replaced as part of larger renovation work but could be painted or covered temporarily if a more finished appearance is desired. (Minor)

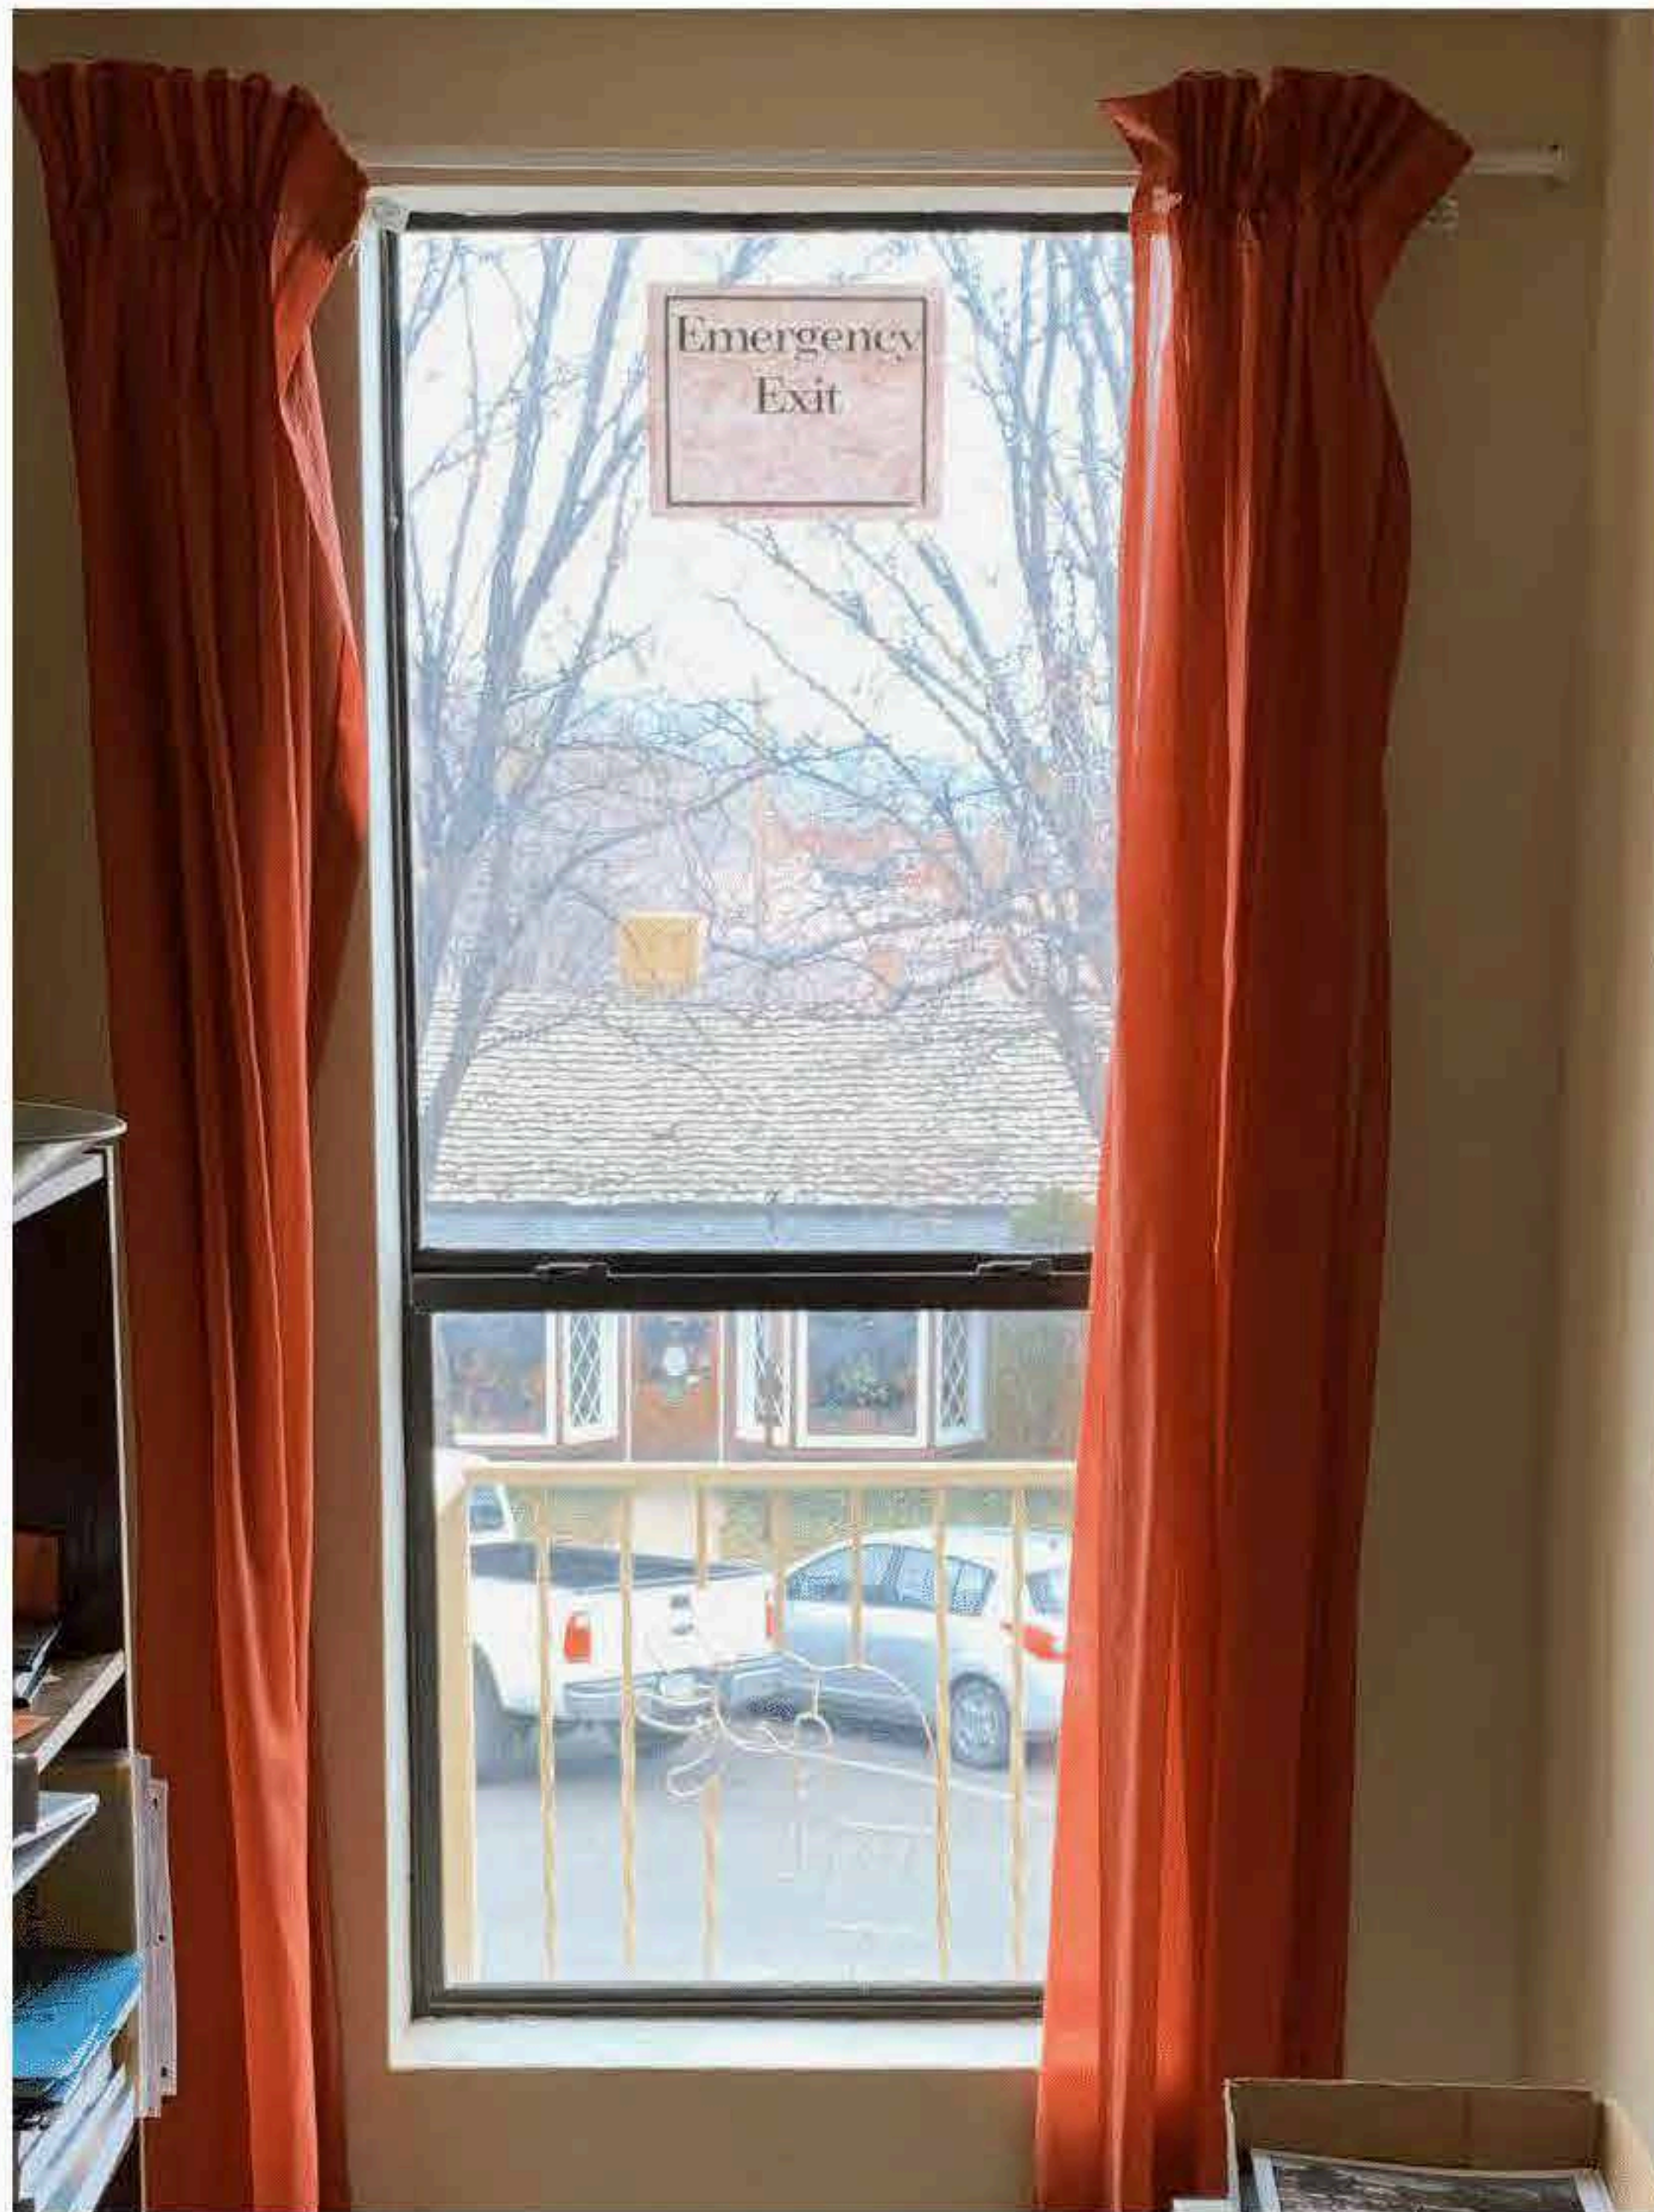
Figure 3.5-7: Current typical single hung aluminum window

The windows are in Fair condition. Not all of the upper windows open properly, several screens need replaced, but no leaks have been observed. They are not energy efficient.

The windows are functional as is but are recommended to be replaced with more historically accurate but energy efficient double hung, one-over-one wood window units, with the main level street facing storefront being returned to its original configuration. The non-original central window on the front (East) facade that was presumably added for egress reasons, seriously disrupted the integrity of the Mesker facade should be removed if a code compliance path can be established to allow it. See the Preservation Plan section of this report for more detail.

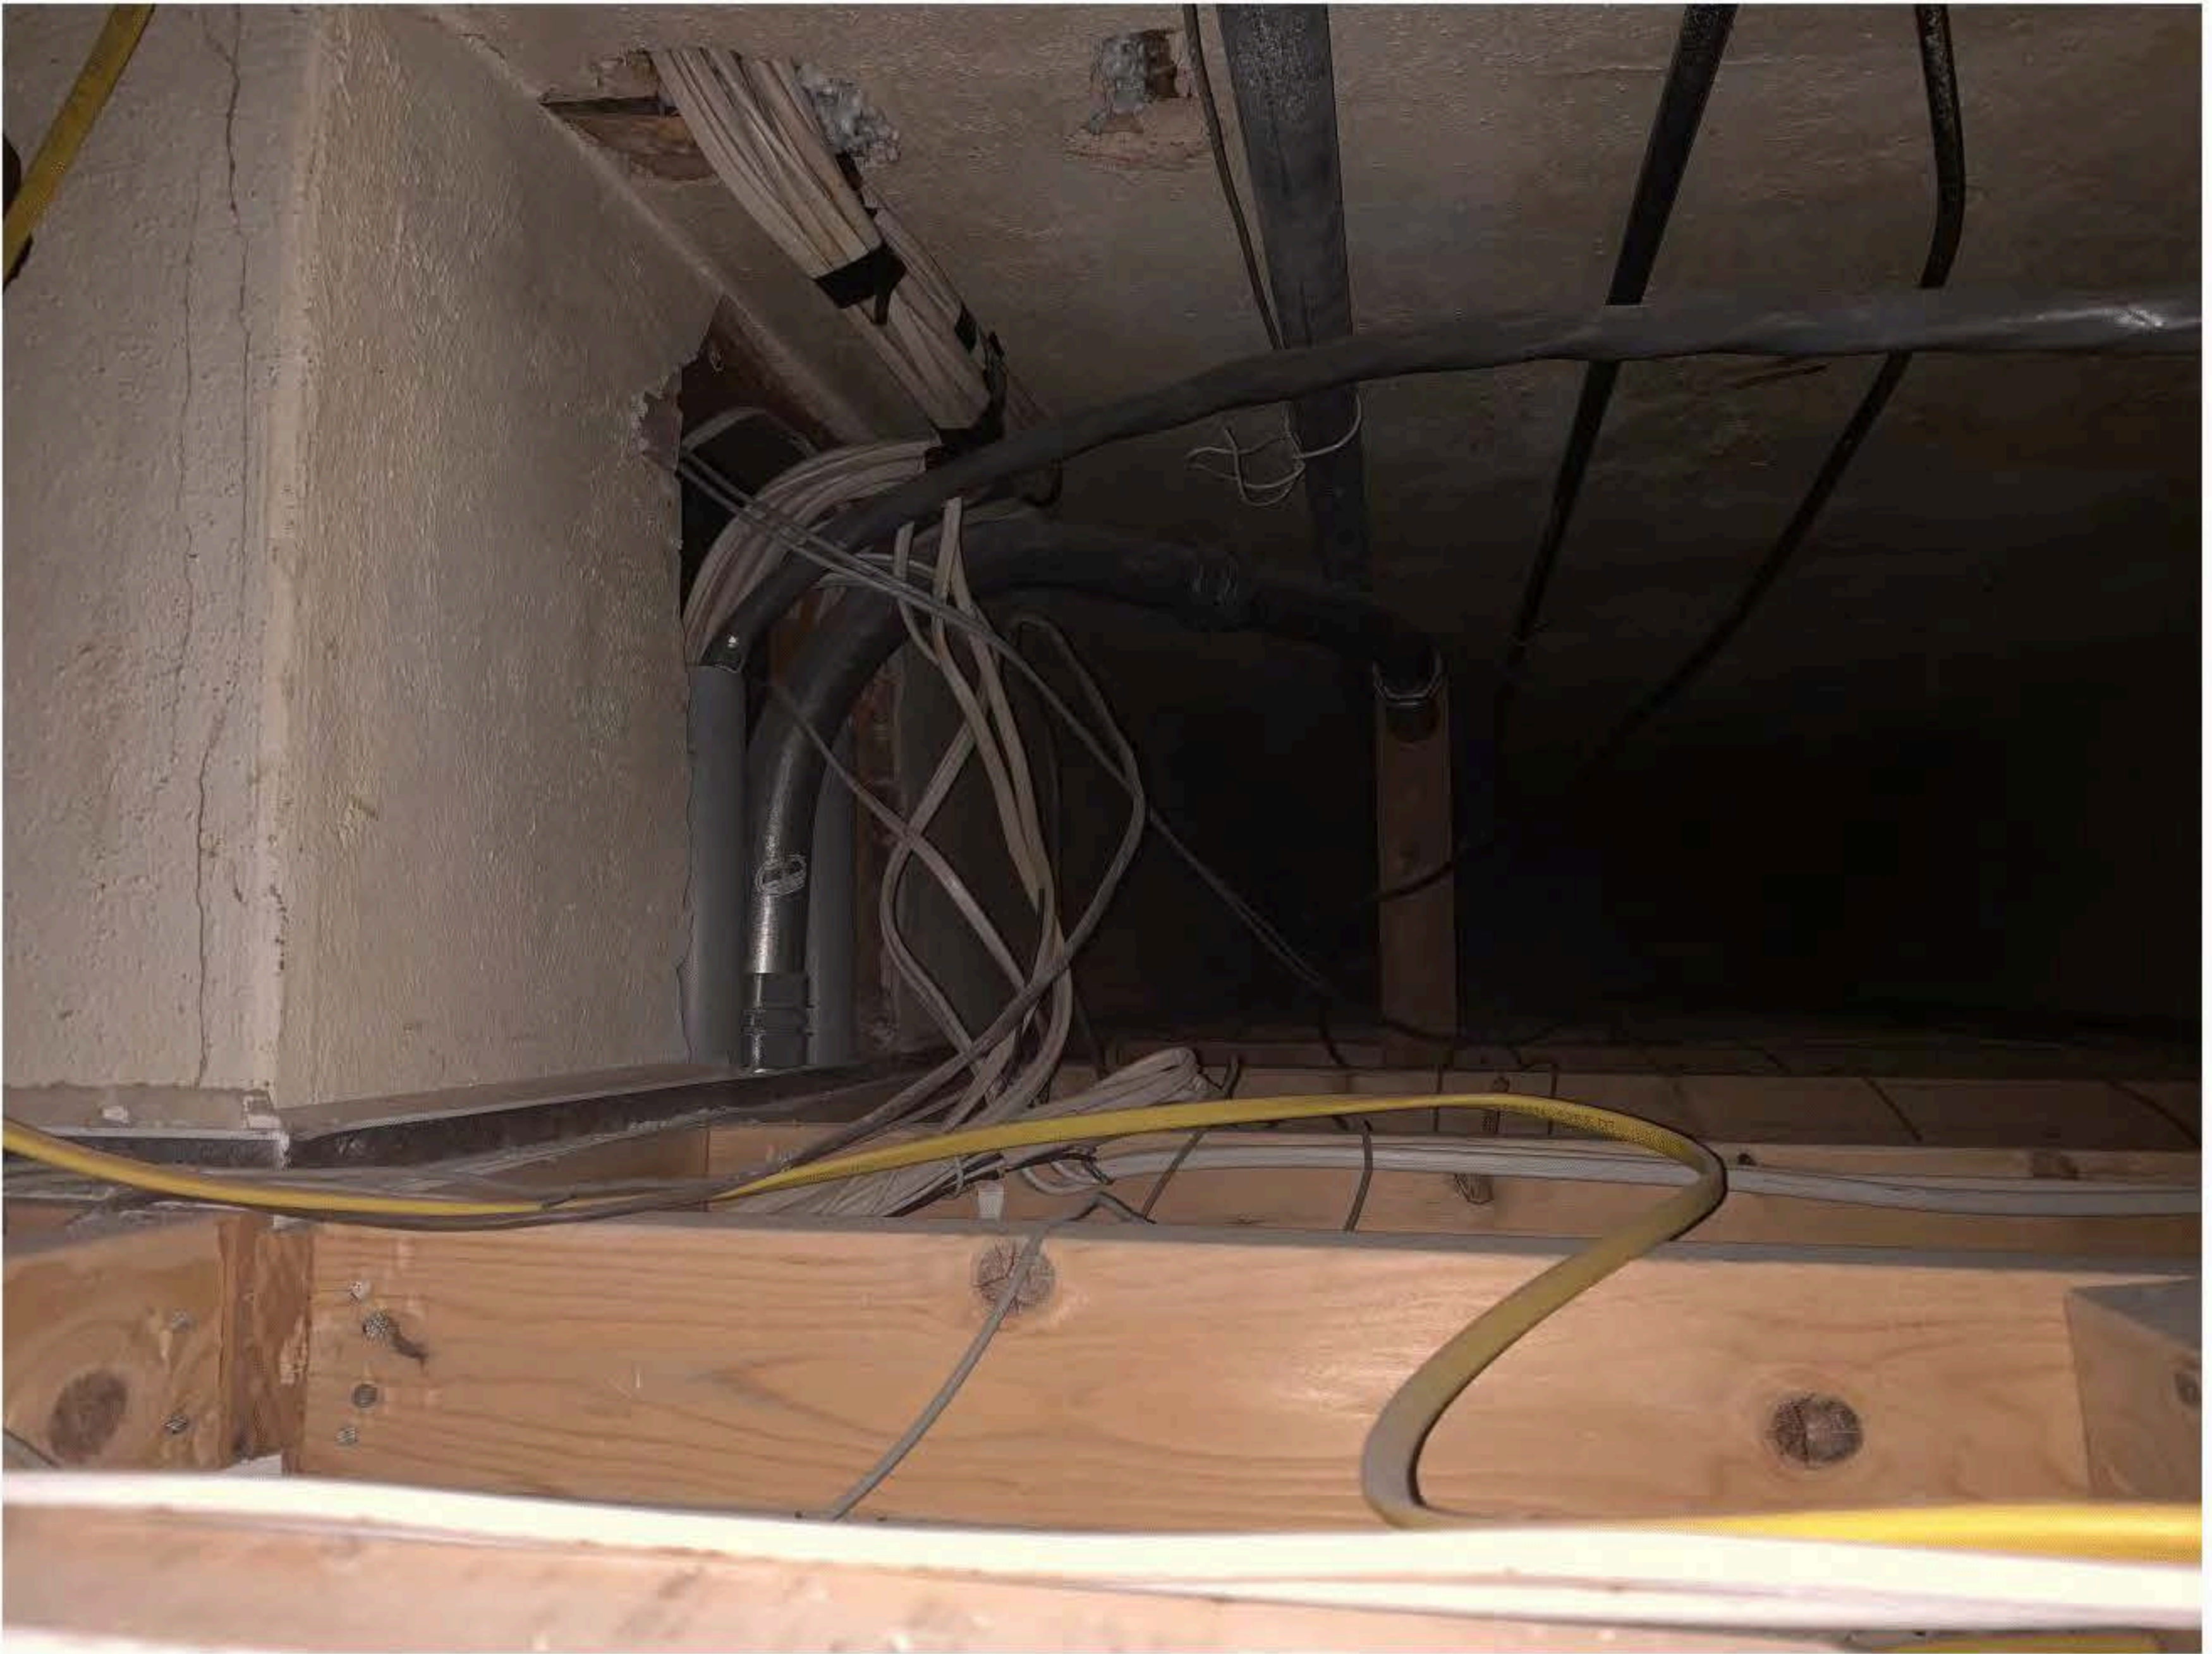
Figure 3.8-4: Upper level wire runs

Much of the renovation work that was done included running a large amount of new wiring above the new dropped ceilings. In general, this is a mess and exhibits a lack of detail and clean and professional installation methods but no obvious unsafe electrical conditions were observed. (Note that this is a general observation only, a qualified electrician or electrical inspector should be consulted for electrical code analysis.)
