# Historic Structure Assessment

## Cortez Cultural Center

25 N Market St., Cortez, CO 81321

SHF Project # 2019-HA-001

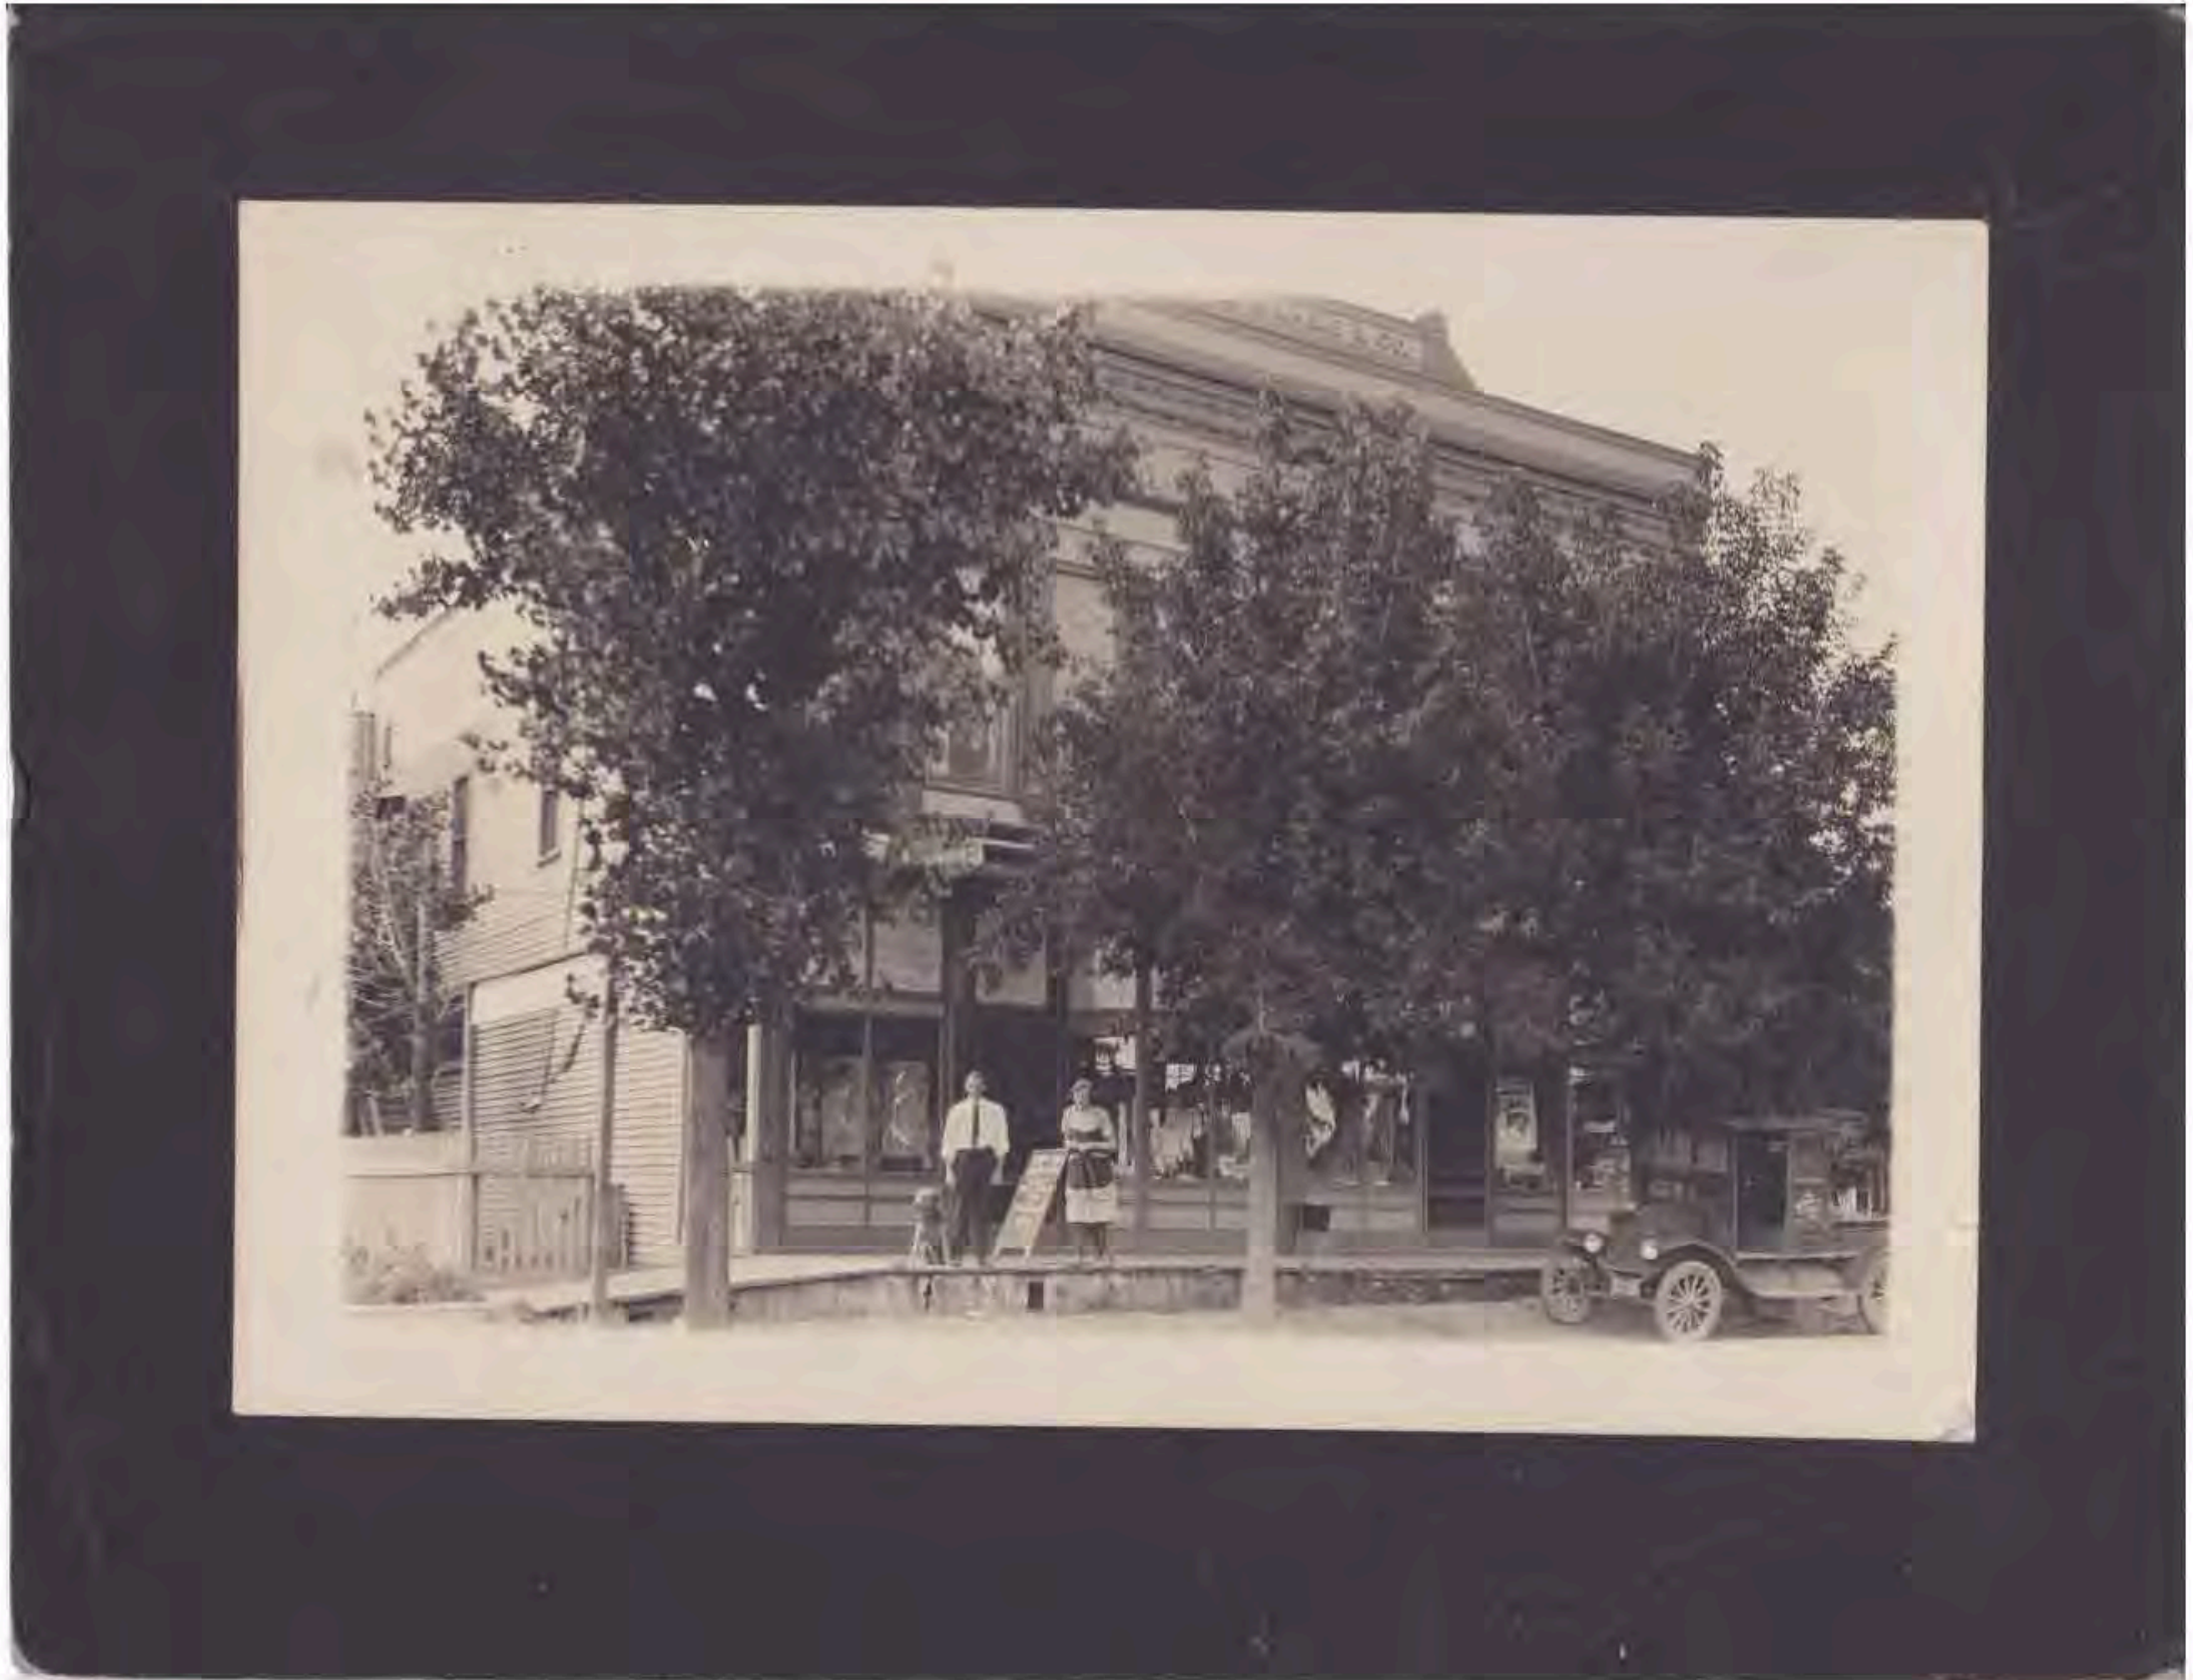
Figure 2-1: Original configuration of the E.R. Lamb Mercantile

The E.R. Lamb Mercantile building was built in 1909 by Edwin R. and Mary A. Lamb (Note that his name is often mistakenly listed as Edward). It was a prime example of 19th century small town commercial architecture, featuring an elaborate pressed tin upper level storefront, cornice, and pediment signage by Mesker Bros. of St. Louis, MO (Figure 1, as identified by Got

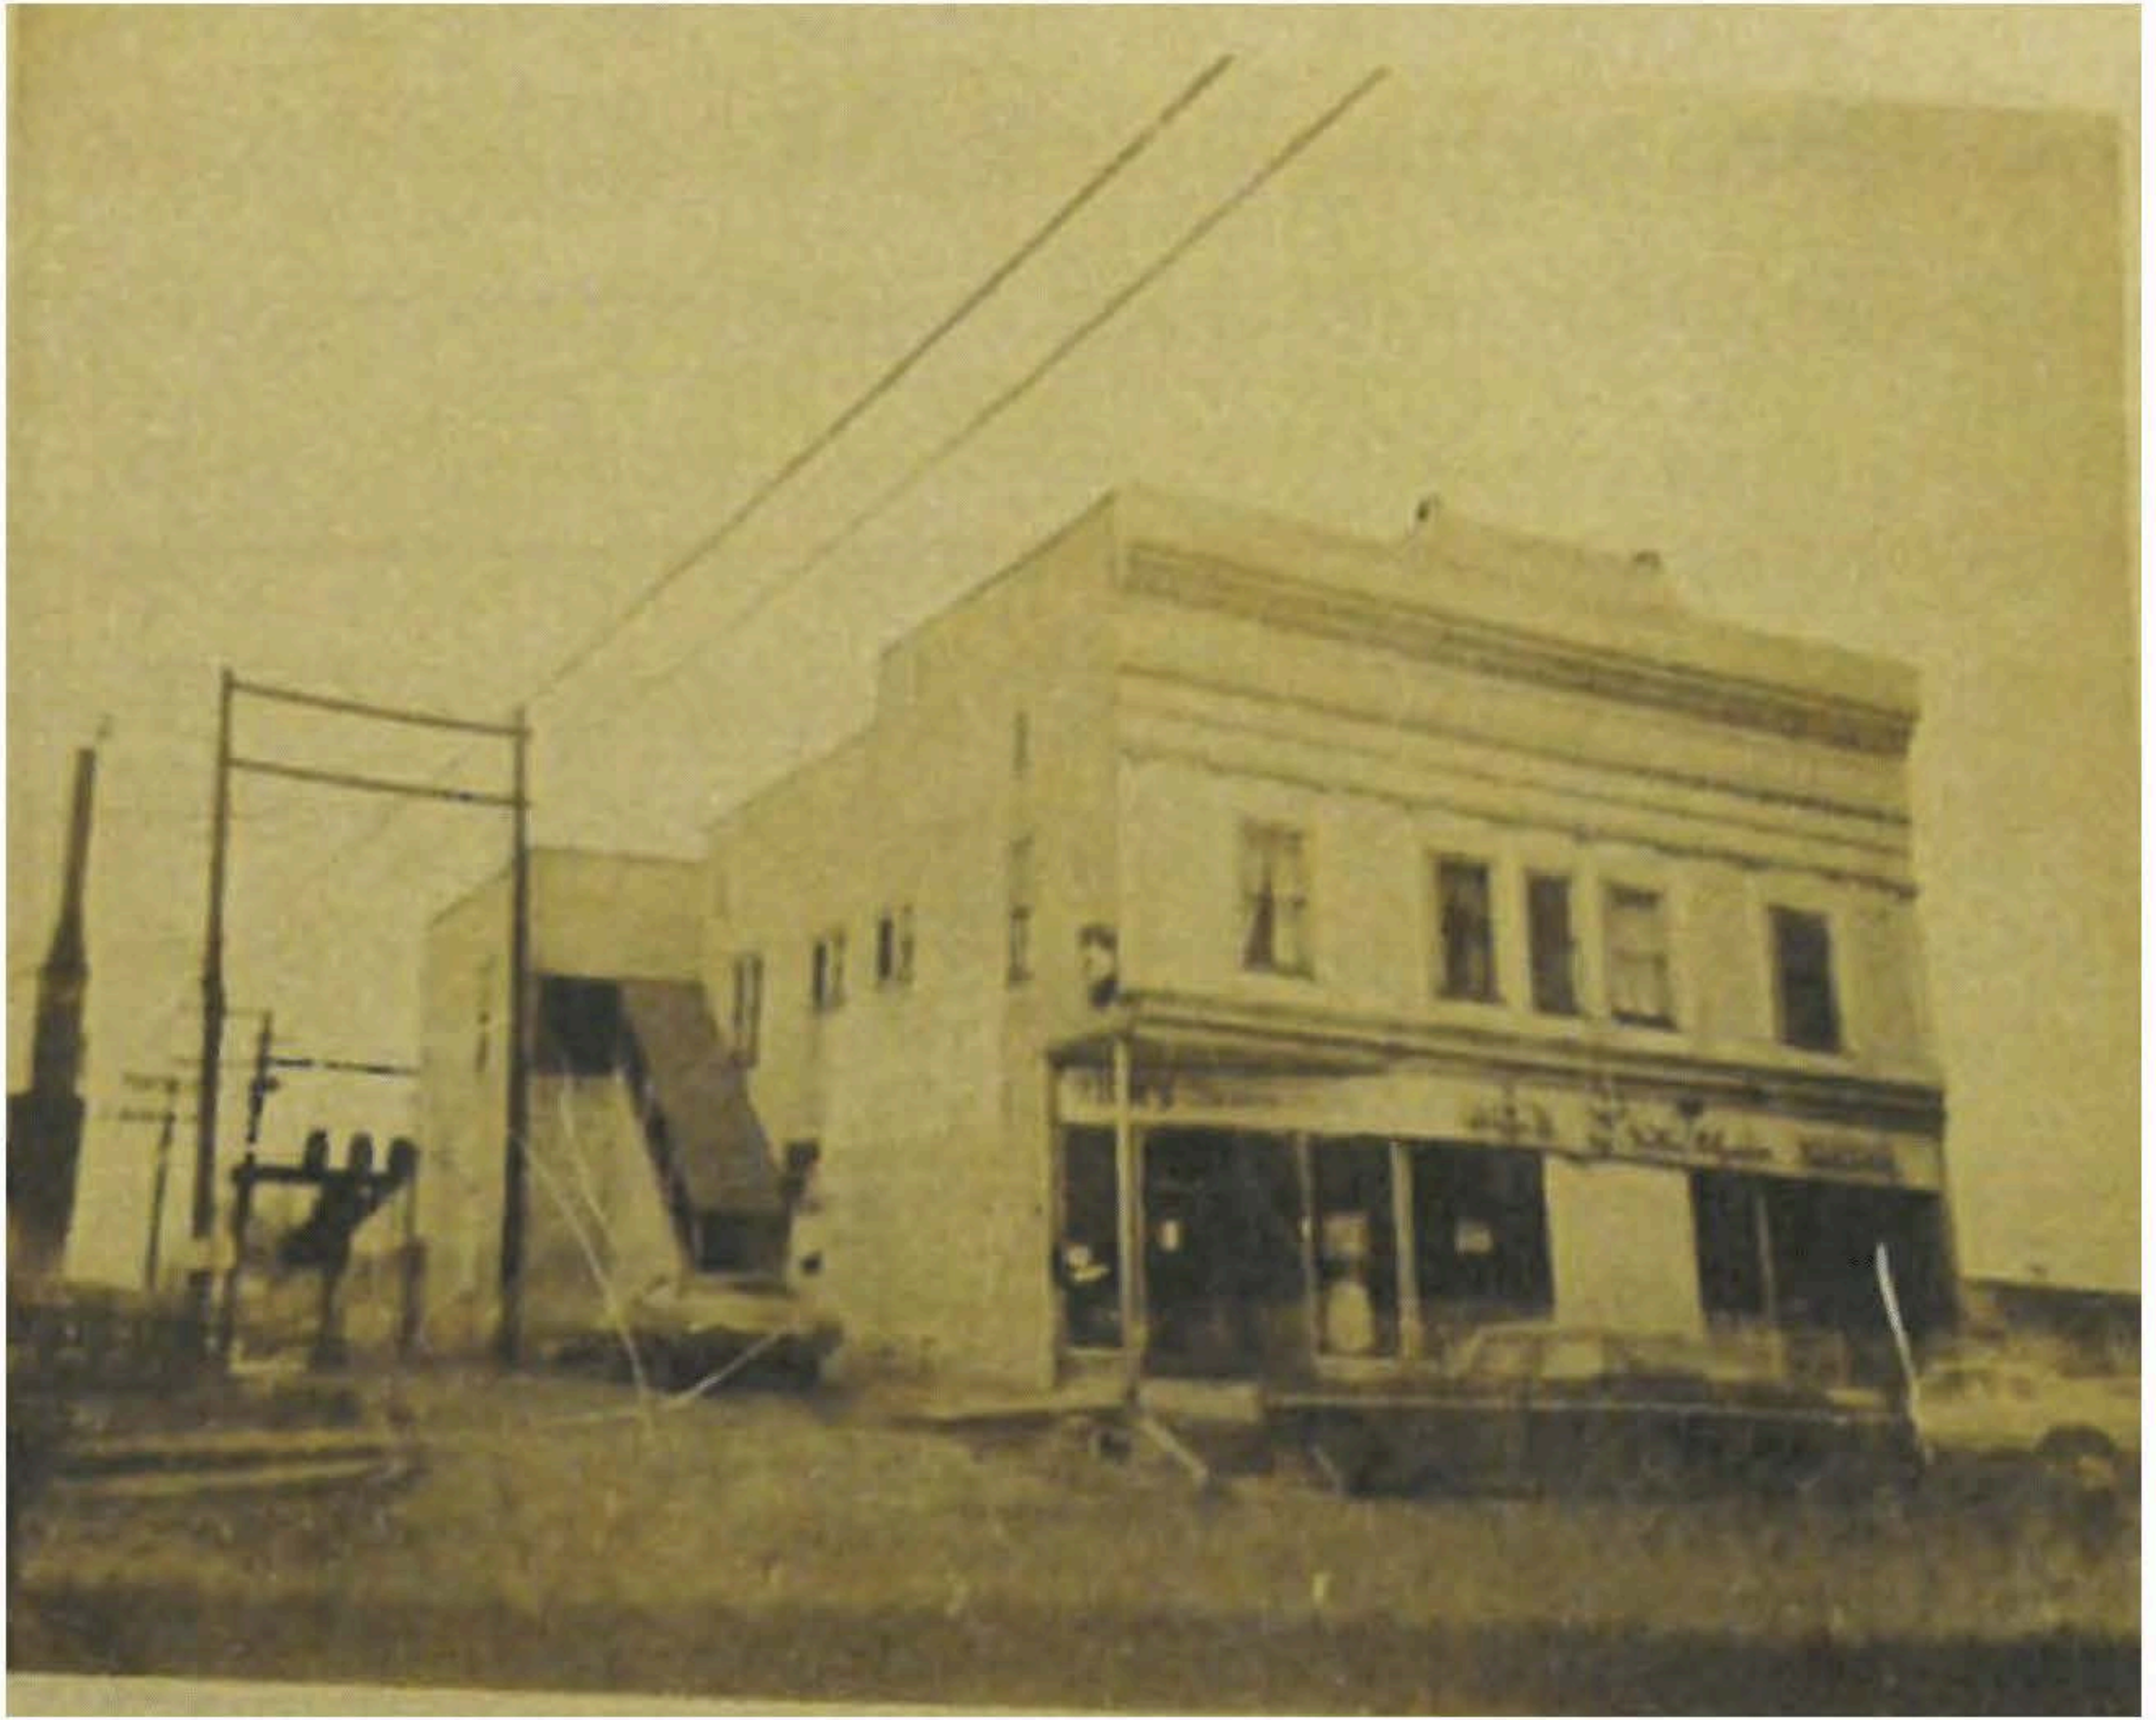
Figure 2-2: Circa 1960's photograph after alterations

The building has been extensively altered by at least 2 remodels. Sometime prior to a photograph taken in the 1960's, the original millwork and plate glass storefront and entrance was replaced with a then contemporary aluminum and glass storefront with accompanying signage band and a central window was added to the front (East) facade on the 2nd. floor (Figure 2).

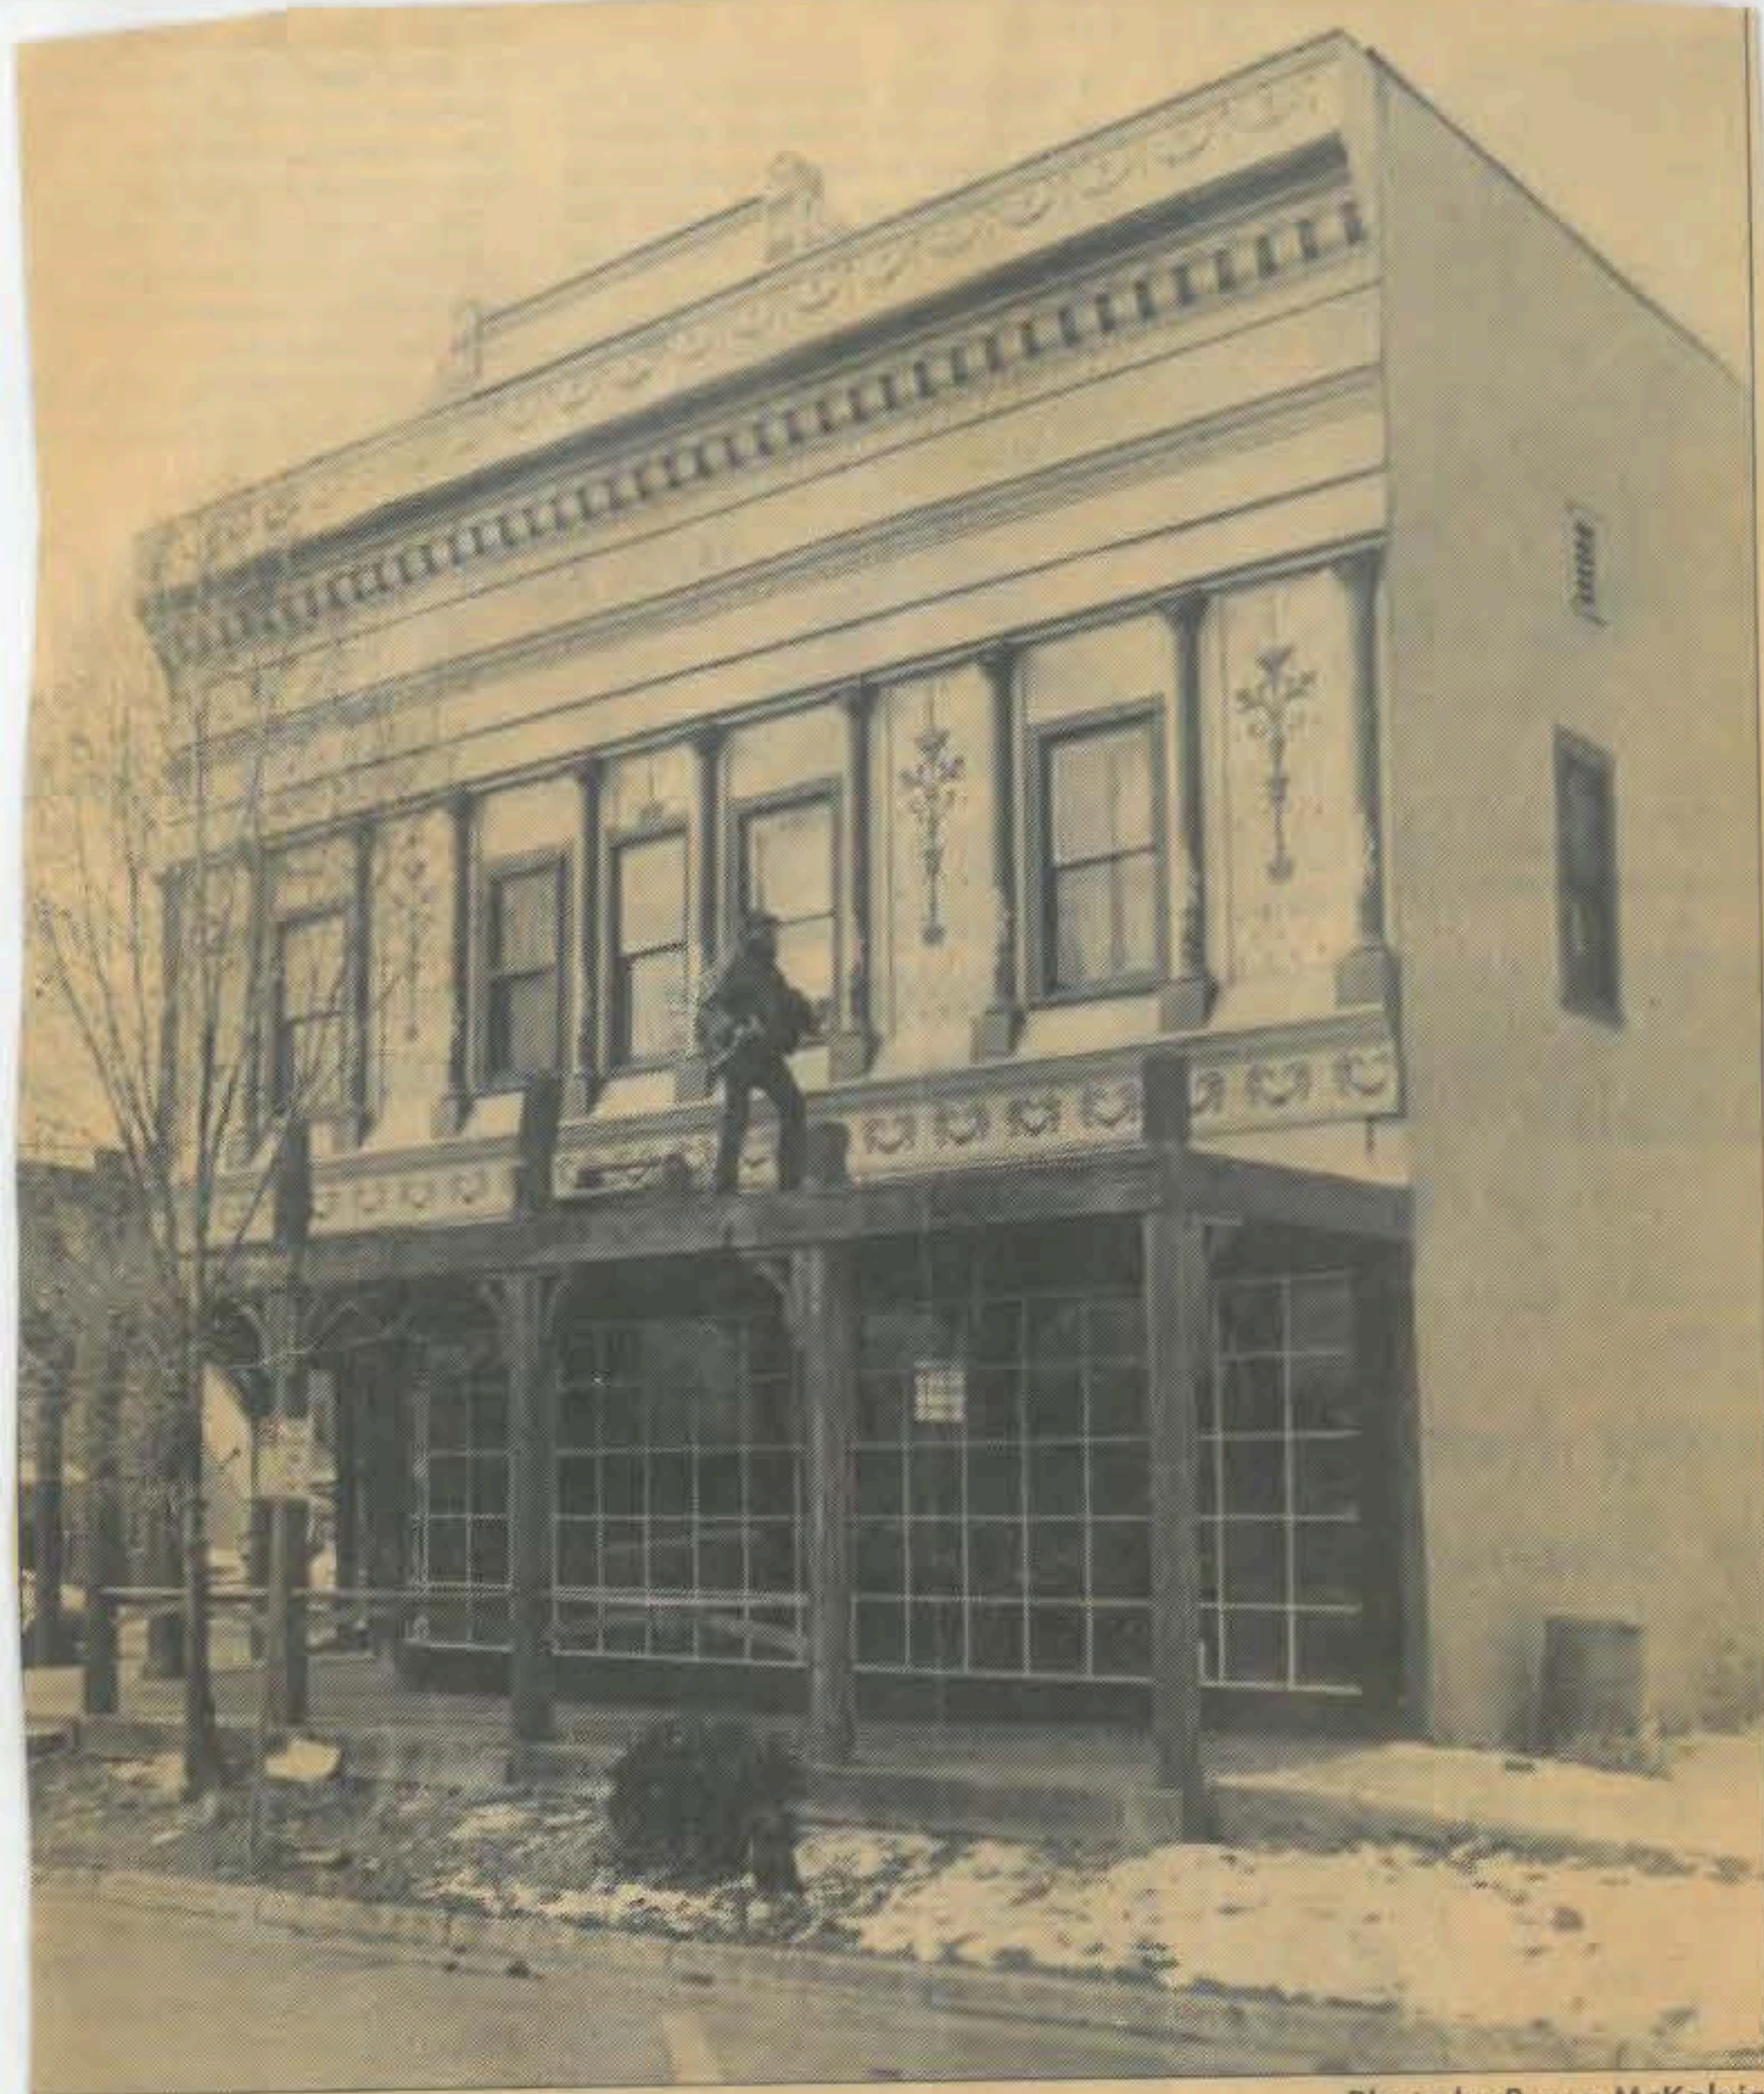
Figure 2-3: Circa 1970's-80's photograph after further alterations

At some point in the '70s-'80s a timber porch was added and it appears the glazing units were replaced with new units with false divided lights.(Figure 2-3)

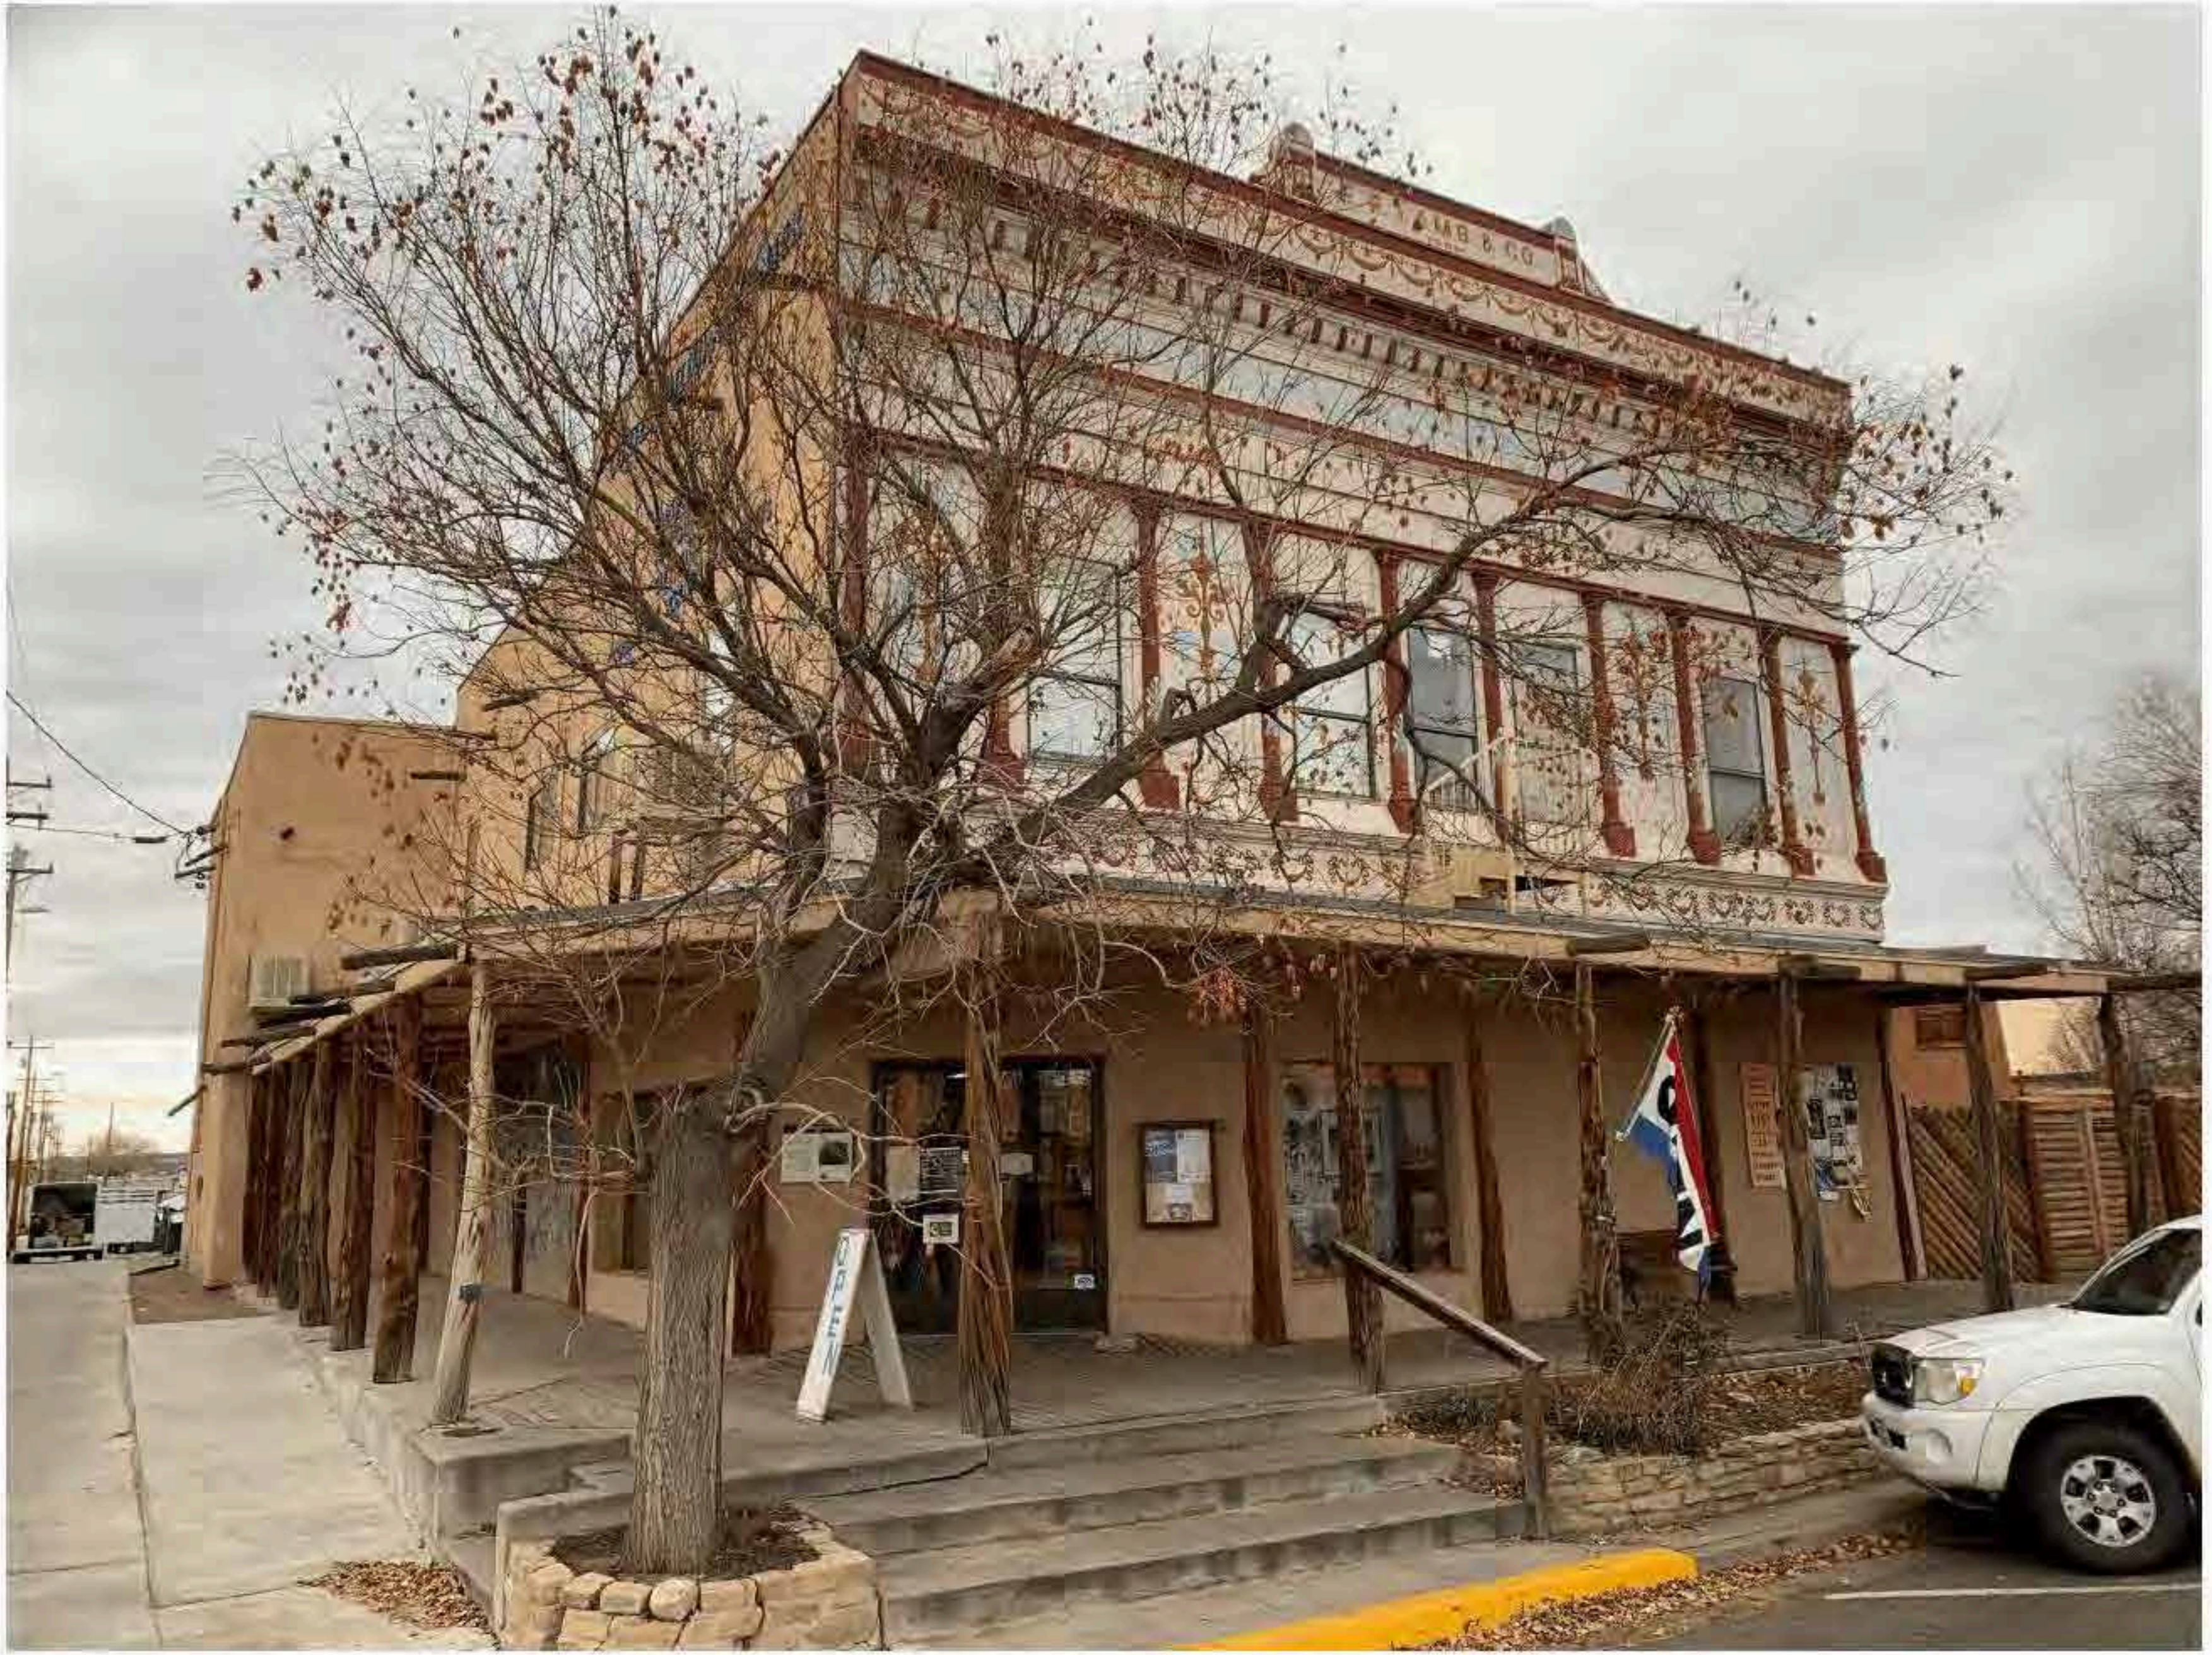
Figure 2-4: Current configuration as of Winter 2018

The building became home to the Cortez Cultural Center in 1987-88 and was subsequently extensively altered with the addition of a faux pueblo style porch with juniper posts, exposed faux juniper pole vigas/rafters, and stucco finishes inside and out. The amphitheater and Hogan was added in 1993 to enhance the venue for outdoor performances. An elevator was added in 1997.

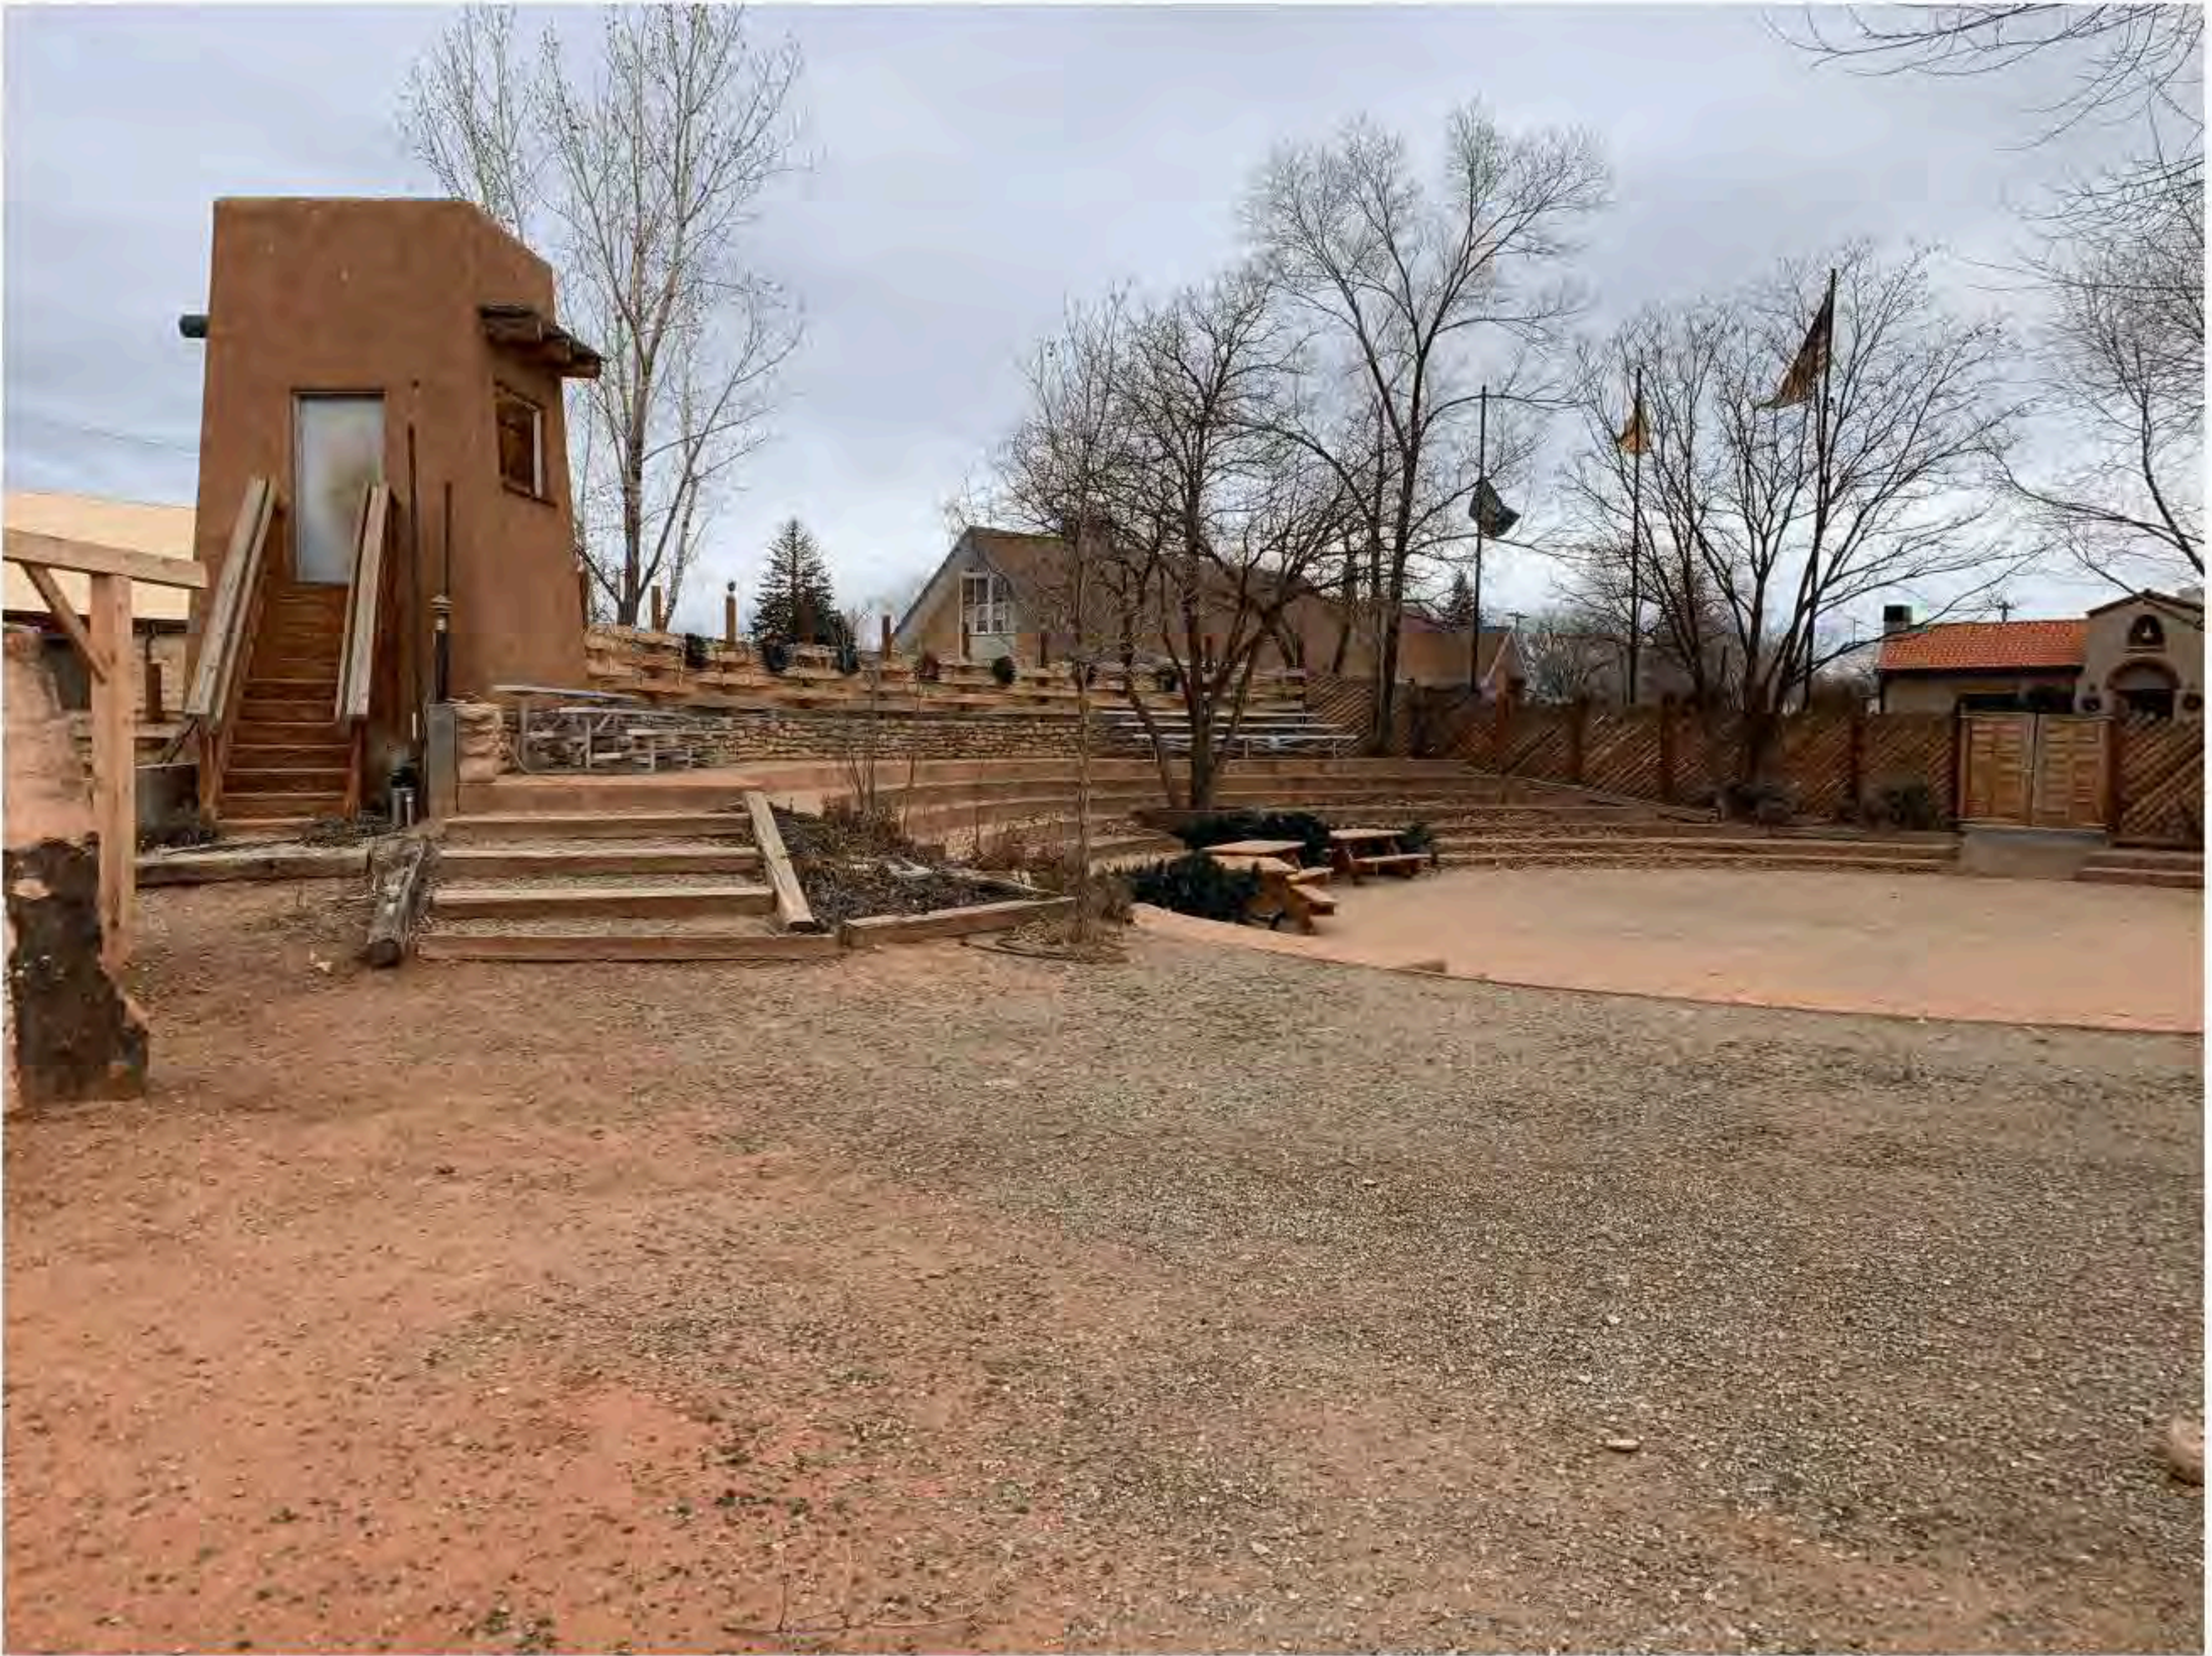
Figure 3.1-2: Amphitheater and Tower

Overall the site is in Fair to Good condition. Landscaping and ground cover is in Good condition but could be expanded and enhanced for a more finished appearance. In-Ground irrigation is in poor condition, it is not functioning due to a broken main valve.

Constructed features such as the amphitheater tower and hogan are in Fair condition. The Hogan is in need of the typical maintenance re-plastering and evaluation of the roof beams, some of which are sagging. The amphitheater tower wood work such as the stair, trim, sills, and vigas, and railroad tie steps need maintenance or replacement.
