# Historic Structure Assessment

## Cortez Cultural Center

25 N Market St., Cortez, CO 81321

SHF Project # 2019-HA-001

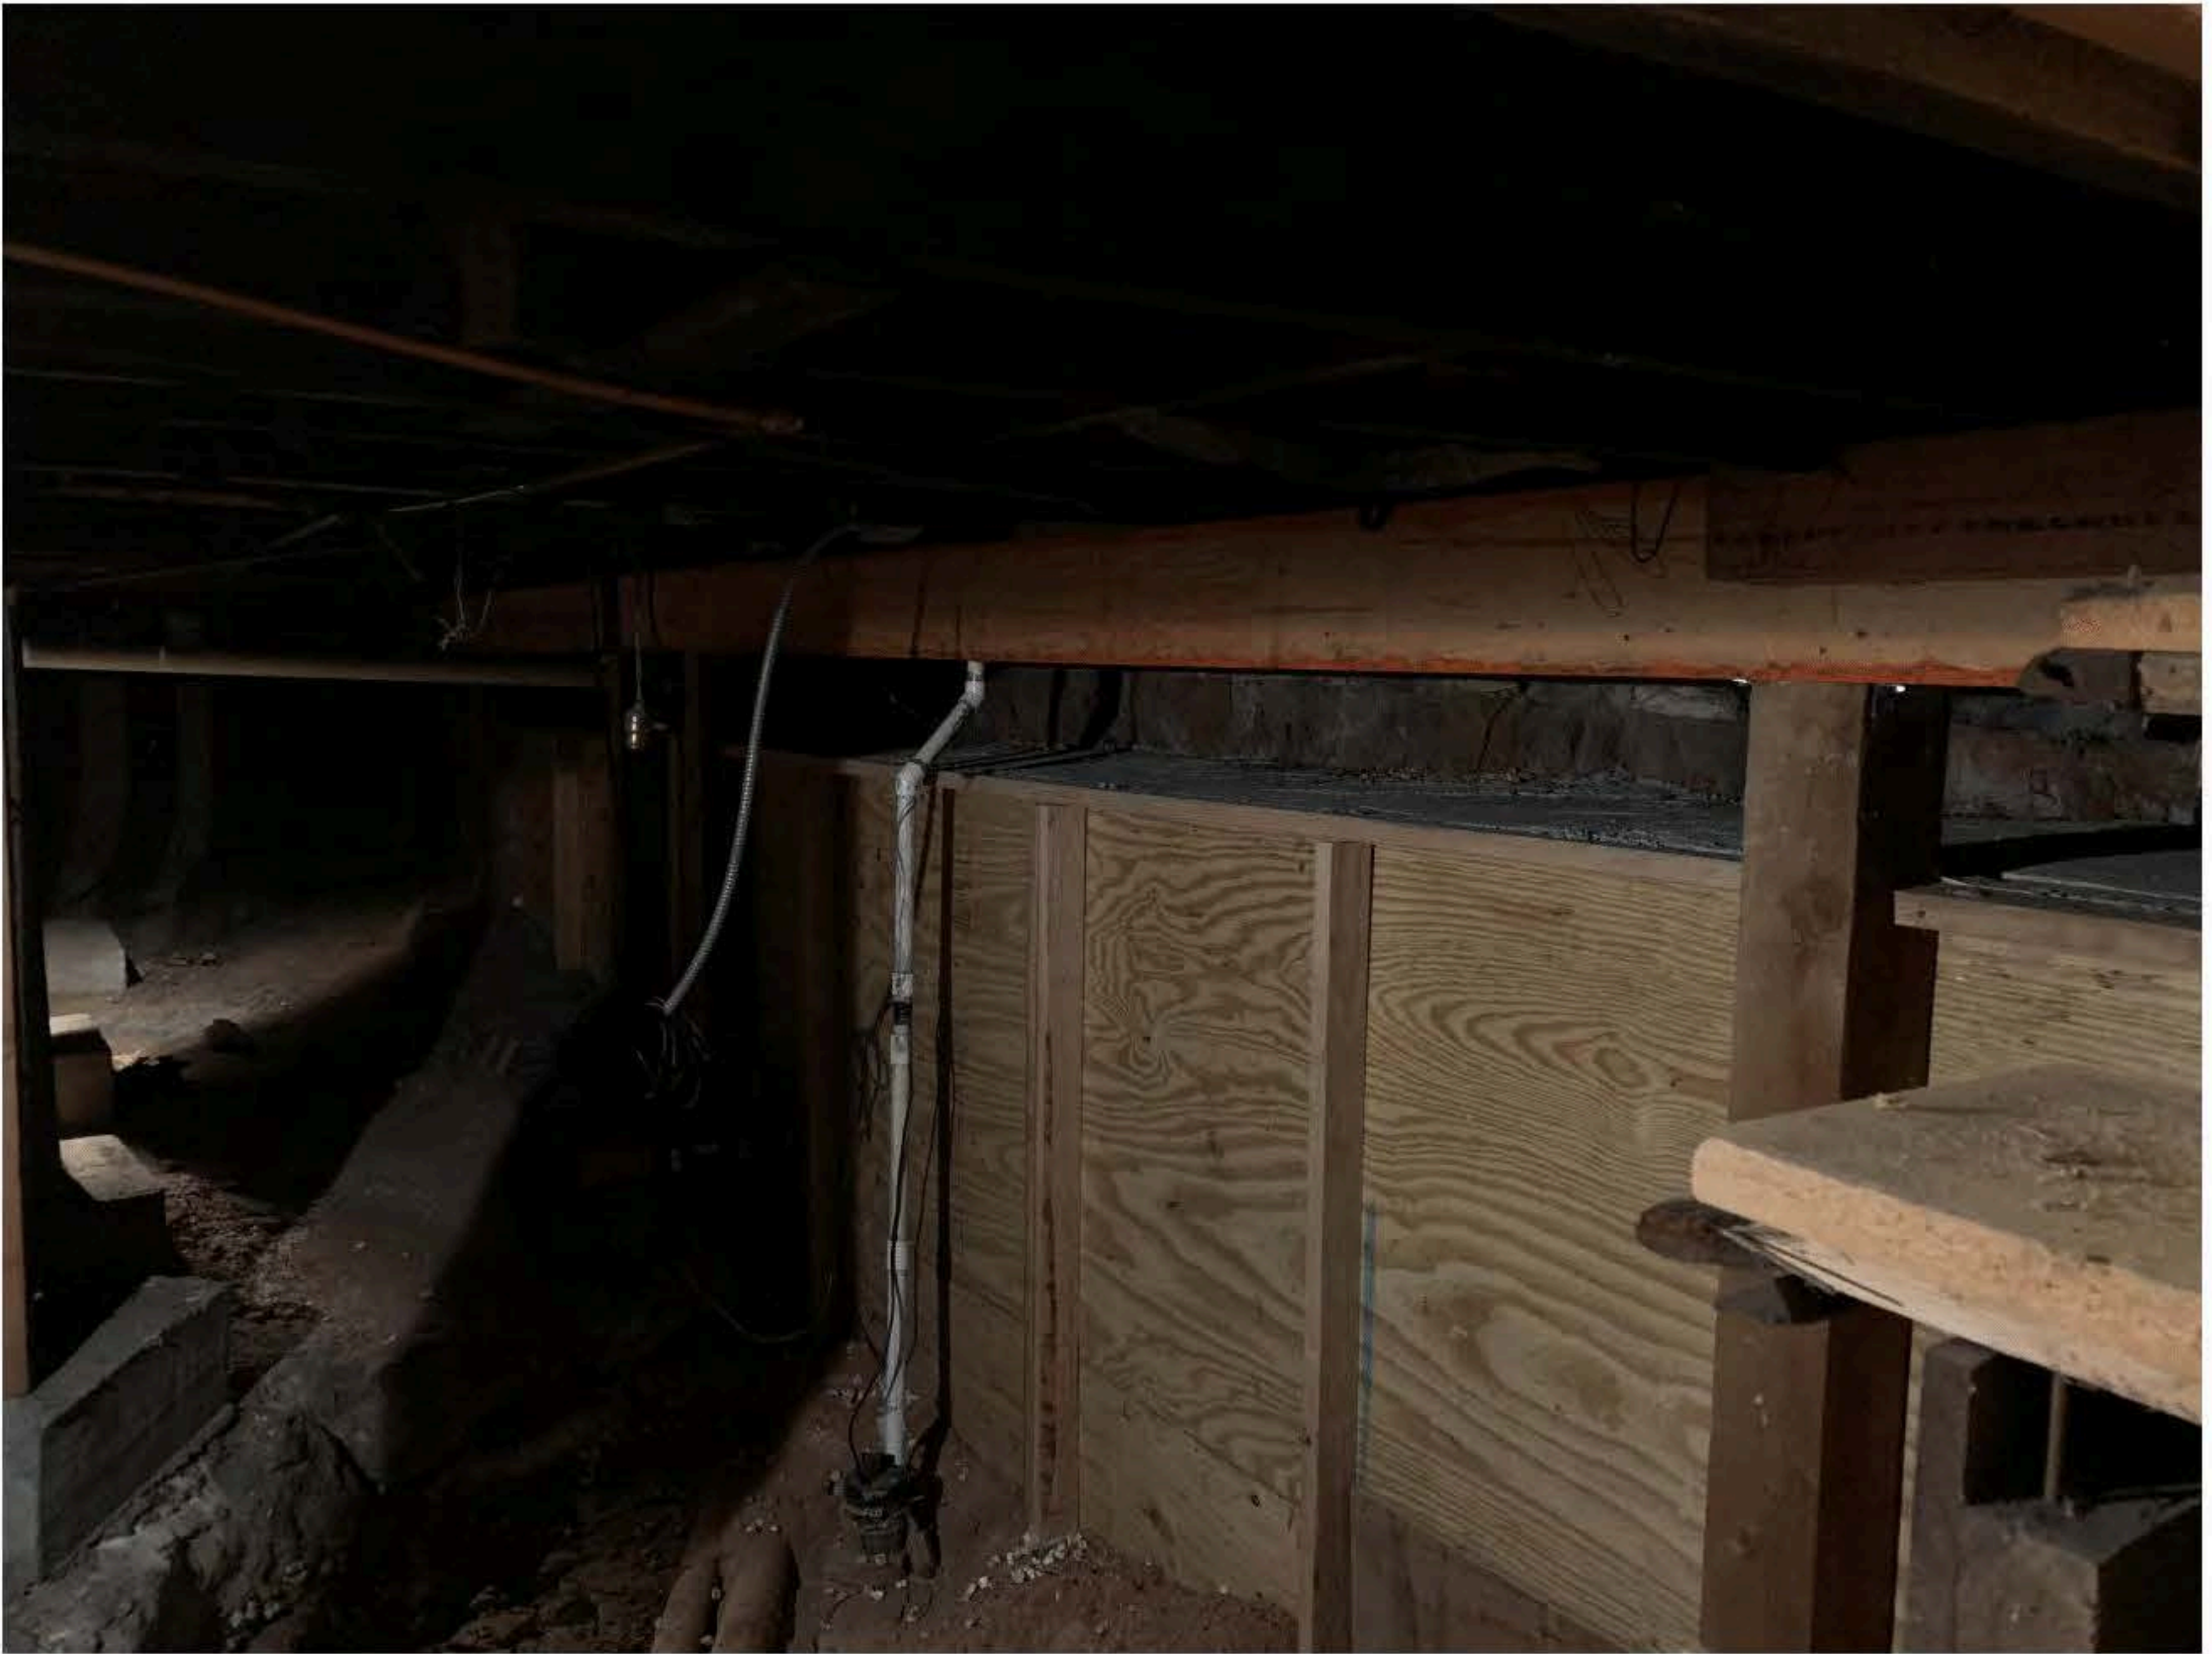
Figure 3.2-2: Basement Retaining

The partial basement is excavated earth with approximately 5' floor from the earthen floor to the bottom of the joists. (Figure 3.2-1) The main floor joist spans are supported by a wood beam system of varying ages and sizes. These are supported with heavy timber columns that currently rest on poured concrete footings. There have been successive reinforcements of this part of the floor structure. The most recent was per undated drawings by Charles A Hubbard (See Appendices), though they were not precisely followed, with the PT Timber footings specified being replaced with concrete and the timber posts and beams described being substituted with a variety of scabbed on and replaced LVLs, timbers, and sawn lumber. On the South a poured concrete retaining wall was placed along with additional columns and beams to shore up the earth wall, as well as provide additional floor support.

Some areas of the excavated basement have partially collapsing walls that are gradually sloughing off soil. These are not directly supporting bearing conditions.

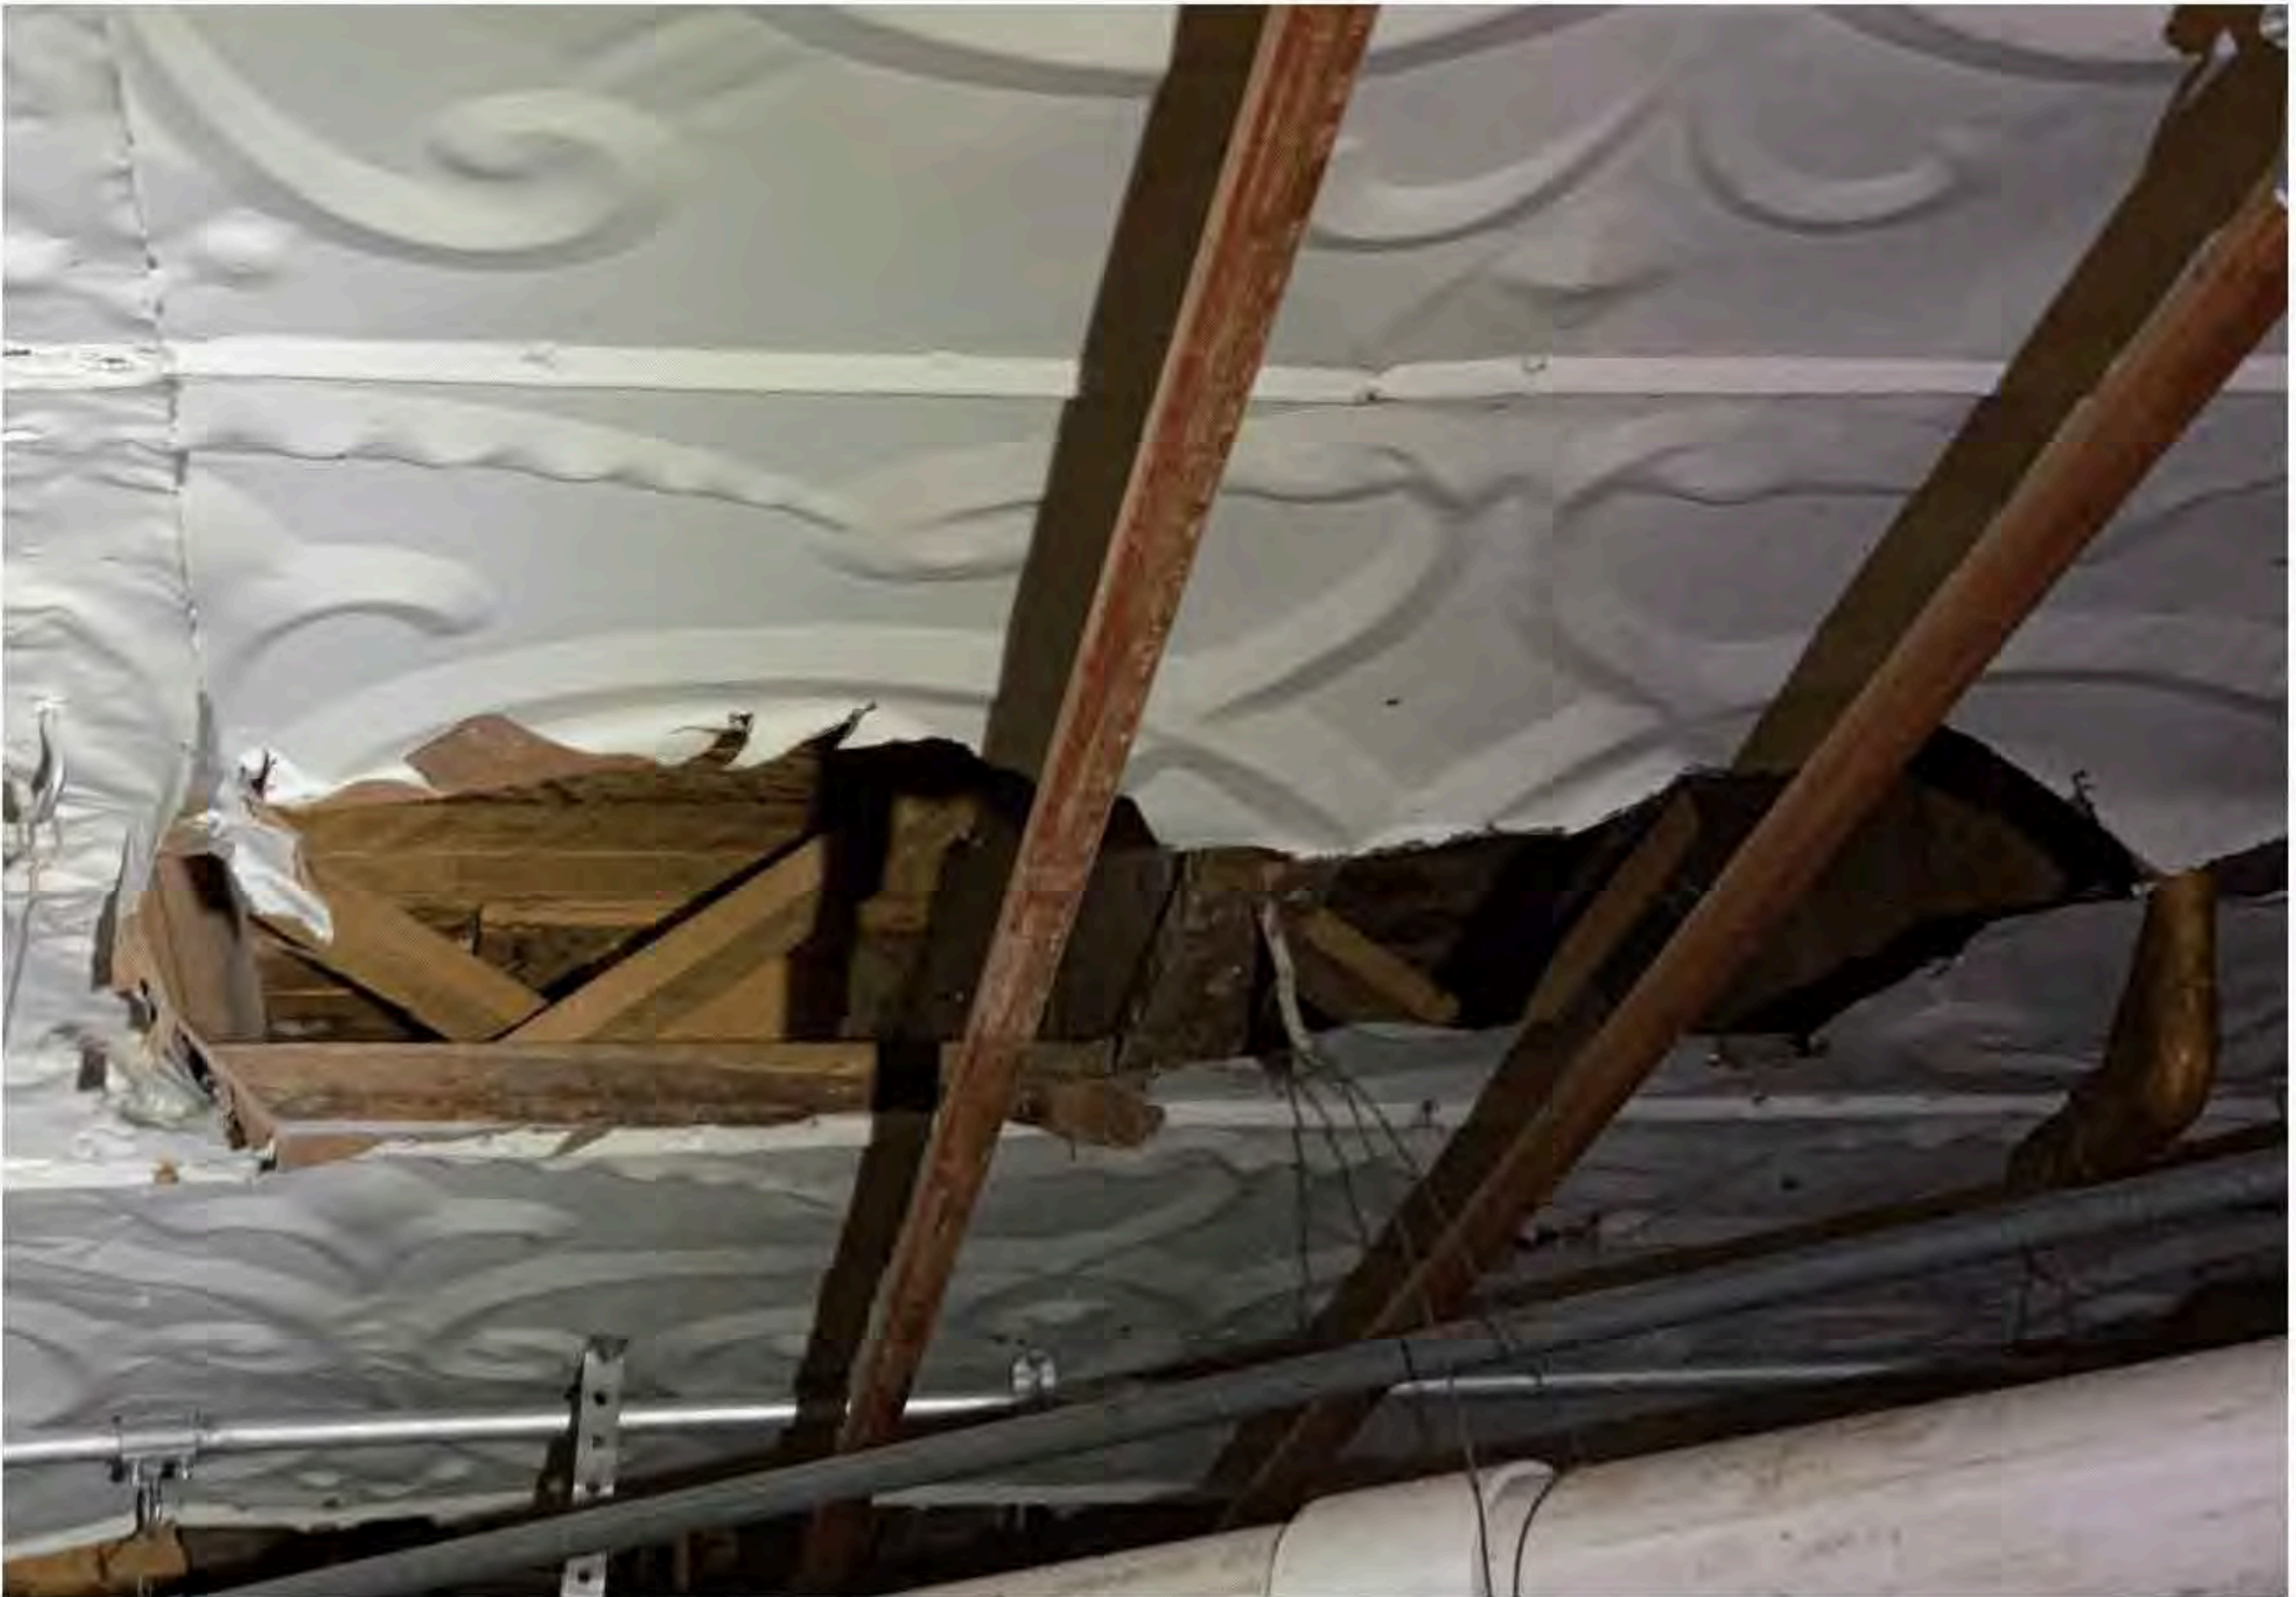
Figure 3.2-4: Glimpse of 2nd. level floor system

The two above ground floors are 2 x 4 light wood framing. The floor and wall system interface detail is unknown, i.e. platform or balloon framing, etc. large spans are assumed to be timbers though they are not visible in most areas as they are covered by non-historic stucco. Typical of the building type, the main level had high ceilings of approximately 11', while the upper level had lath and plaster ceilings. The front half of the main level and the entire upper level have Non-Historic dropped ceilings.

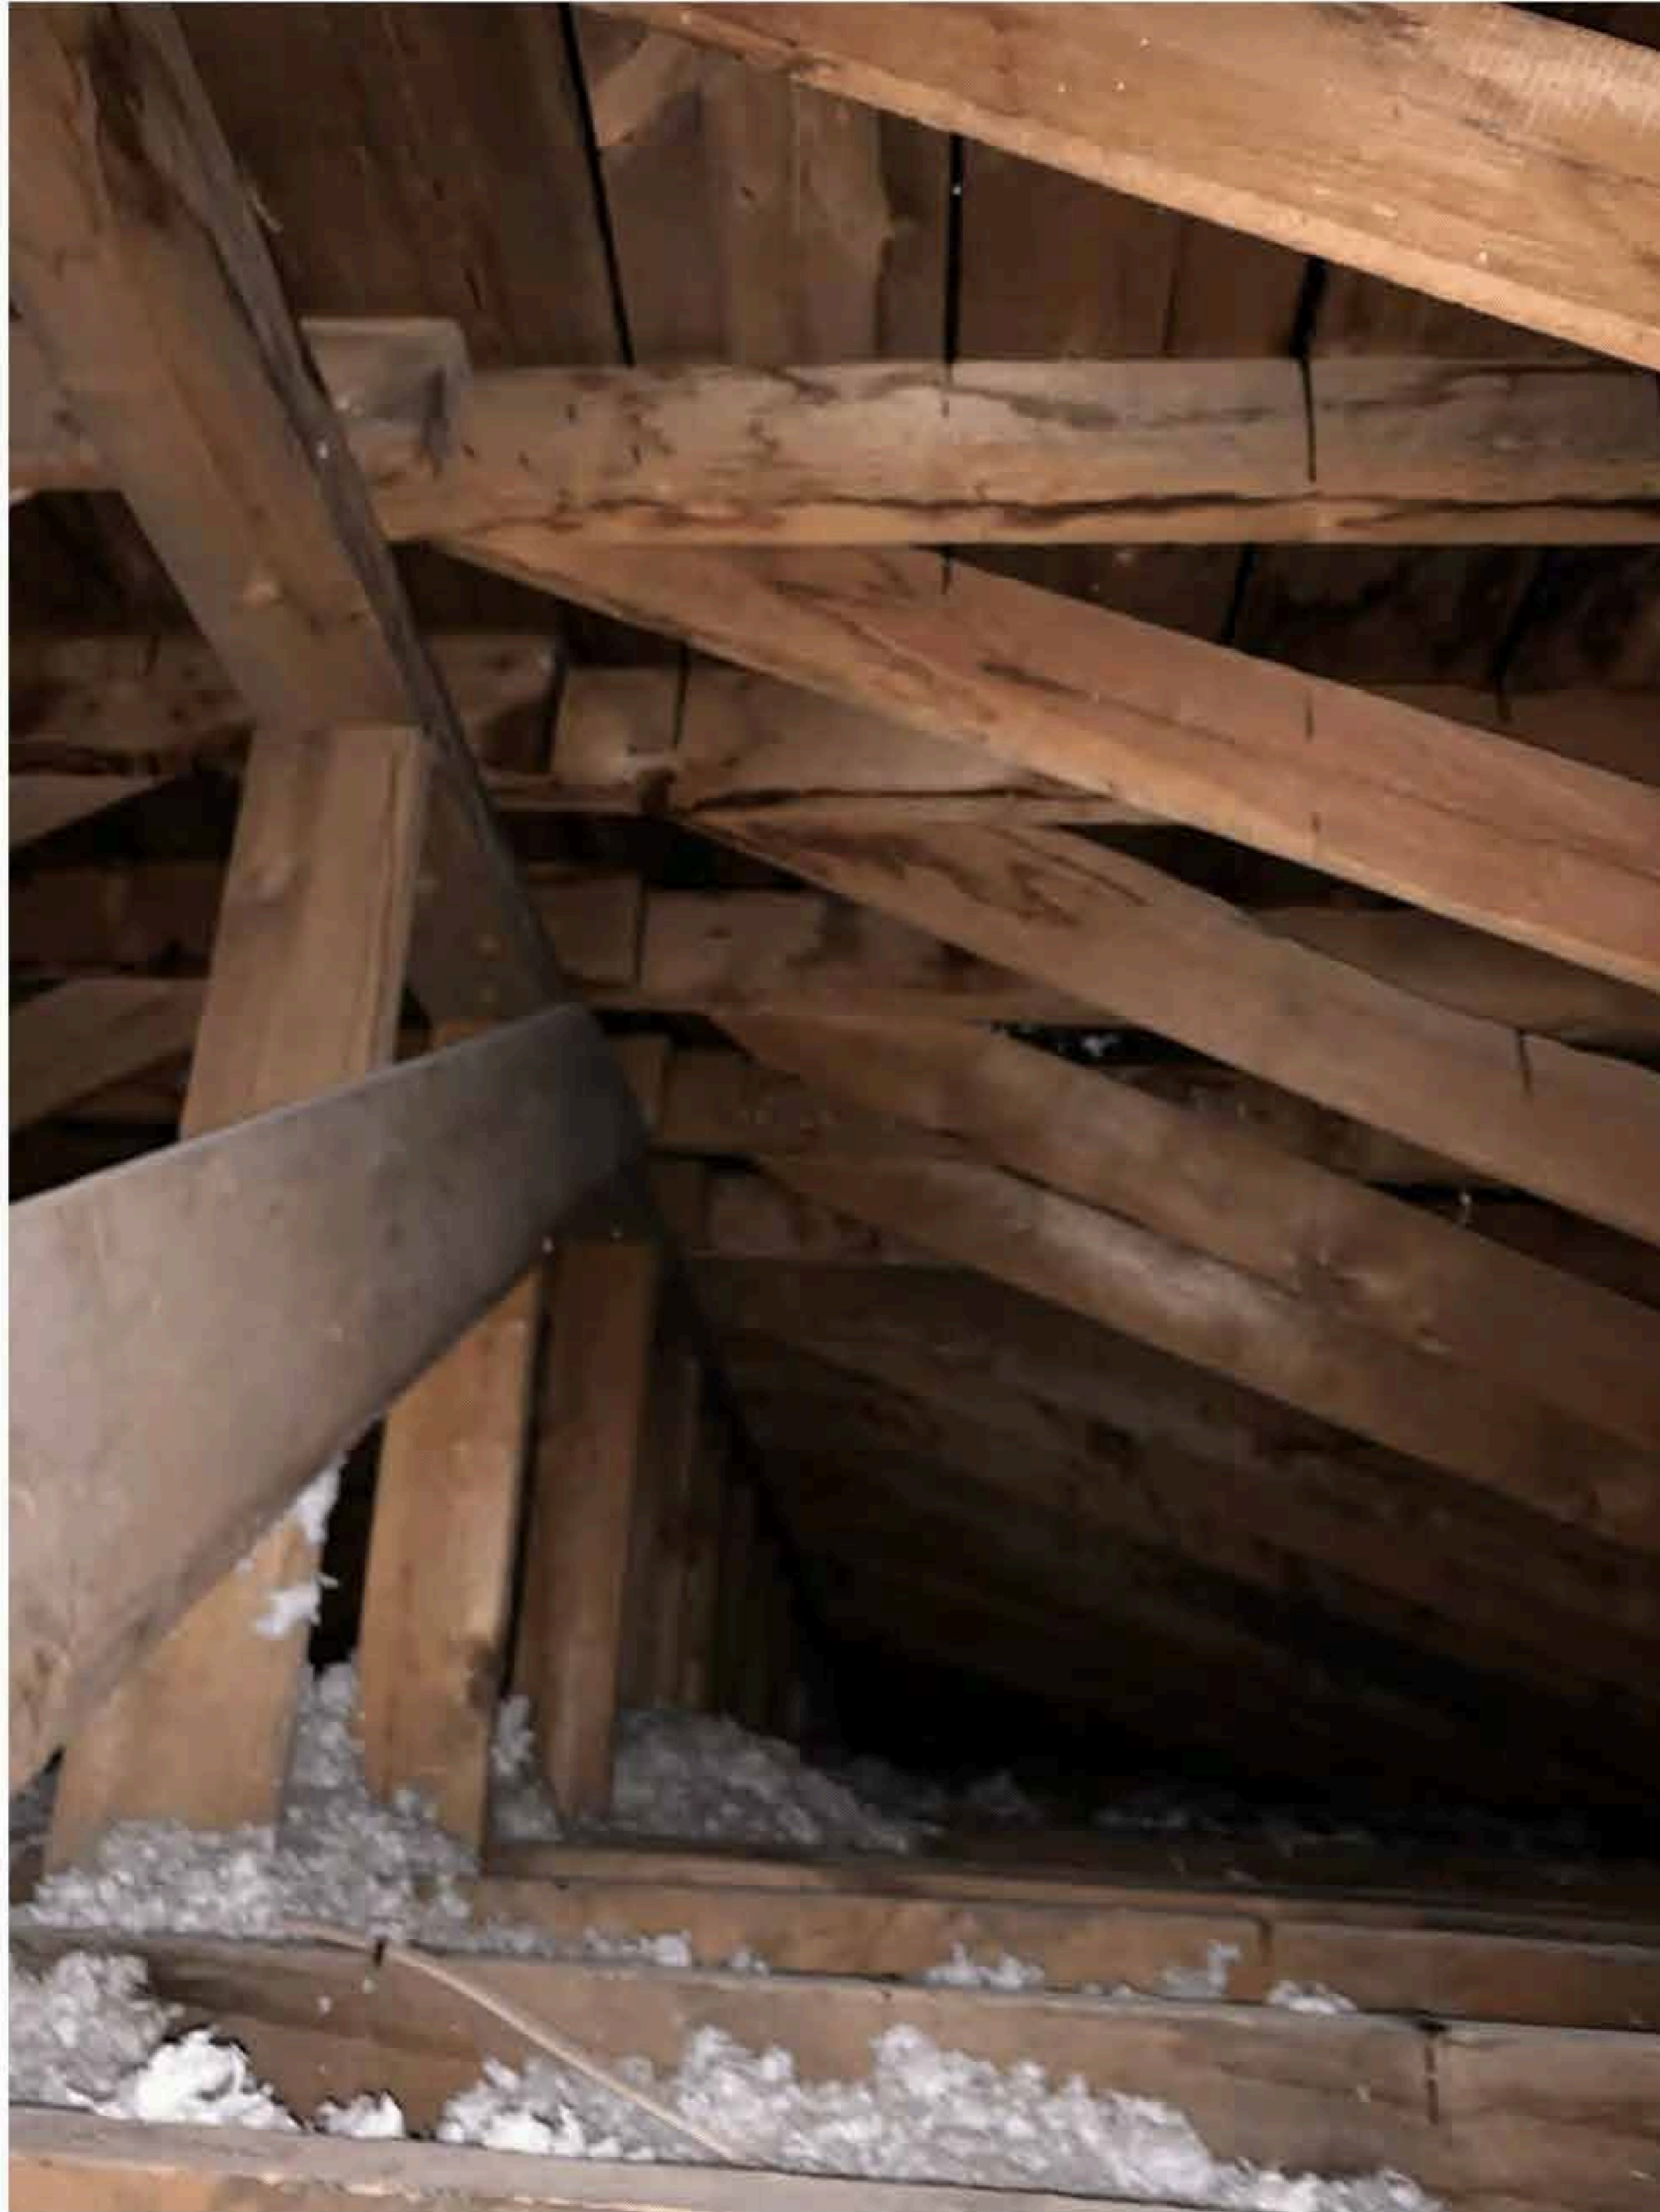
Figure 3.2-5: Roof Structure

The roof has a low slope from the front parapet (East) to the back (West) wall. It is 2 x 8 rough sawn lumber at 24" O.C. spacing. It has 1x rough sawn lumber bracing / trussing between the upper rafters and the ceiling joists (Figure 3.2-5). The span is divided by two bearing walls enclosing the central hallway.

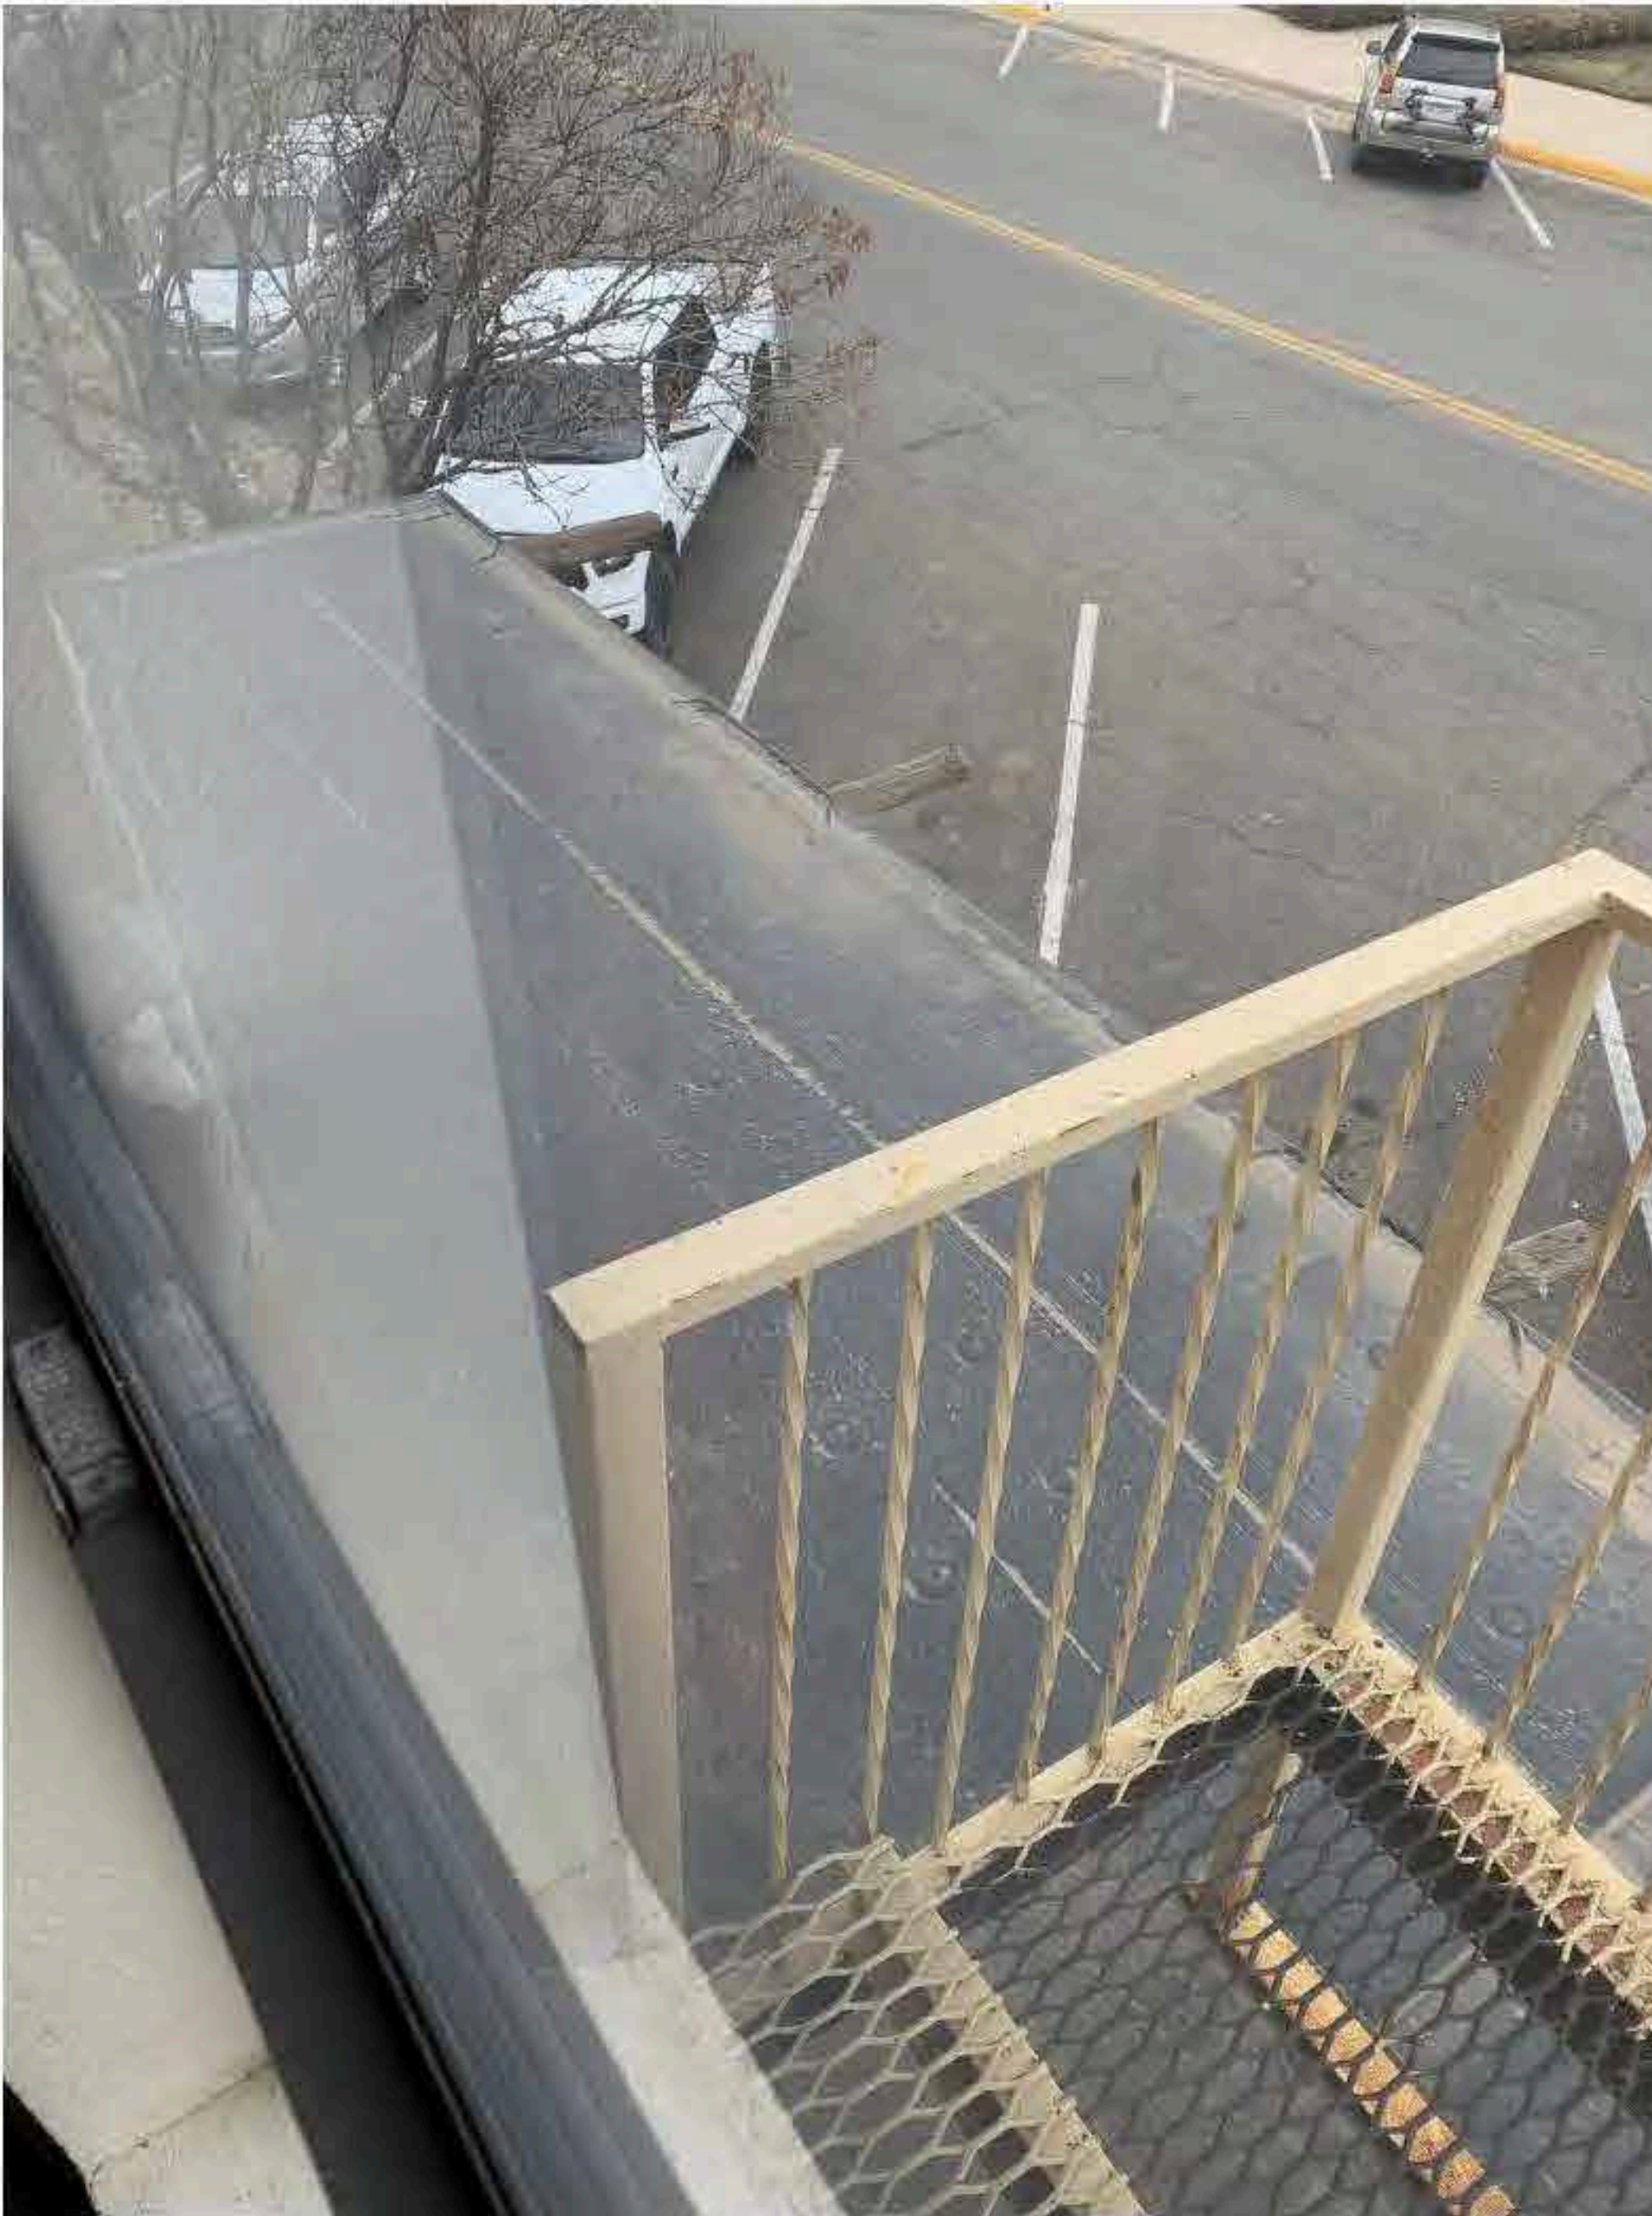
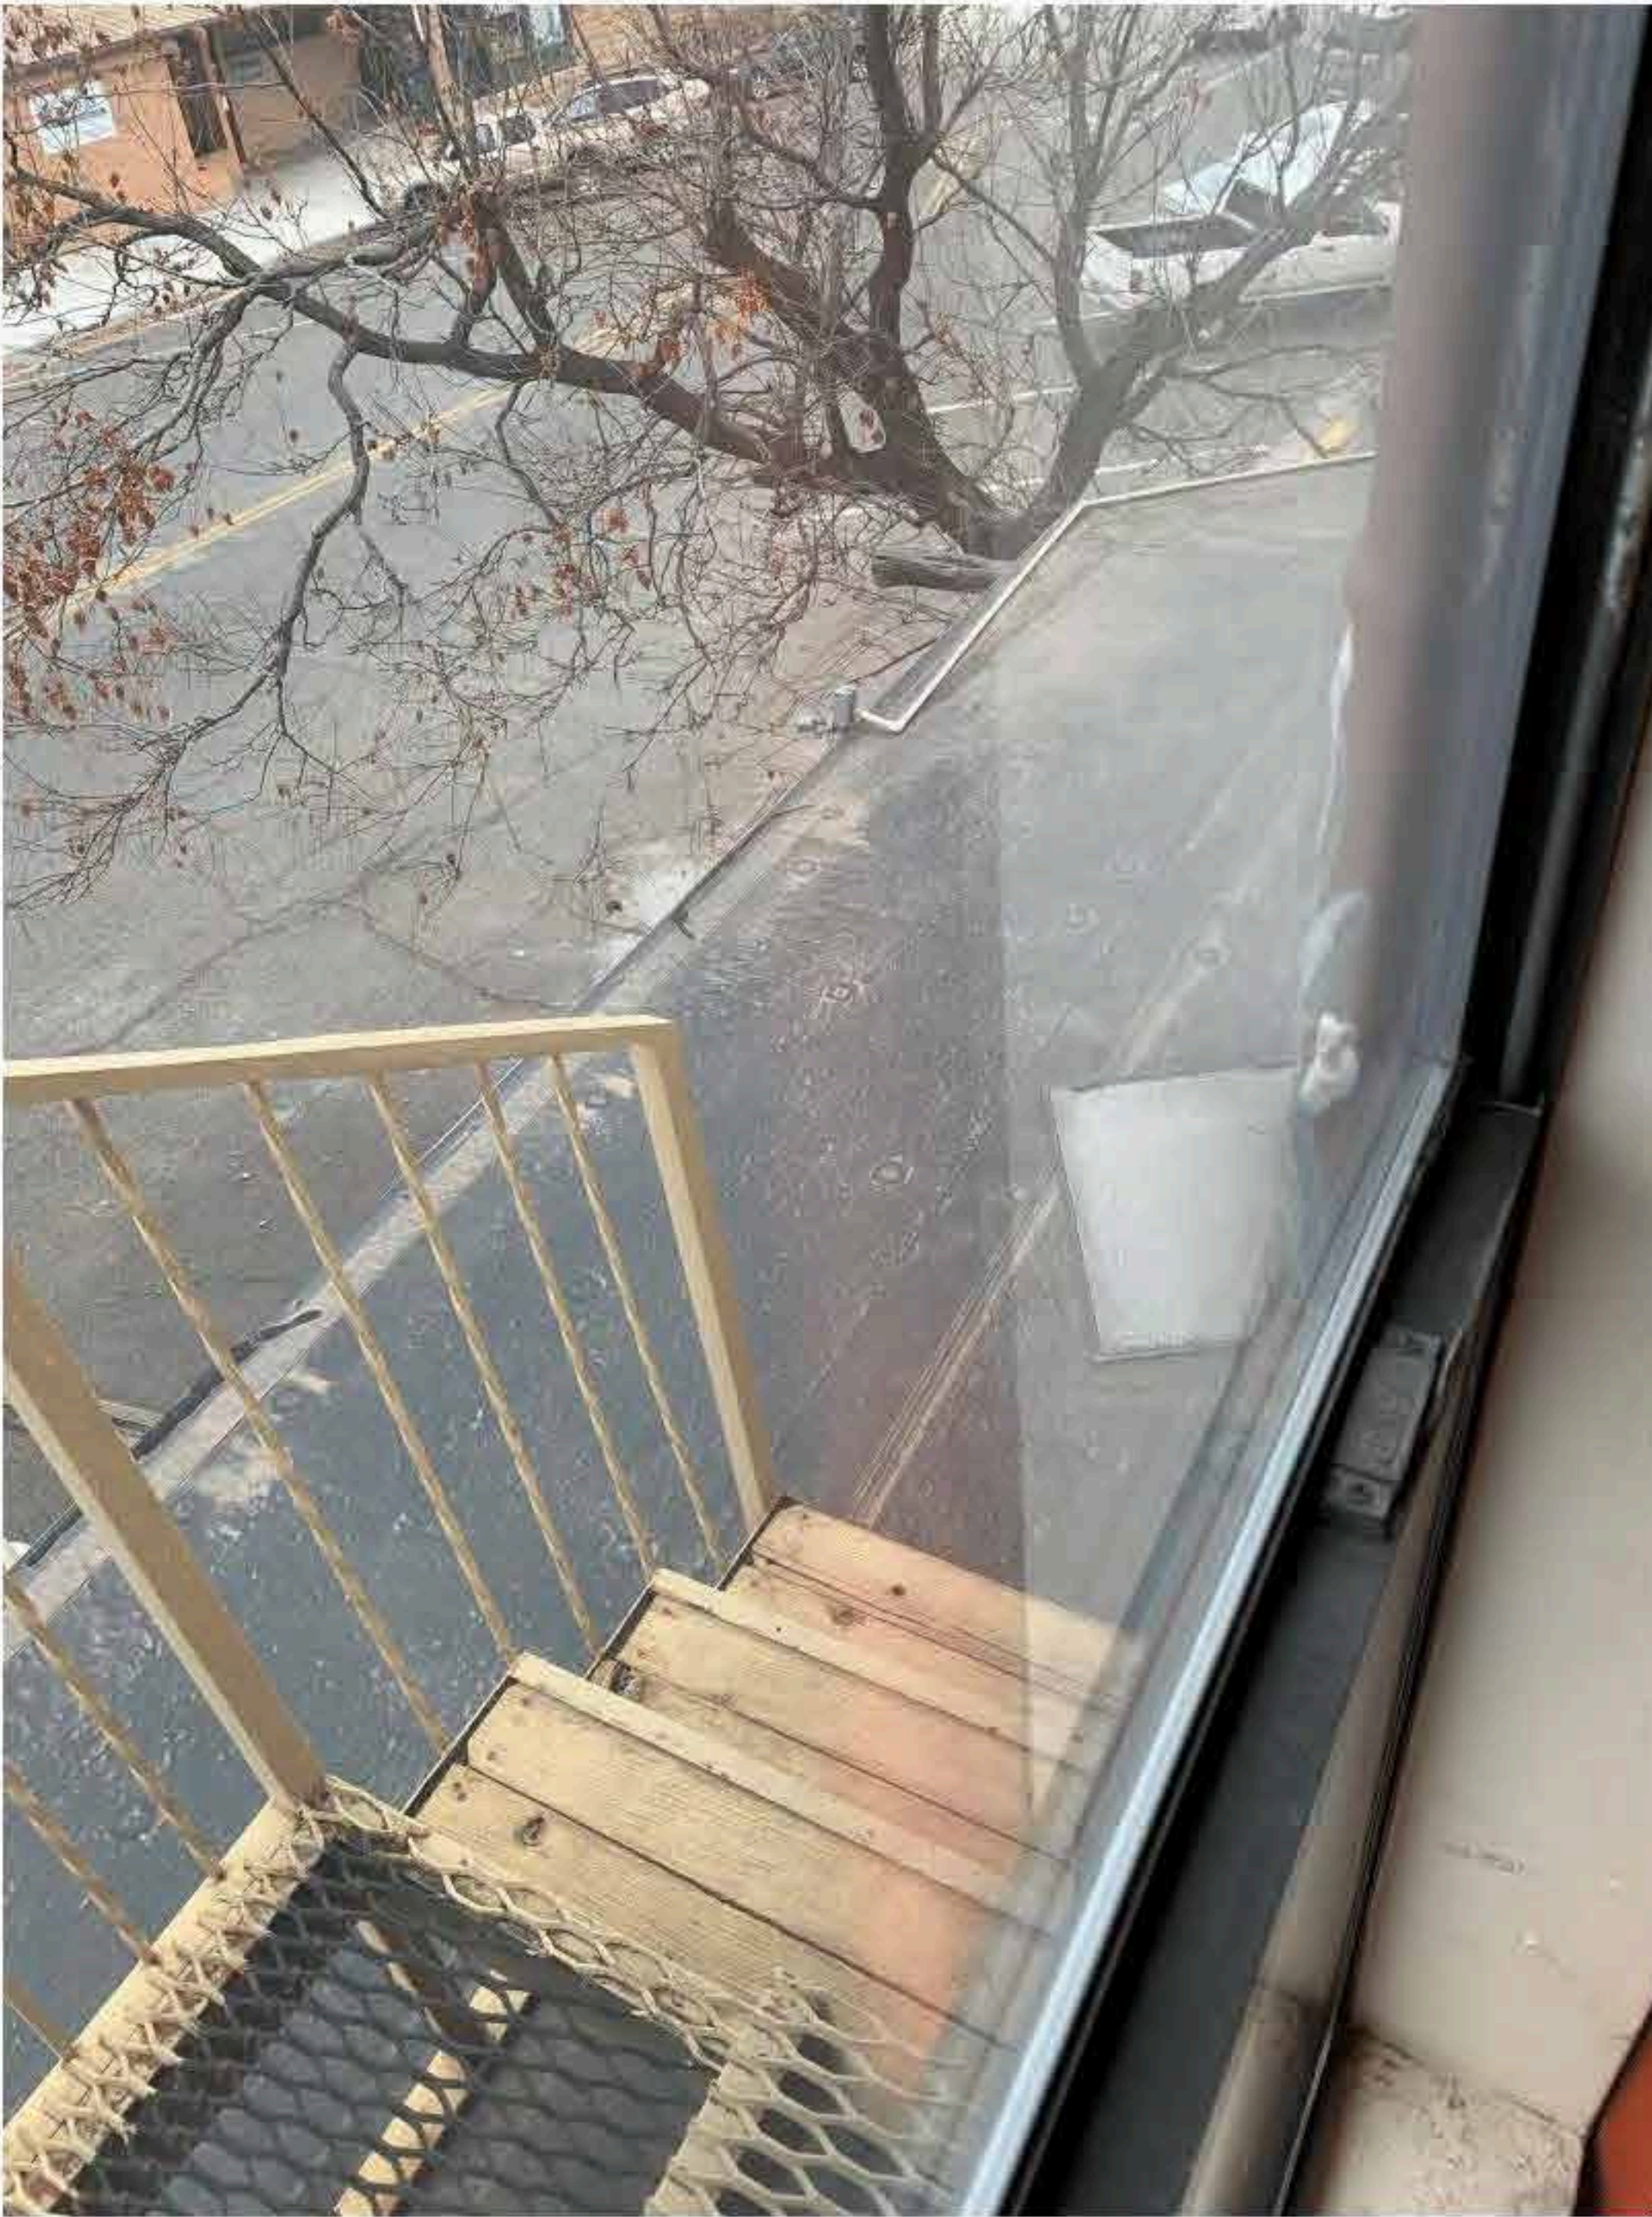
The walkway porch roof is EPDM an rubber membrane with galvanized steel drip edge flashing at outside perimeter and unknown flashing at wall junction (Figure 3.4-5&6). Substrate is unknown but appears to be plywood or OSB.

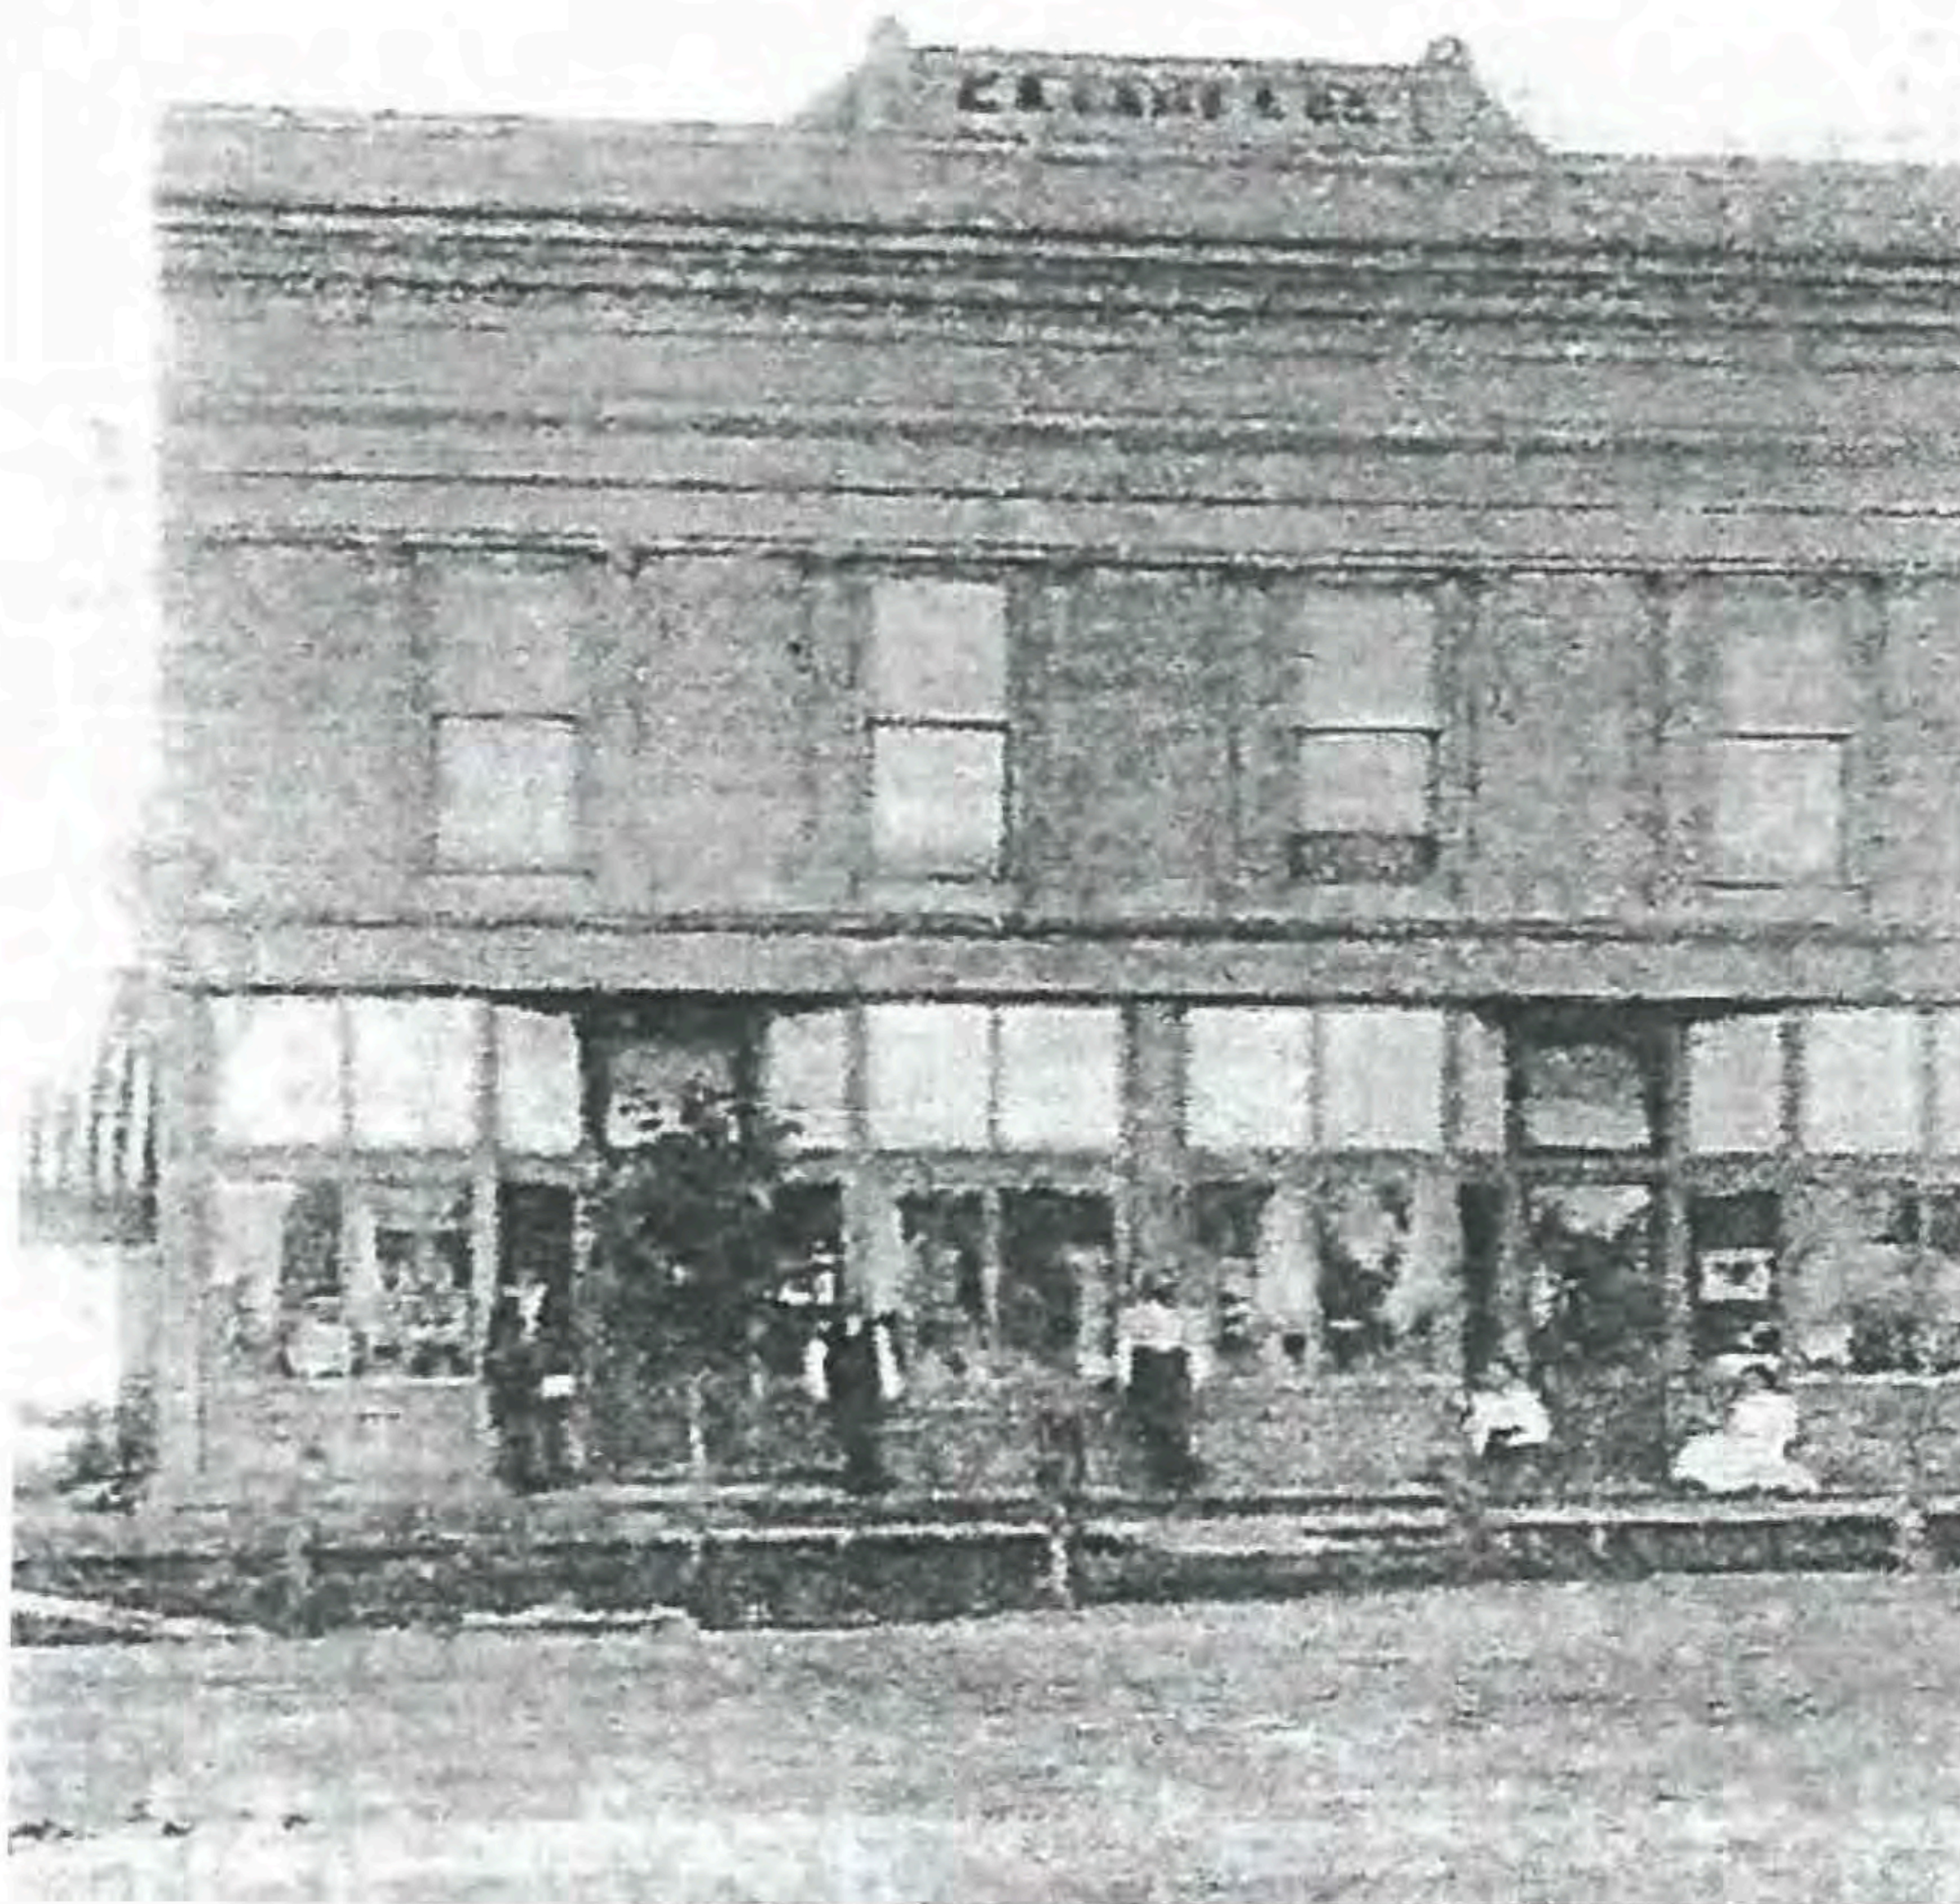
Figure 3.5-1: Original front facade window configuration

There was an additional egress window added in the 1960's or before on the East, front facade. This was placed in the center of the building at the end of the upper level hallway, between two existing windows. This disrupted the original facade design and displaced a section of the Mesker Bros. facade panels.
