# Historic Structure Assessment

## Cortez Cultural Center

25 N Market St., Cortez, CO 81321

SHF Project # 2019-HA-001

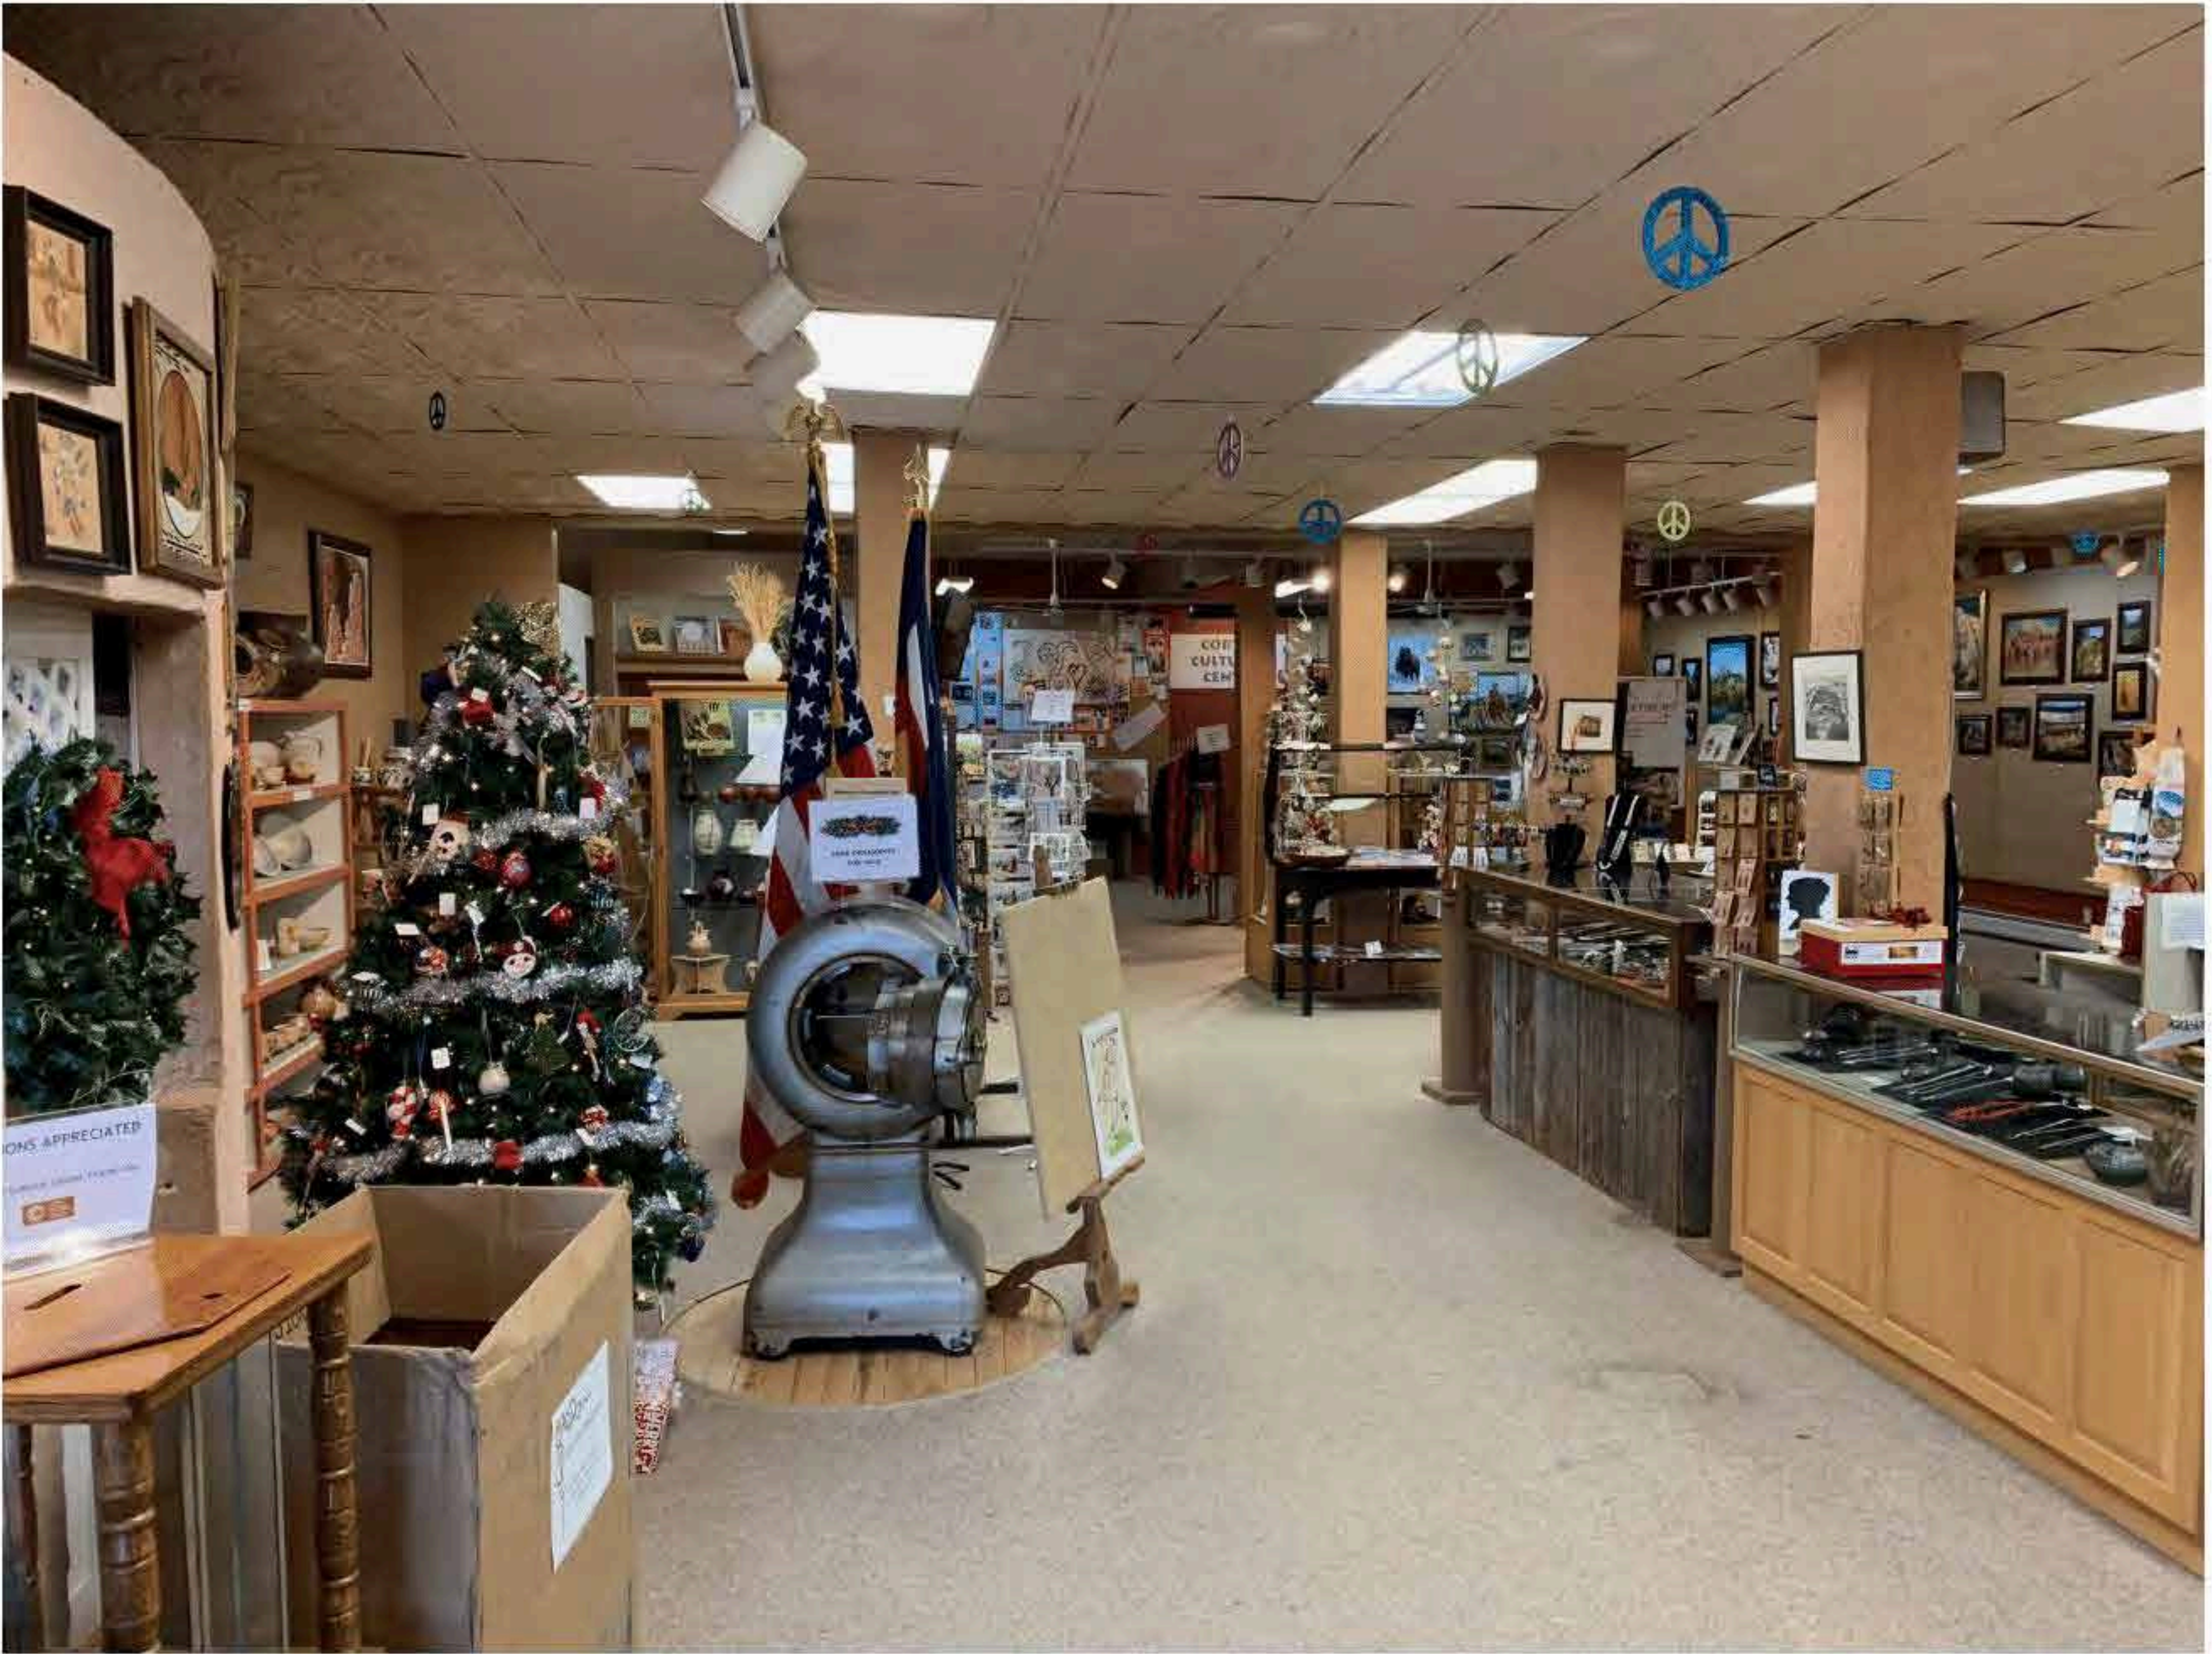
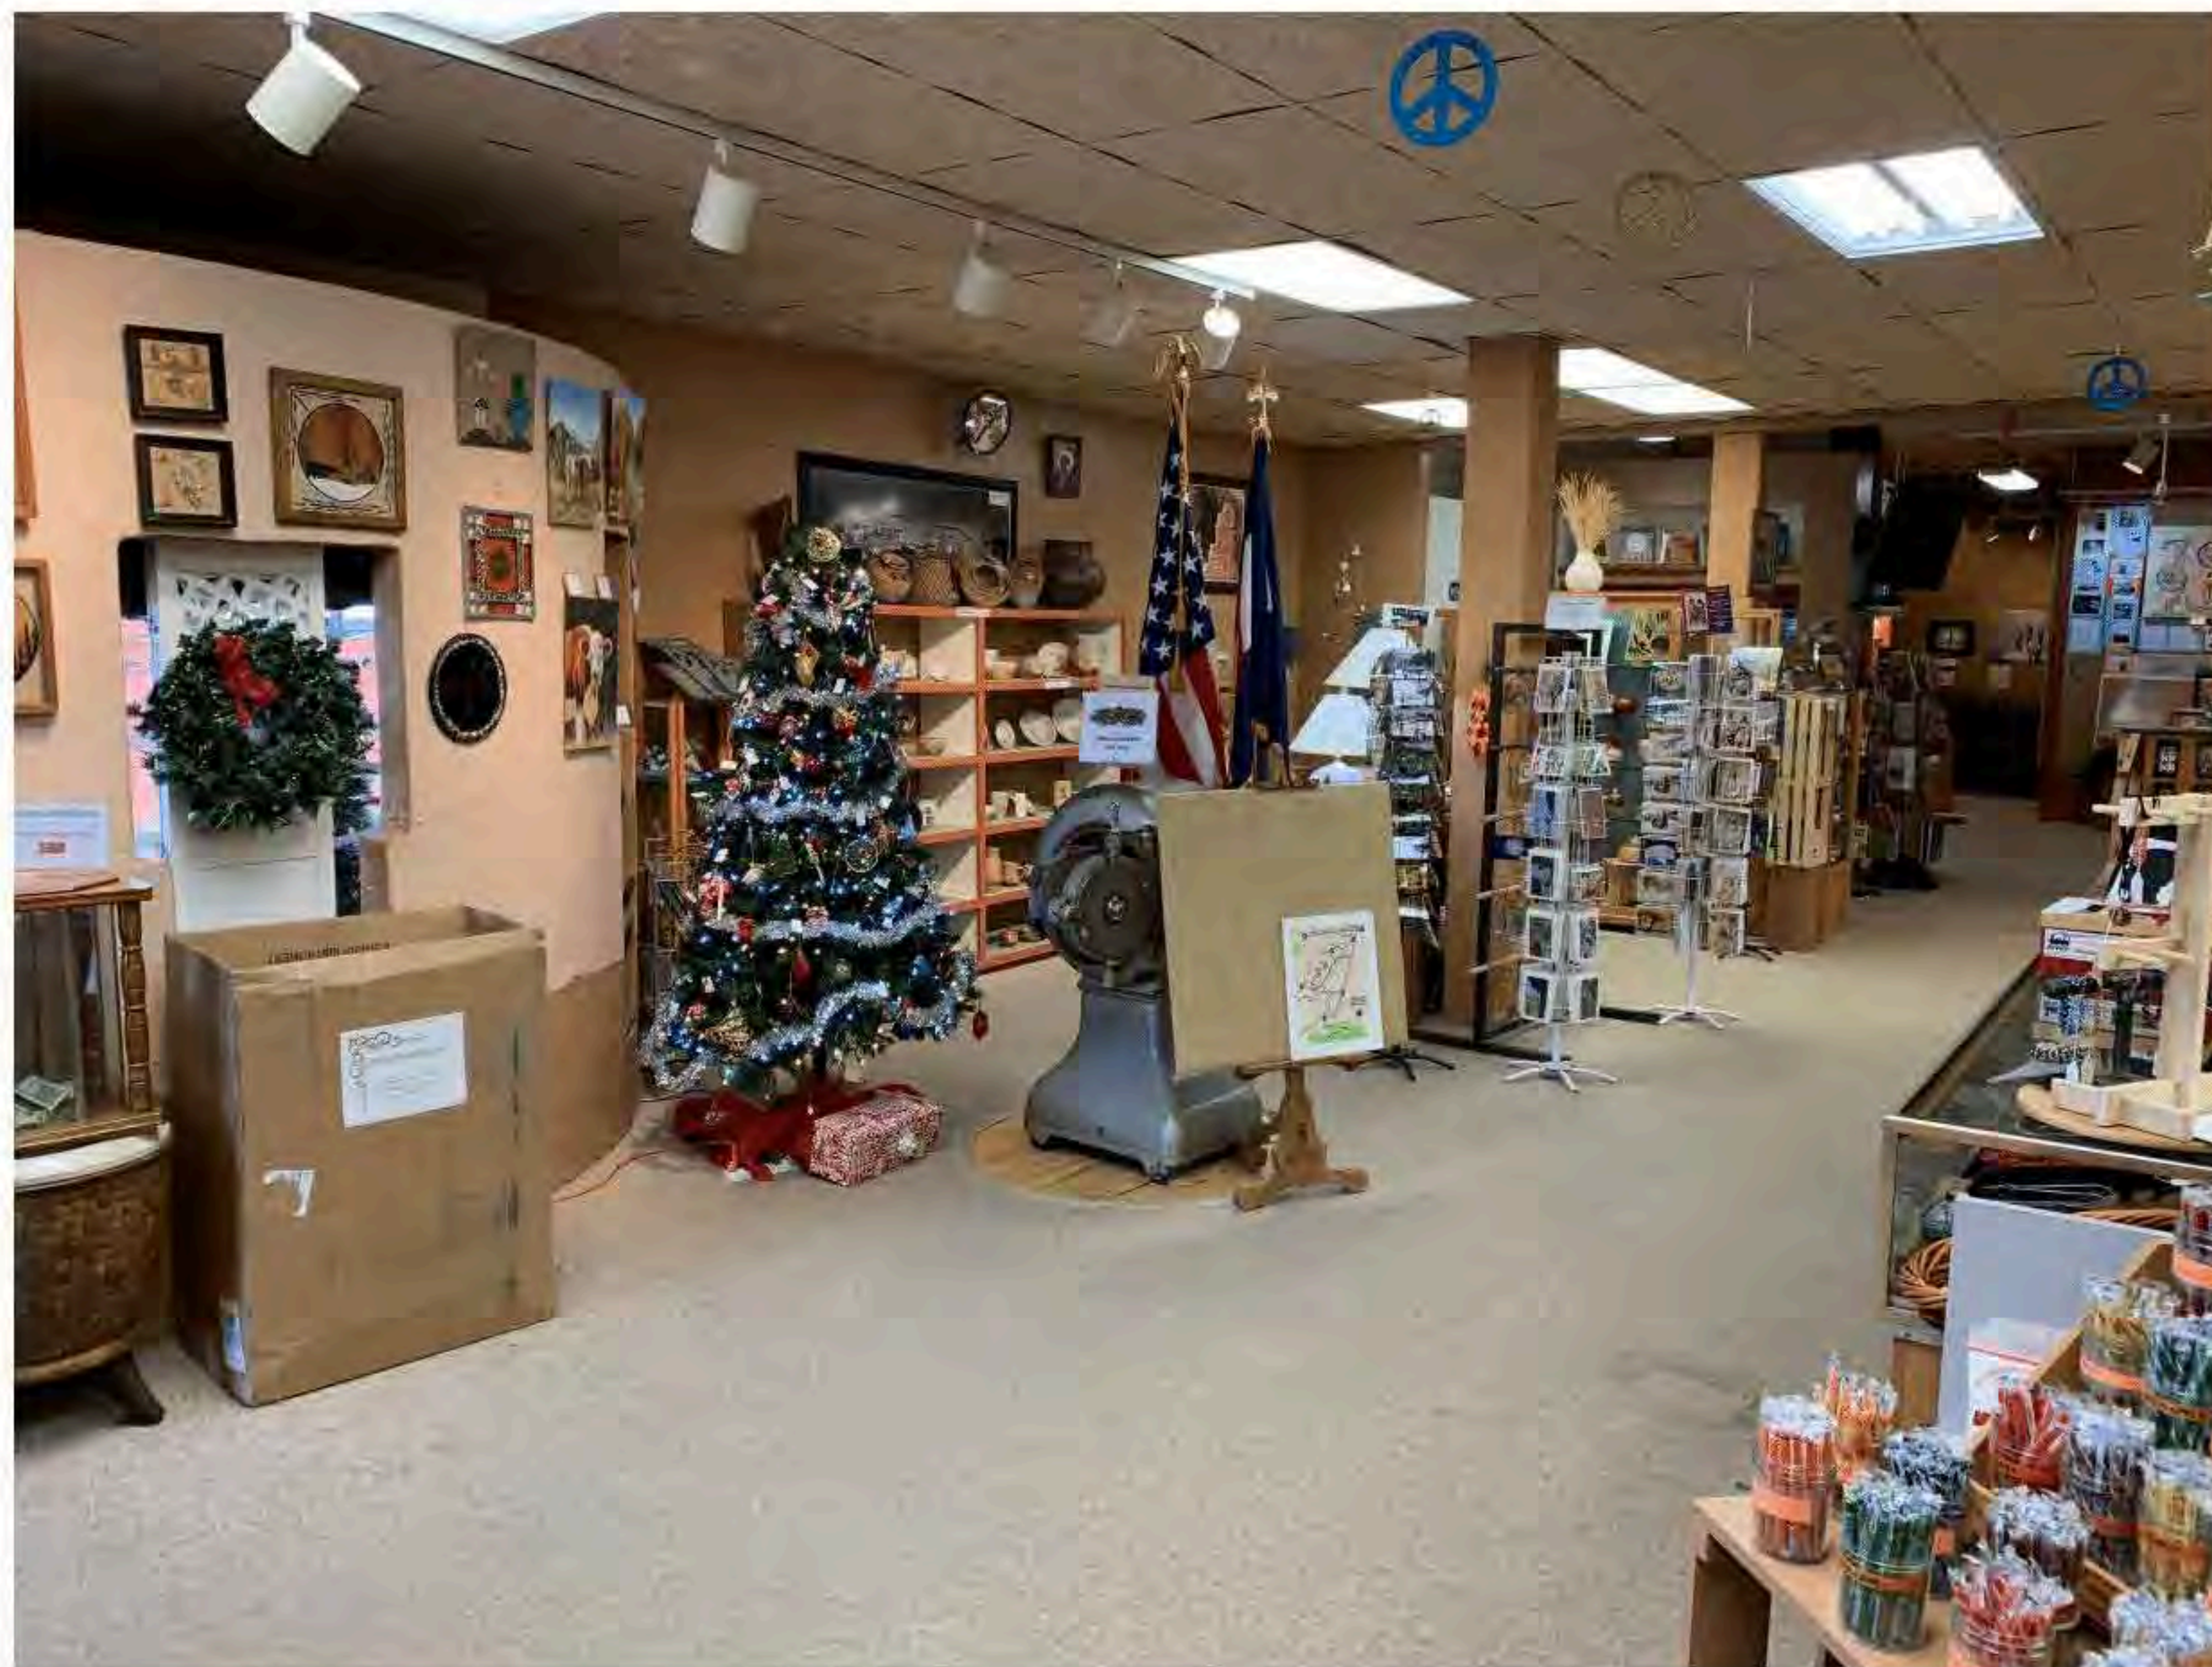
Figure 3.6-1: Current main level interior at entrance

All of the main level finishes, except the pressed tin ceiling, have all been replaced or finished over. The main level floors are carpeted, the carpet appears to be installed over the original wood flooring, which can be seen exposed under the safe on display near the entry (Figure 3.6-1&2).

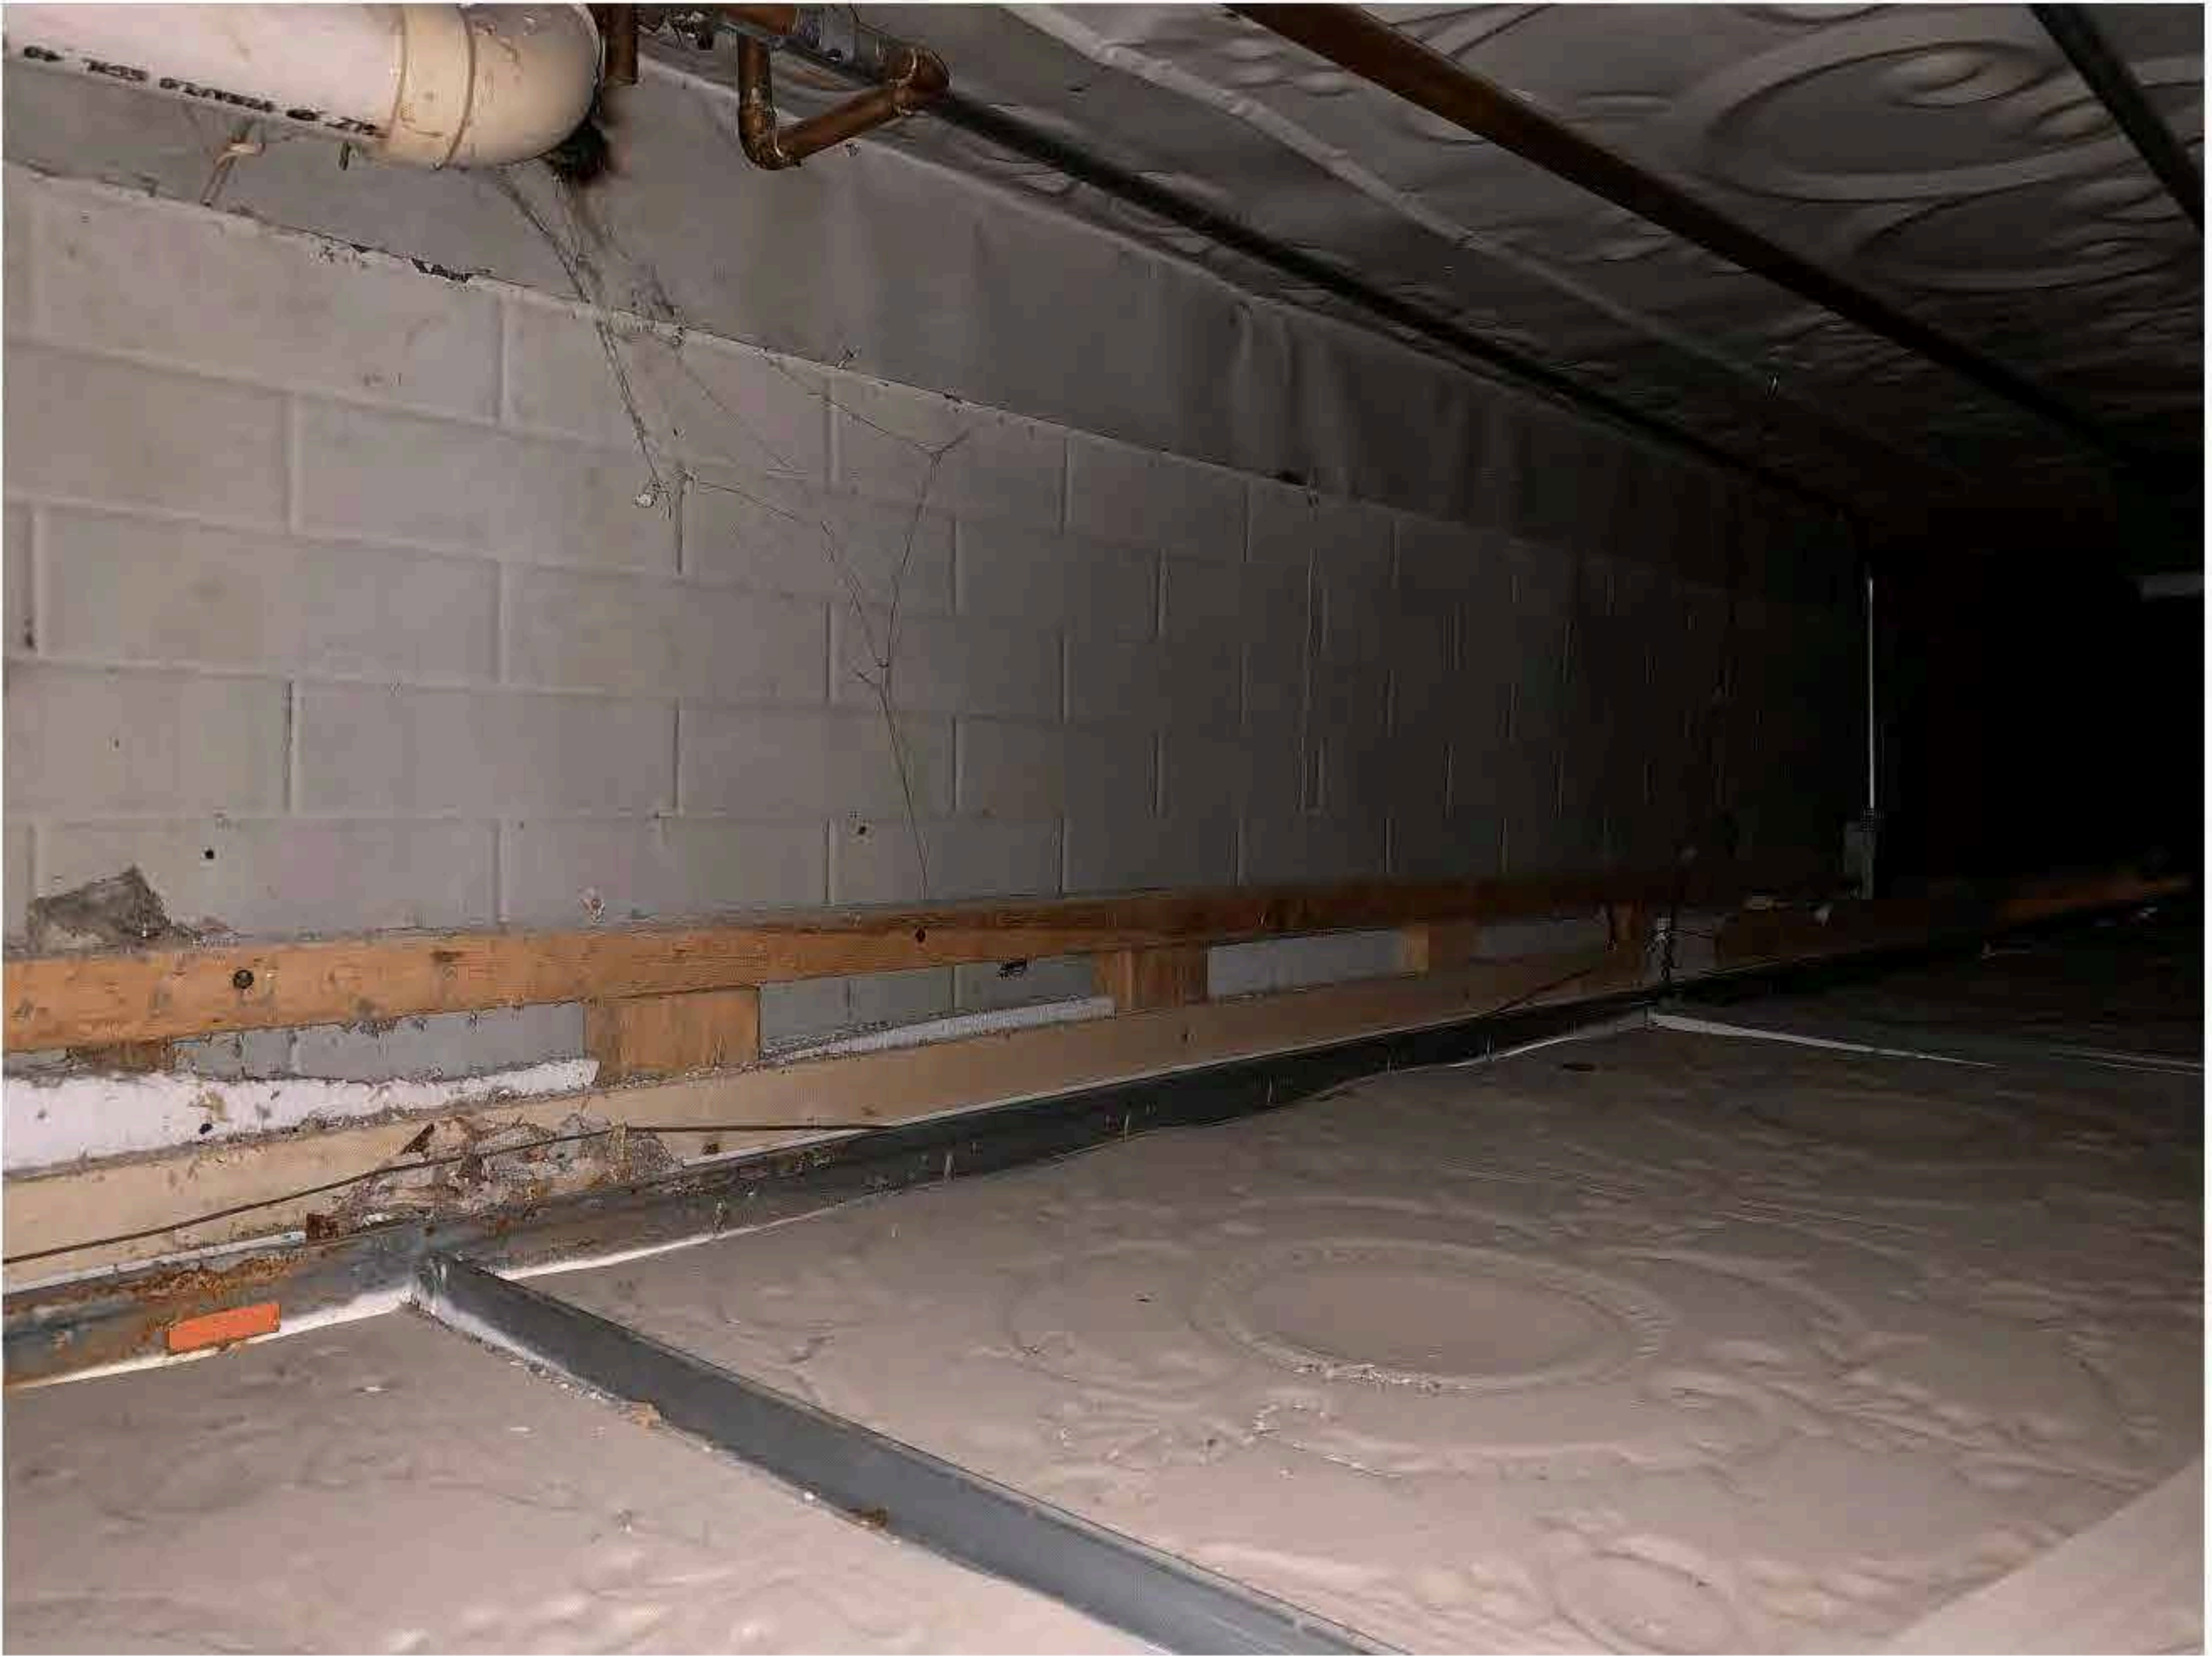
Figure 3.6-4: Dropped tin ceiling and original tin brick pattern wall

The main level walls are a combination of painted smooth troweled and rough stucco like plaster finishes. A small section of original pressed tin wall paneling in a running bond brick pattern can be seen above the dropped ceiling portion (Figure 3.6-4). Exposed columns and beams have been stuccoed over. The original cladding / finish is unknown. The exterior walls have been furred out and new GWB installed, hiding the original lathe and plaster and stamped tin wall coverings

The original pressed tin ceilings are still present. The front (East) portion of the ceiling over the main sales area and counter has been dropped with a typical suspended ceiling grid installed. Reproduction pressed tin panels were installed in the grid. Plumbing and electrical systems were run below the original tin ceiling, thus the non-historic dropped tin ceiling was presumably installed to hide these.

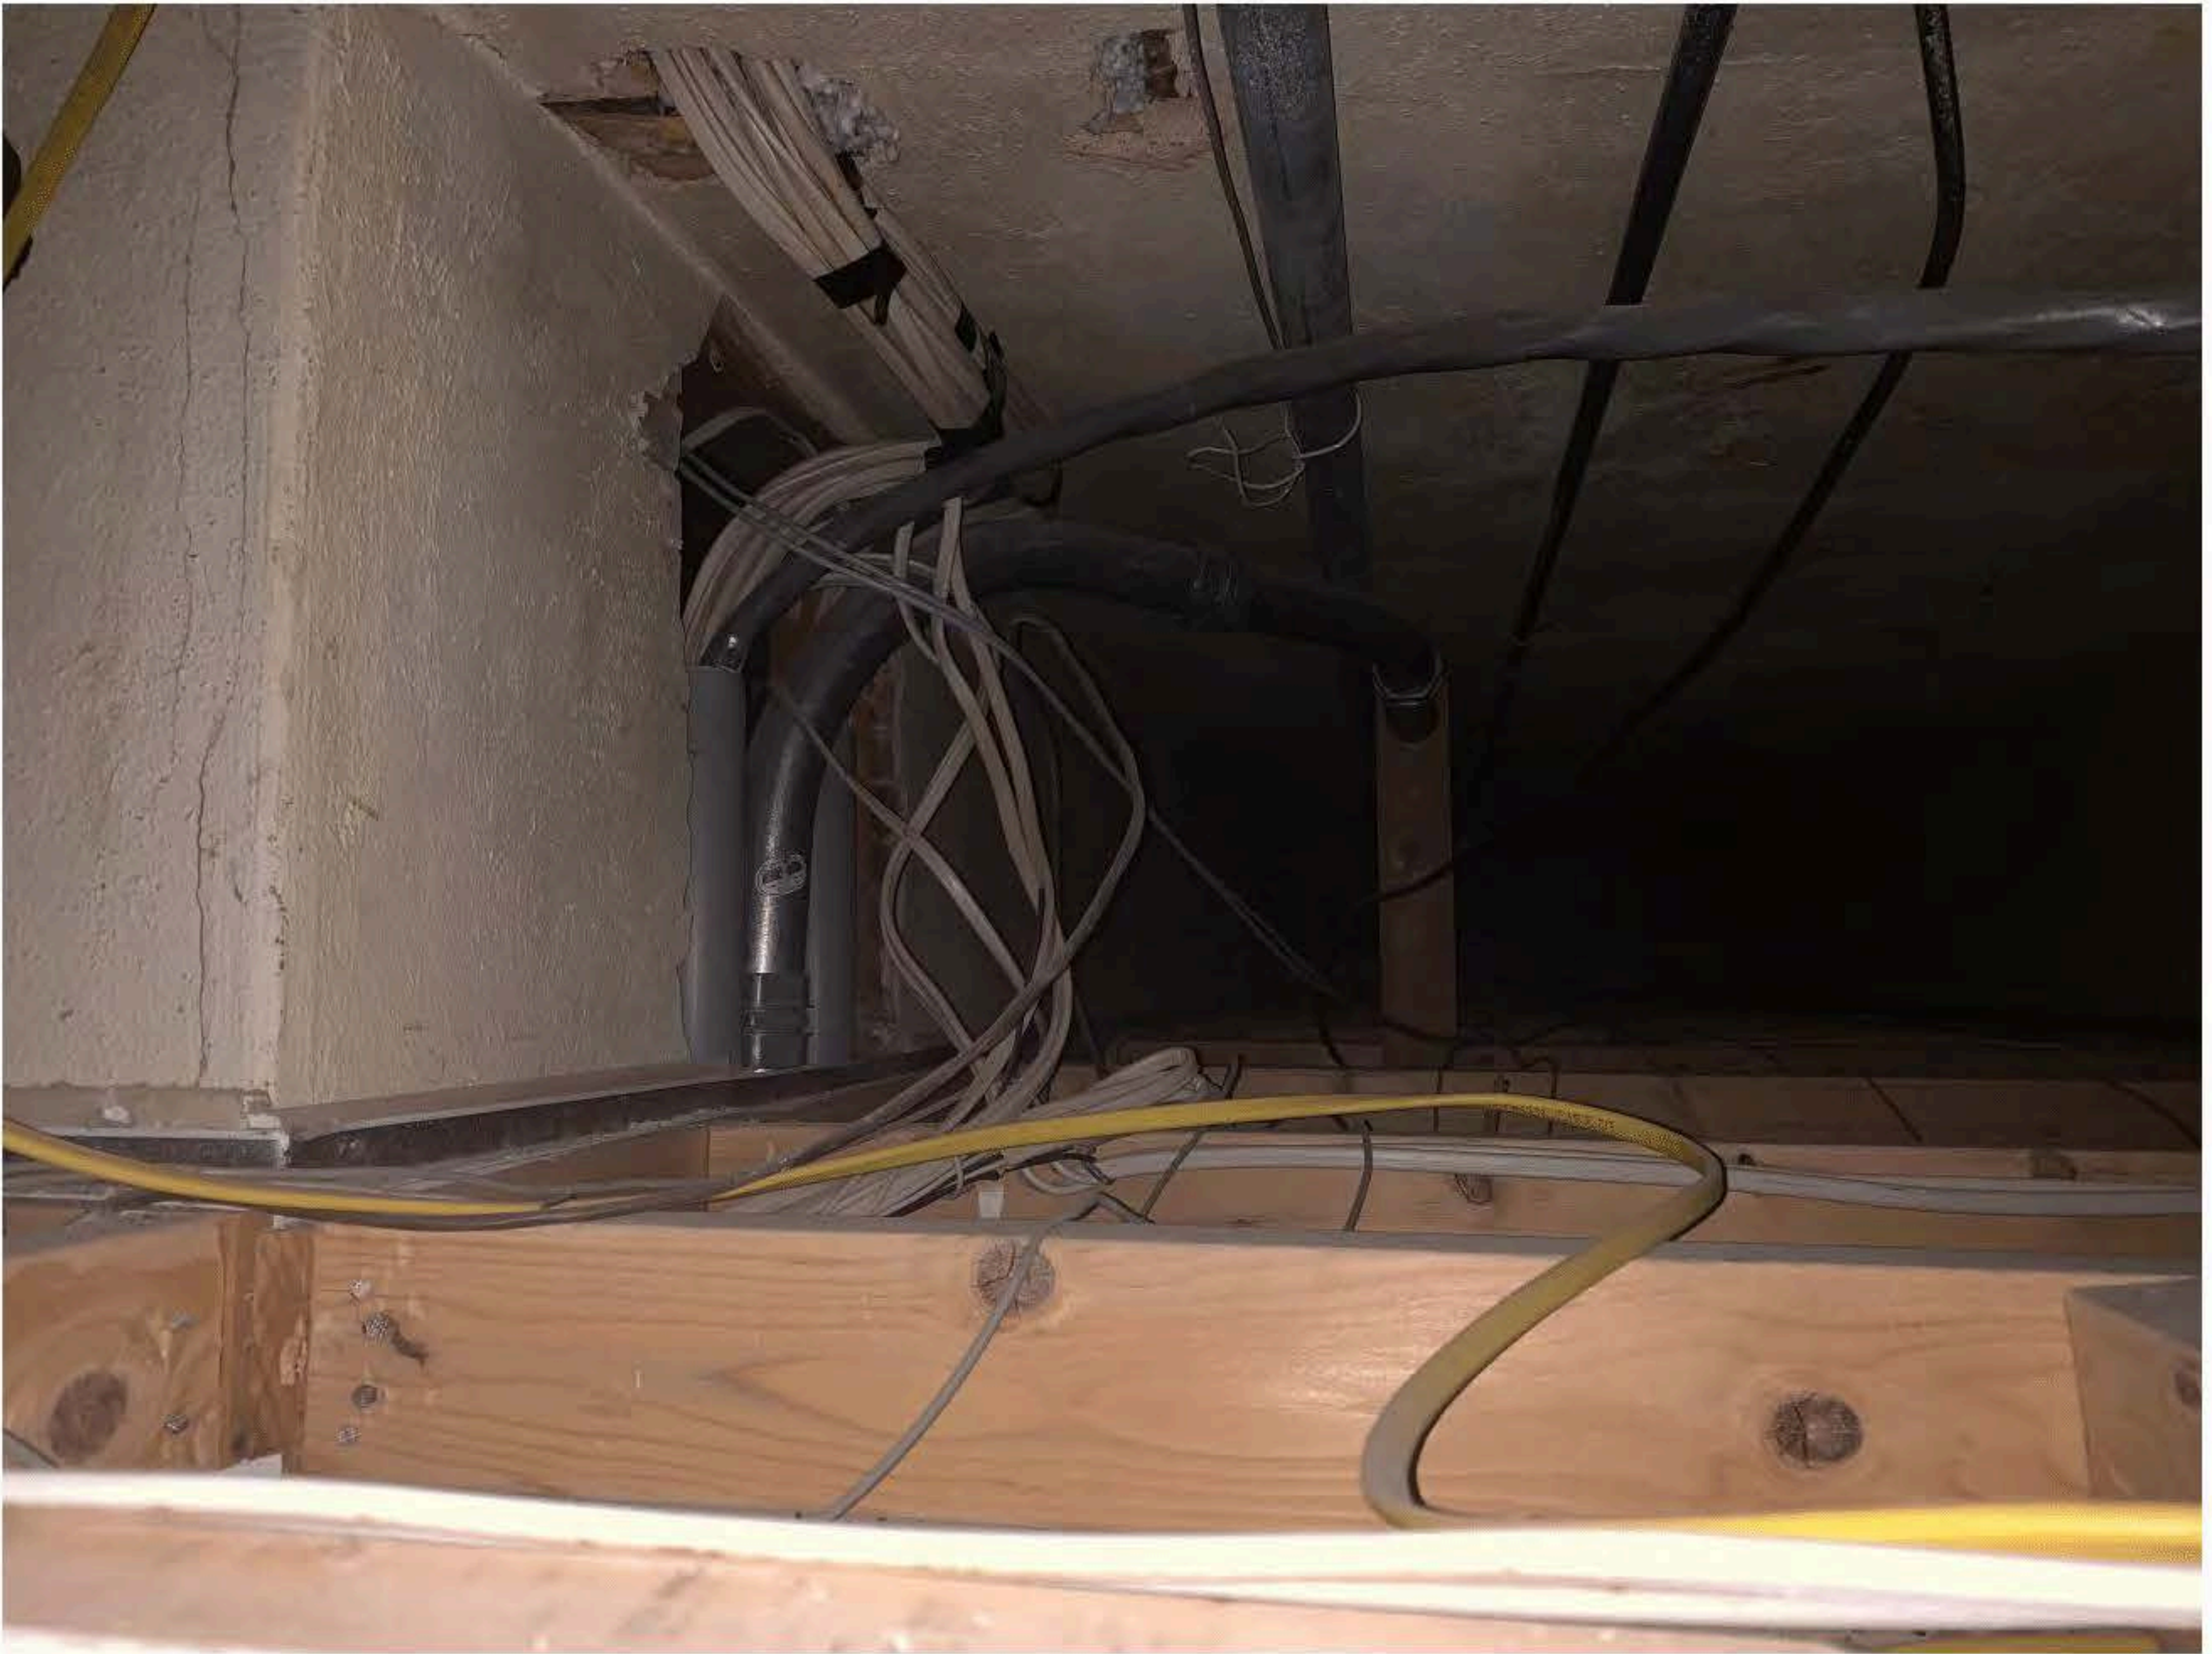
Figure 3.6-6: Dropped GWB ceiling and original lathe and plaster wall and ceiling

The ceilings are GWB hung on new 2x4 framing that has been dropped approximately 16". This extends across the entire upstairs. The original lathe and plaster ceiling and portions of wall finish can be seen above the new dropped ceiling (Figure 3.6-6)

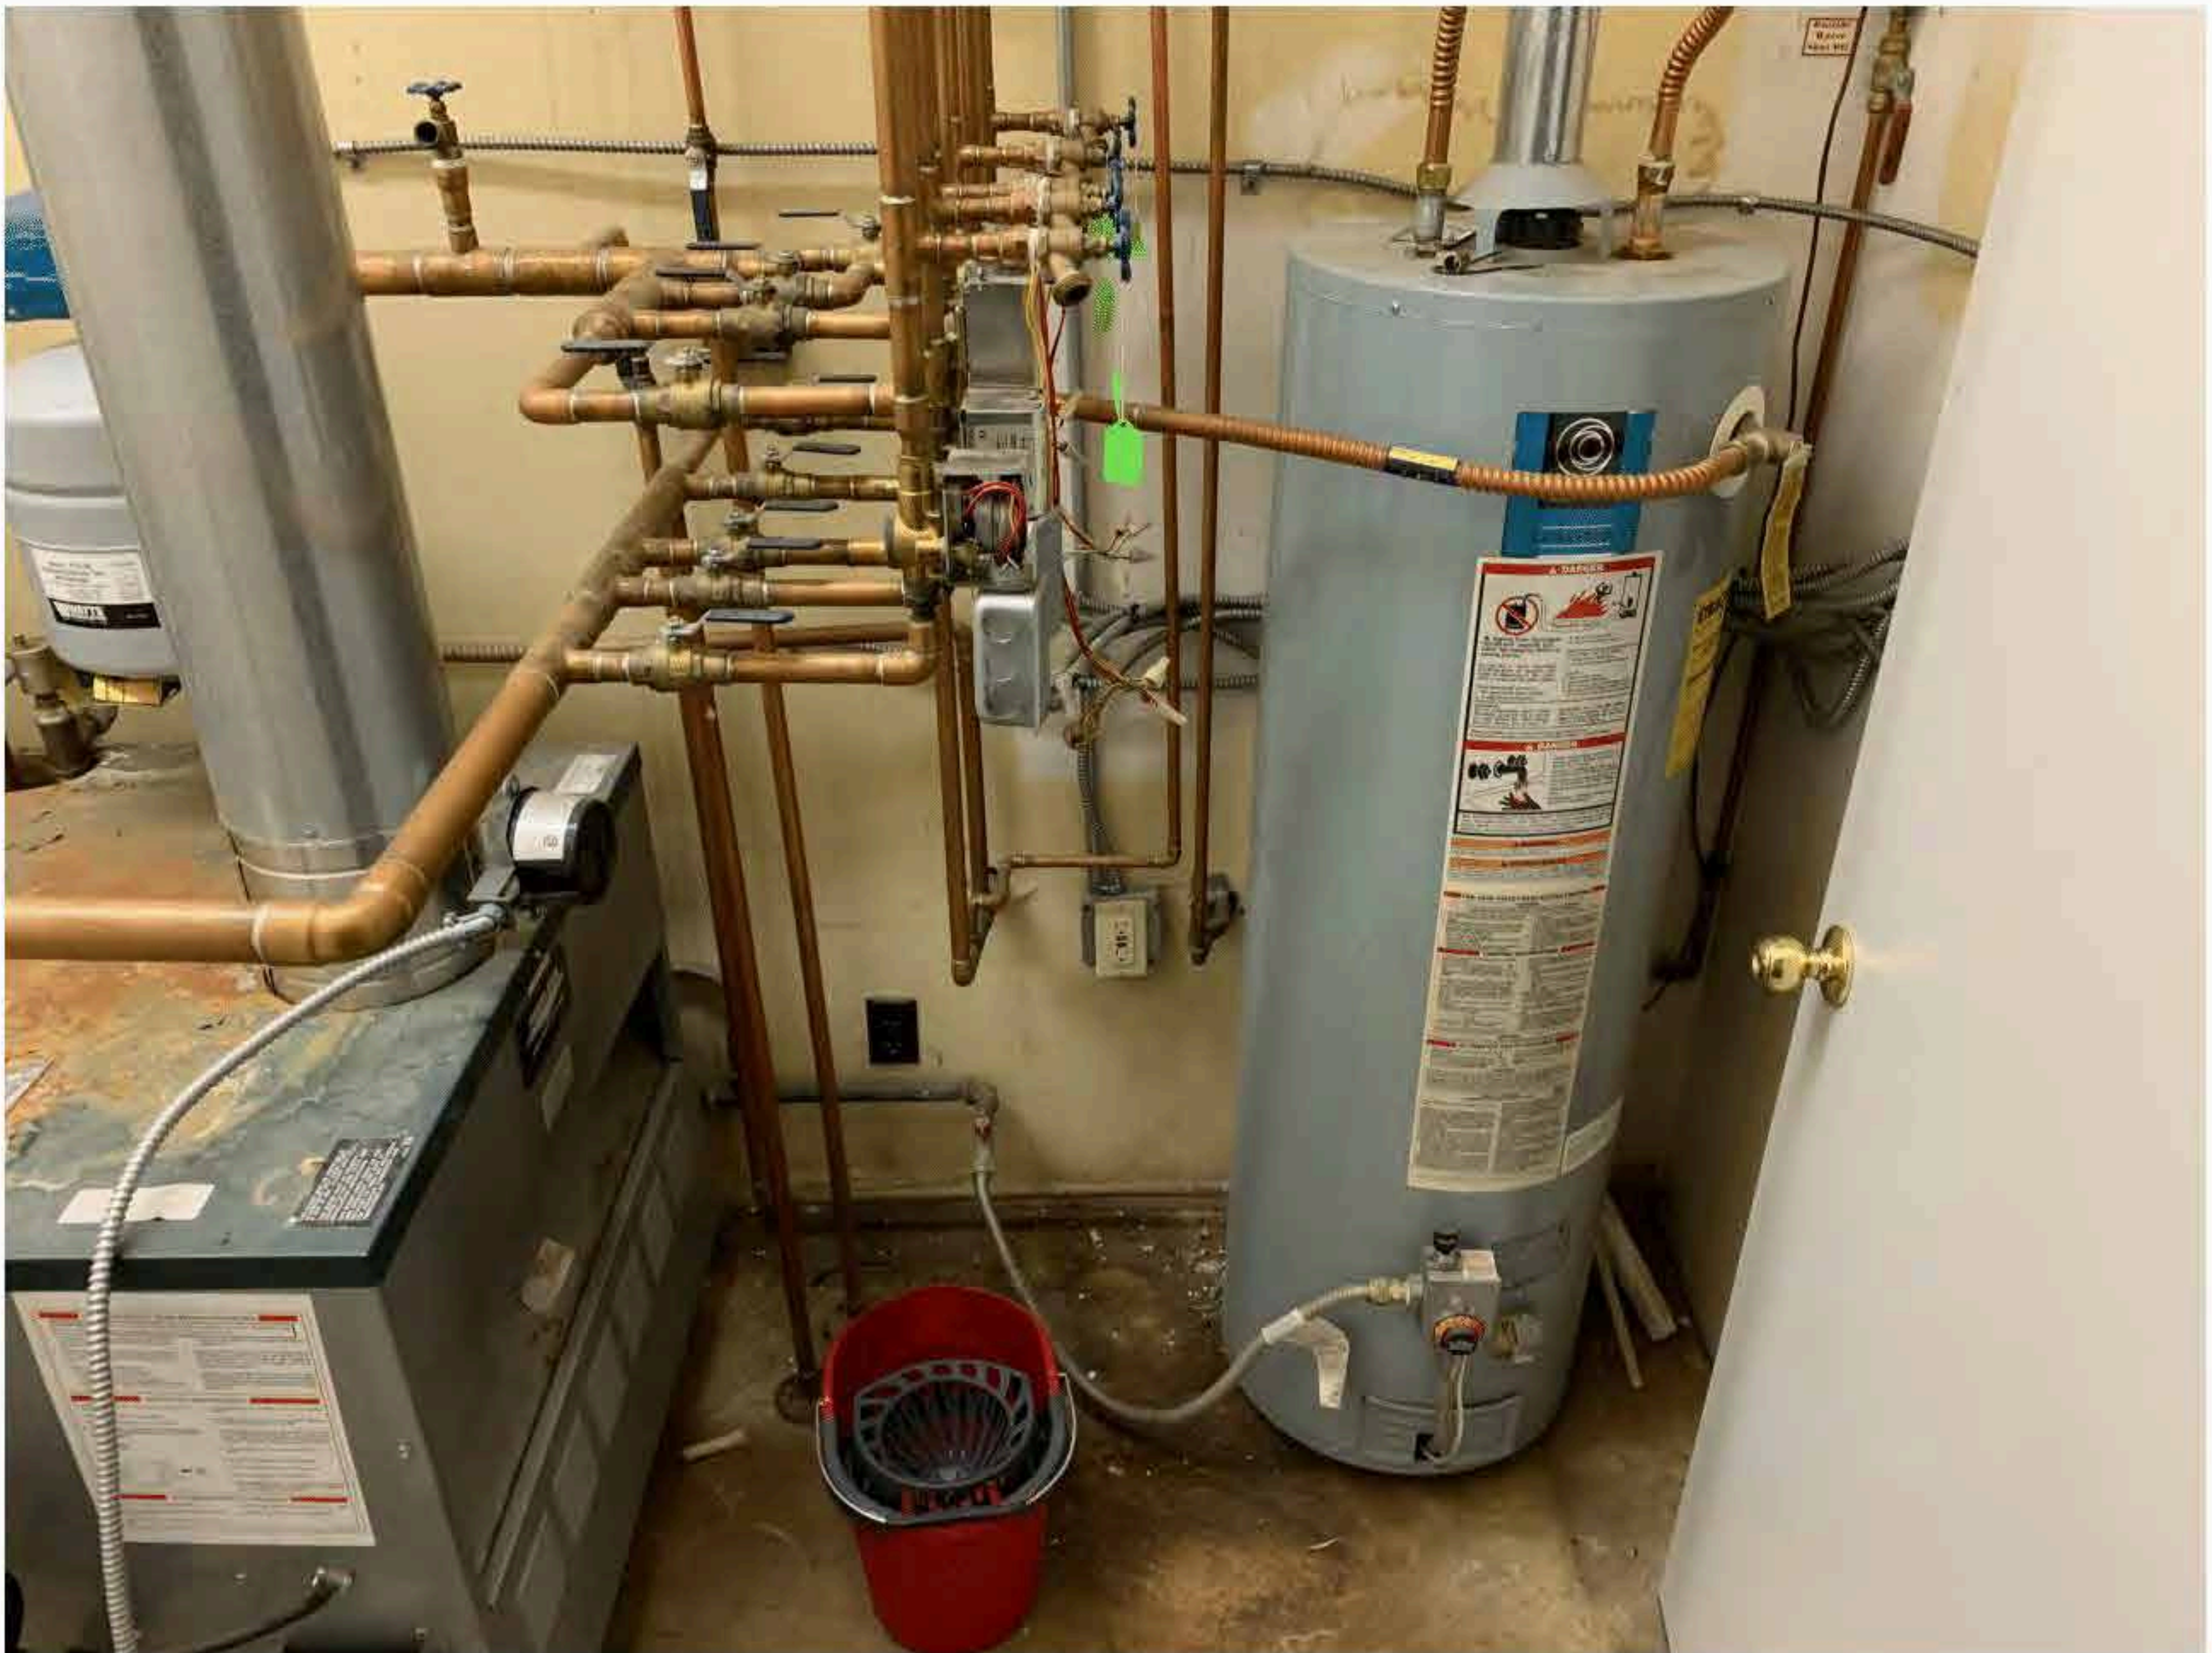
Figure 3.7-1: Hot water boiler and distribution piping and hot water heater

Heat for the building is provided by a gas hot water boiler feeding baseboard radiant heaters with multiple thermostat controlled zones. Metered natural gas is provided by a hook up to the Atmos Energy gas supply.

Hot water is provided by a gas hot water heater on the lower level and an electric hot water heater on the upper level. The upper level hot water heater supplies a small darkroom and possibly the upstairs kitchen and bathrooms as well.

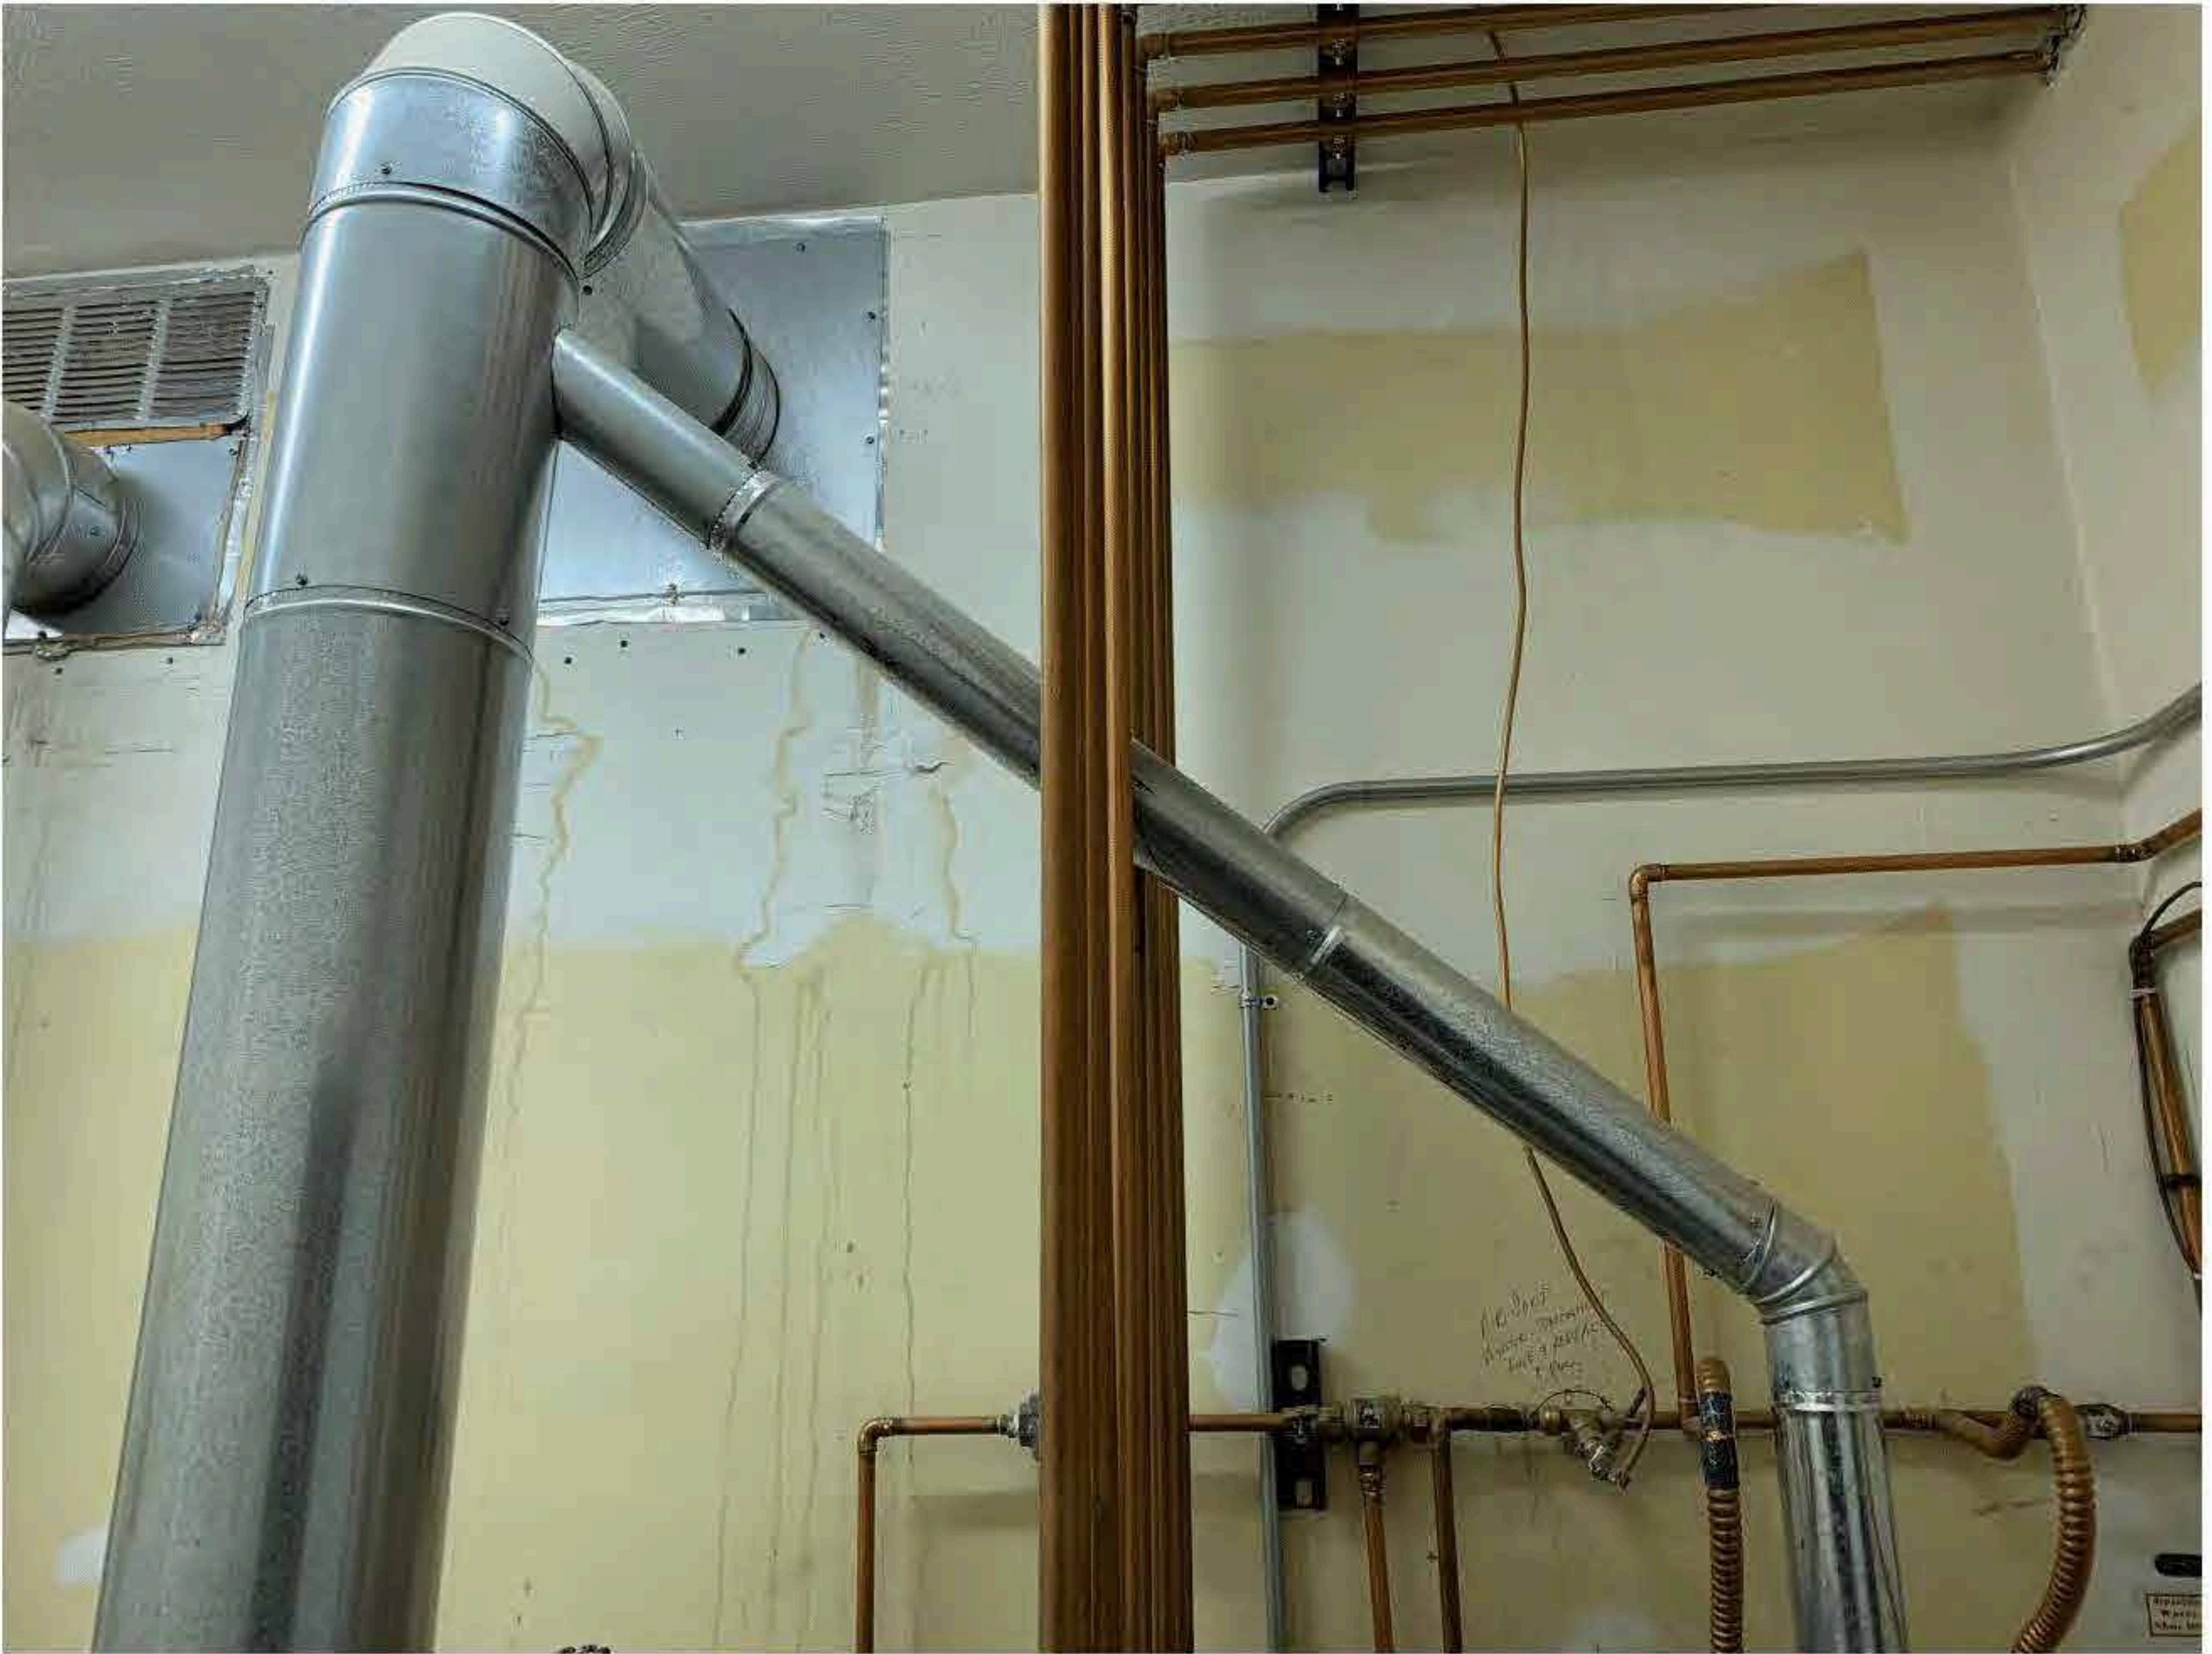
Figure 3.7-2: Hot water boiler and hot water heater flue pipe

All heating system components are in Good condition. No leaks were noted in any part of the system. The boiler shows signs of wear on the surface but functions fine and is of serviceable age. There are owner reported issues with zoning and balancing of the system, producing uneven temperatures and occupant discomfort.

Regularly inspect and maintain all heating system components. Owner reports that zoning and thermostat functions are less than optimal. At such time that system needs upgrades or replacement, an evaluation and design of an optimal system, zoning and controls should be undertaken.
