# Historic Structure Assessment

## Cortez Cultural Center

25 N Market St., Cortez, CO 81321

SHF Project # 2019-HA-001

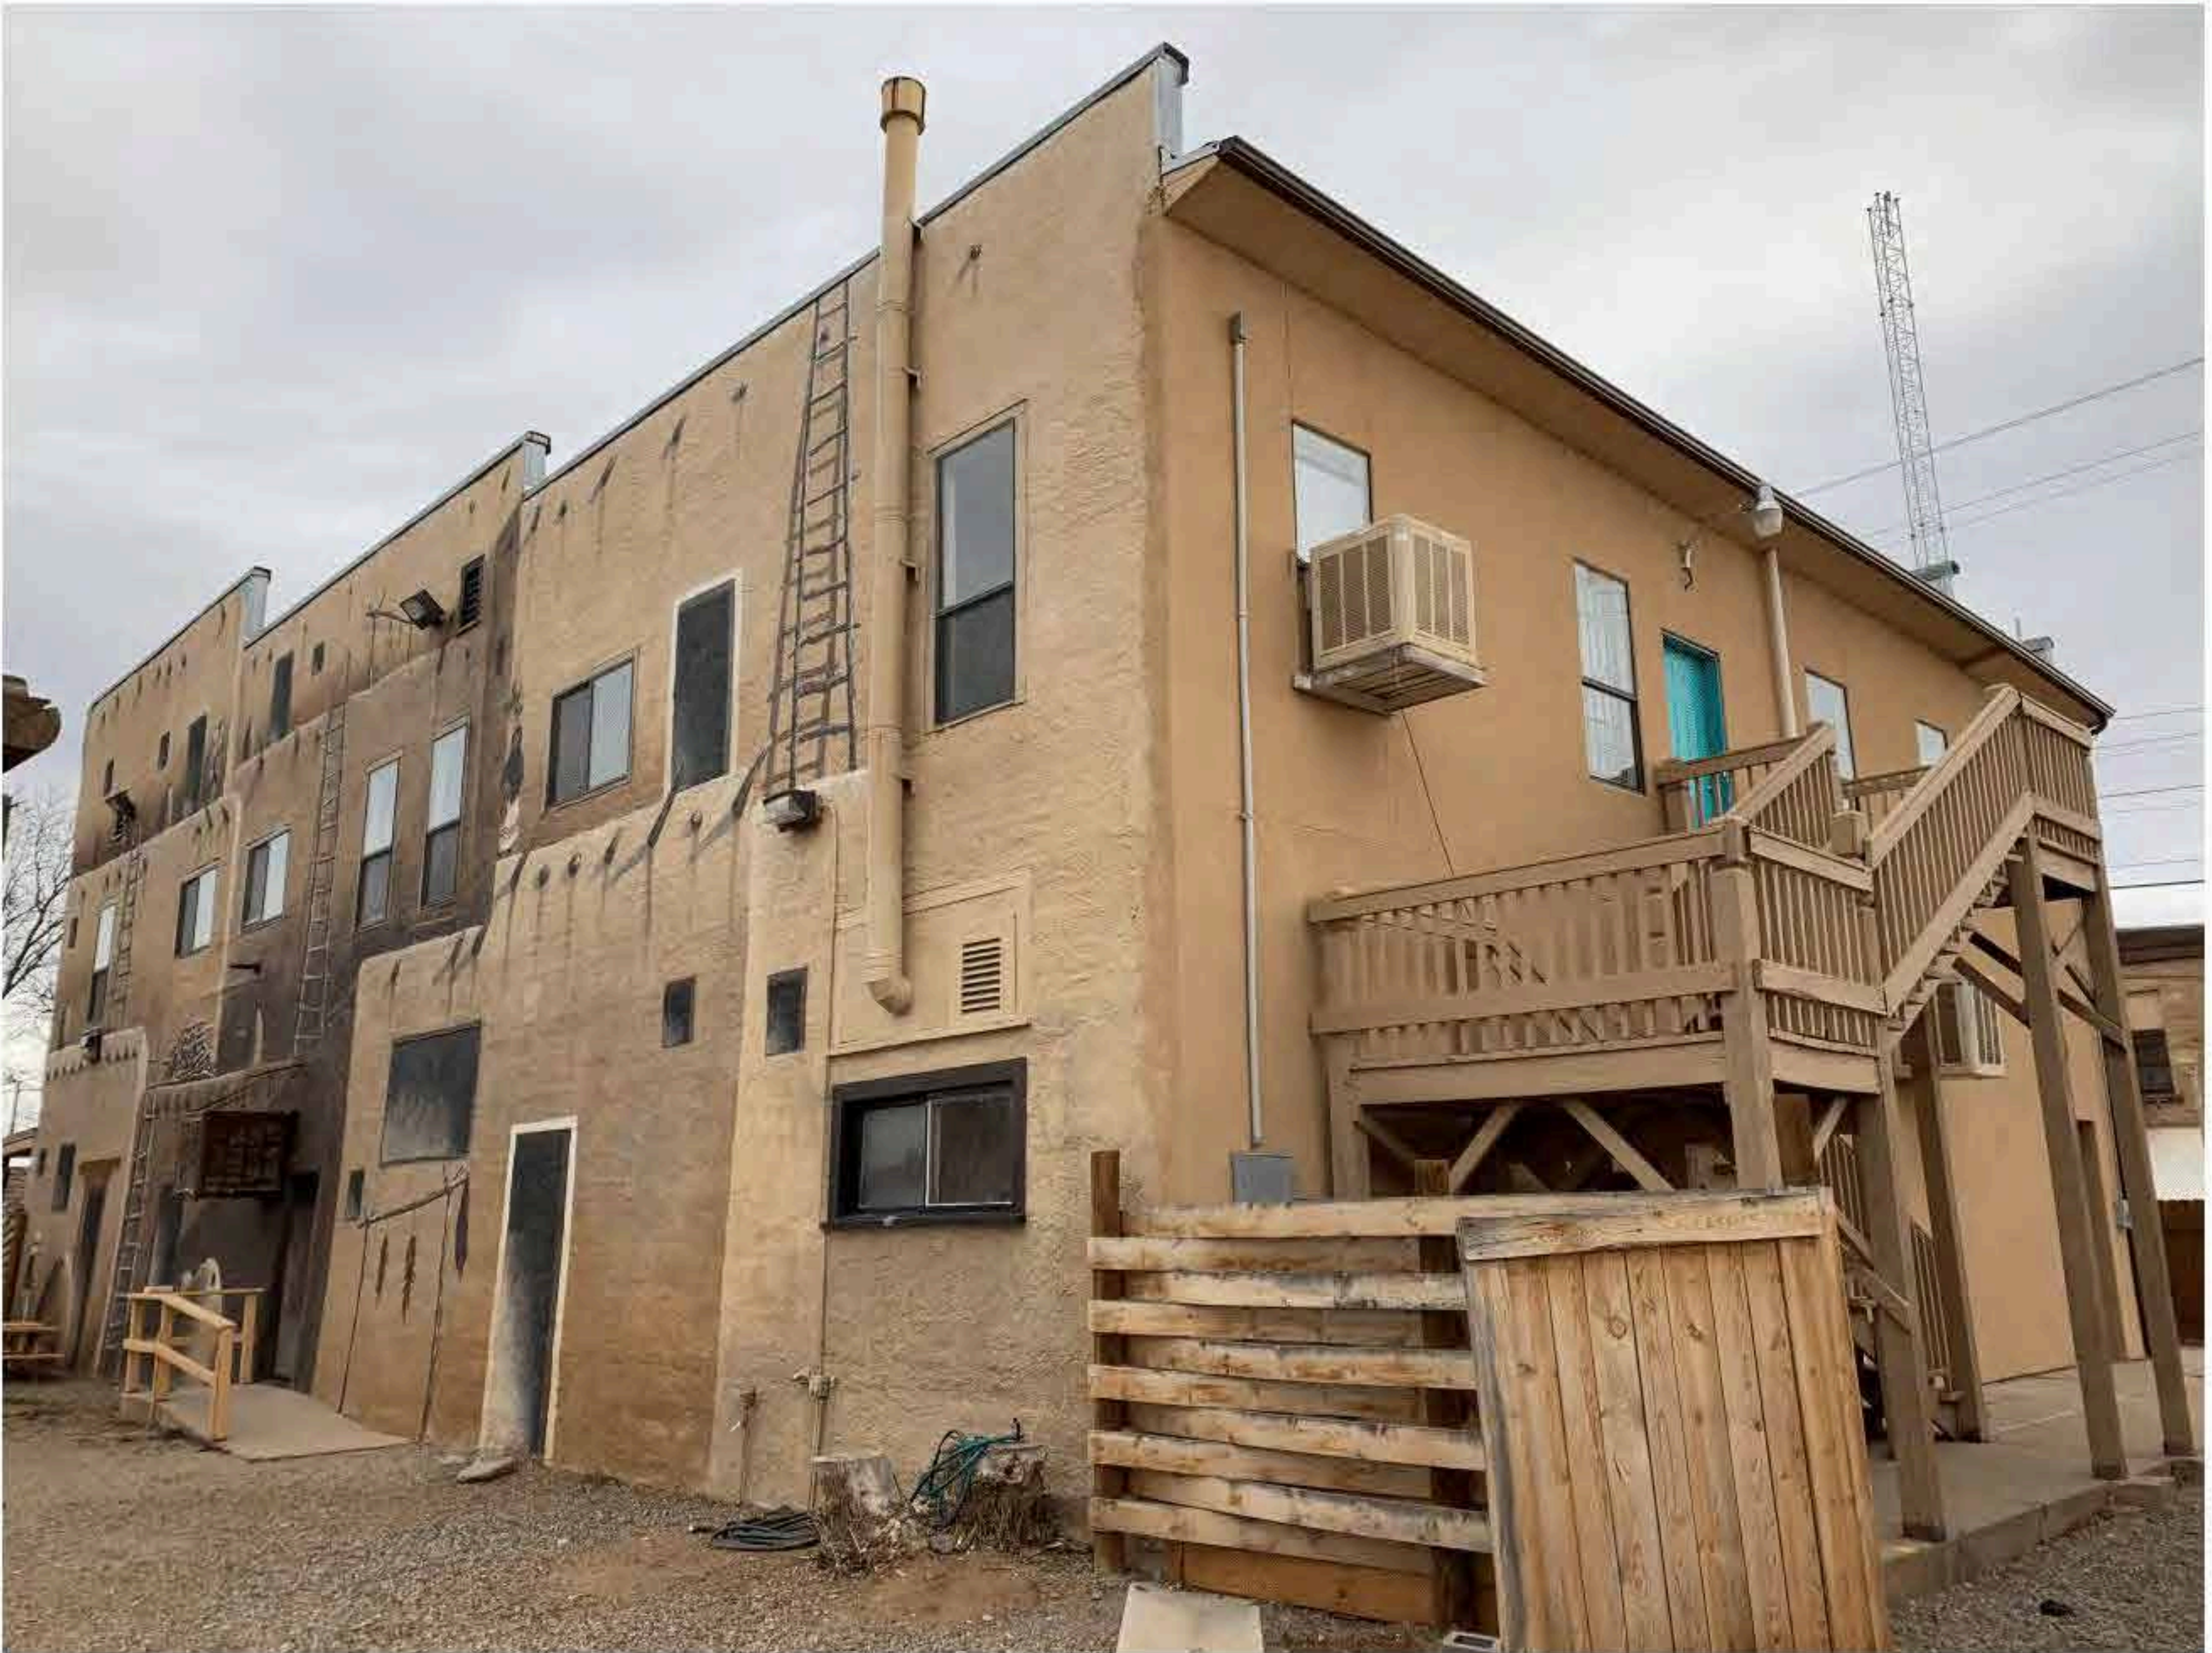
Figure 3.7-3: NW exterior showing 3 evaporative coolers

There are three swamp coolers installed in windows to cool the upstairs, and two installed through the walls in the downstairs. They are very old and expensive to maintain. In 2019 all 5 swamp coolers were serviced abut only two were able to be made to operate satisfactory.

All cooling system components are in Poor condition. Evaporative cooling maintenance contractors report that they are not able to maintain proper operation on three of the five units.

All cooling system components should be replaced as part of the overall Preservation Plan scope of work with particular attention paid to the consistent temperature and humidity control needed for artwork and artifacts houses at the Center.

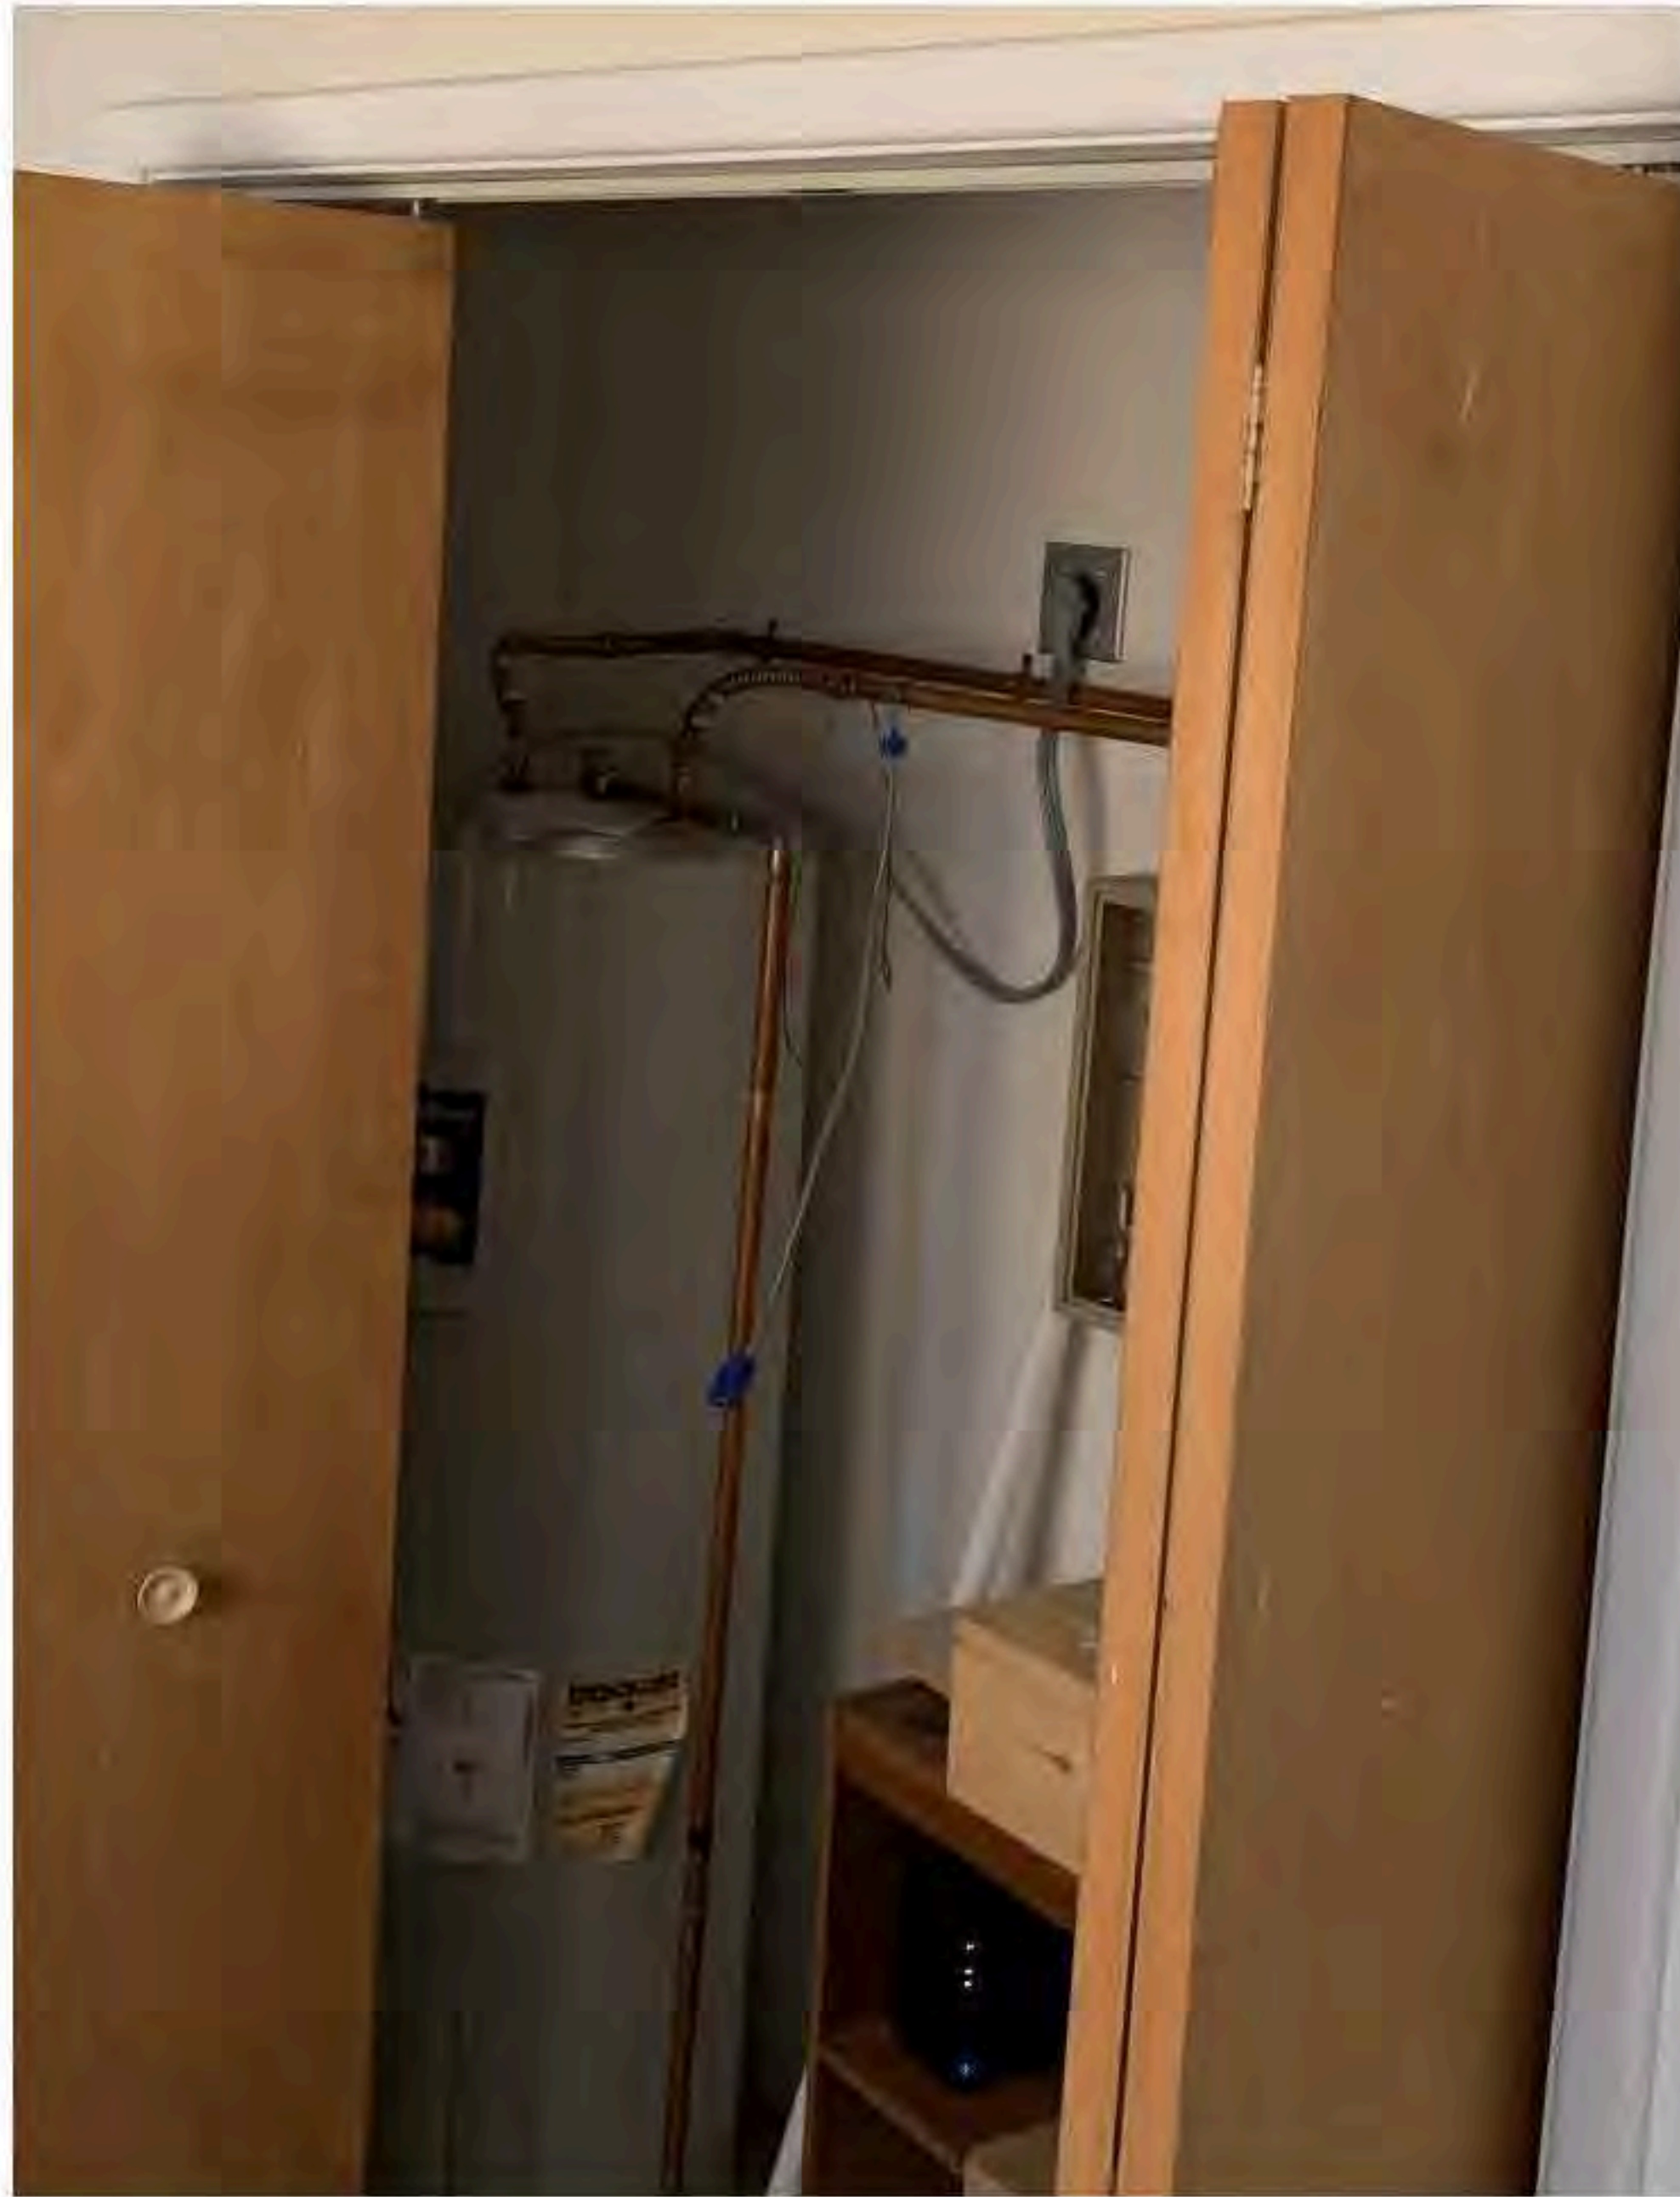
Figure 3.7-4: Upper level closet showing HW heater and copper plumbing

Domestic water is supplied via a metered water tap to the City of Cortez water system. All potable hot and cold water pipes that can be observed are newer soldered copper lines.

Plumbing system components are in Good to Fair condition. No degradation or leaks were observed on the supply or the waste side. Bathroom and kitchen fixtures are in Good to Fair condition, all are serviceable and still within their expected service life.

Regularly inspect and maintain all plumbing systems. Bathrooms and Kitchen would likely be remodeled as part of a future scope of work and at that time all fixtures should be replaced for both cosmetic, water saving, and preventative maintenance reasons.

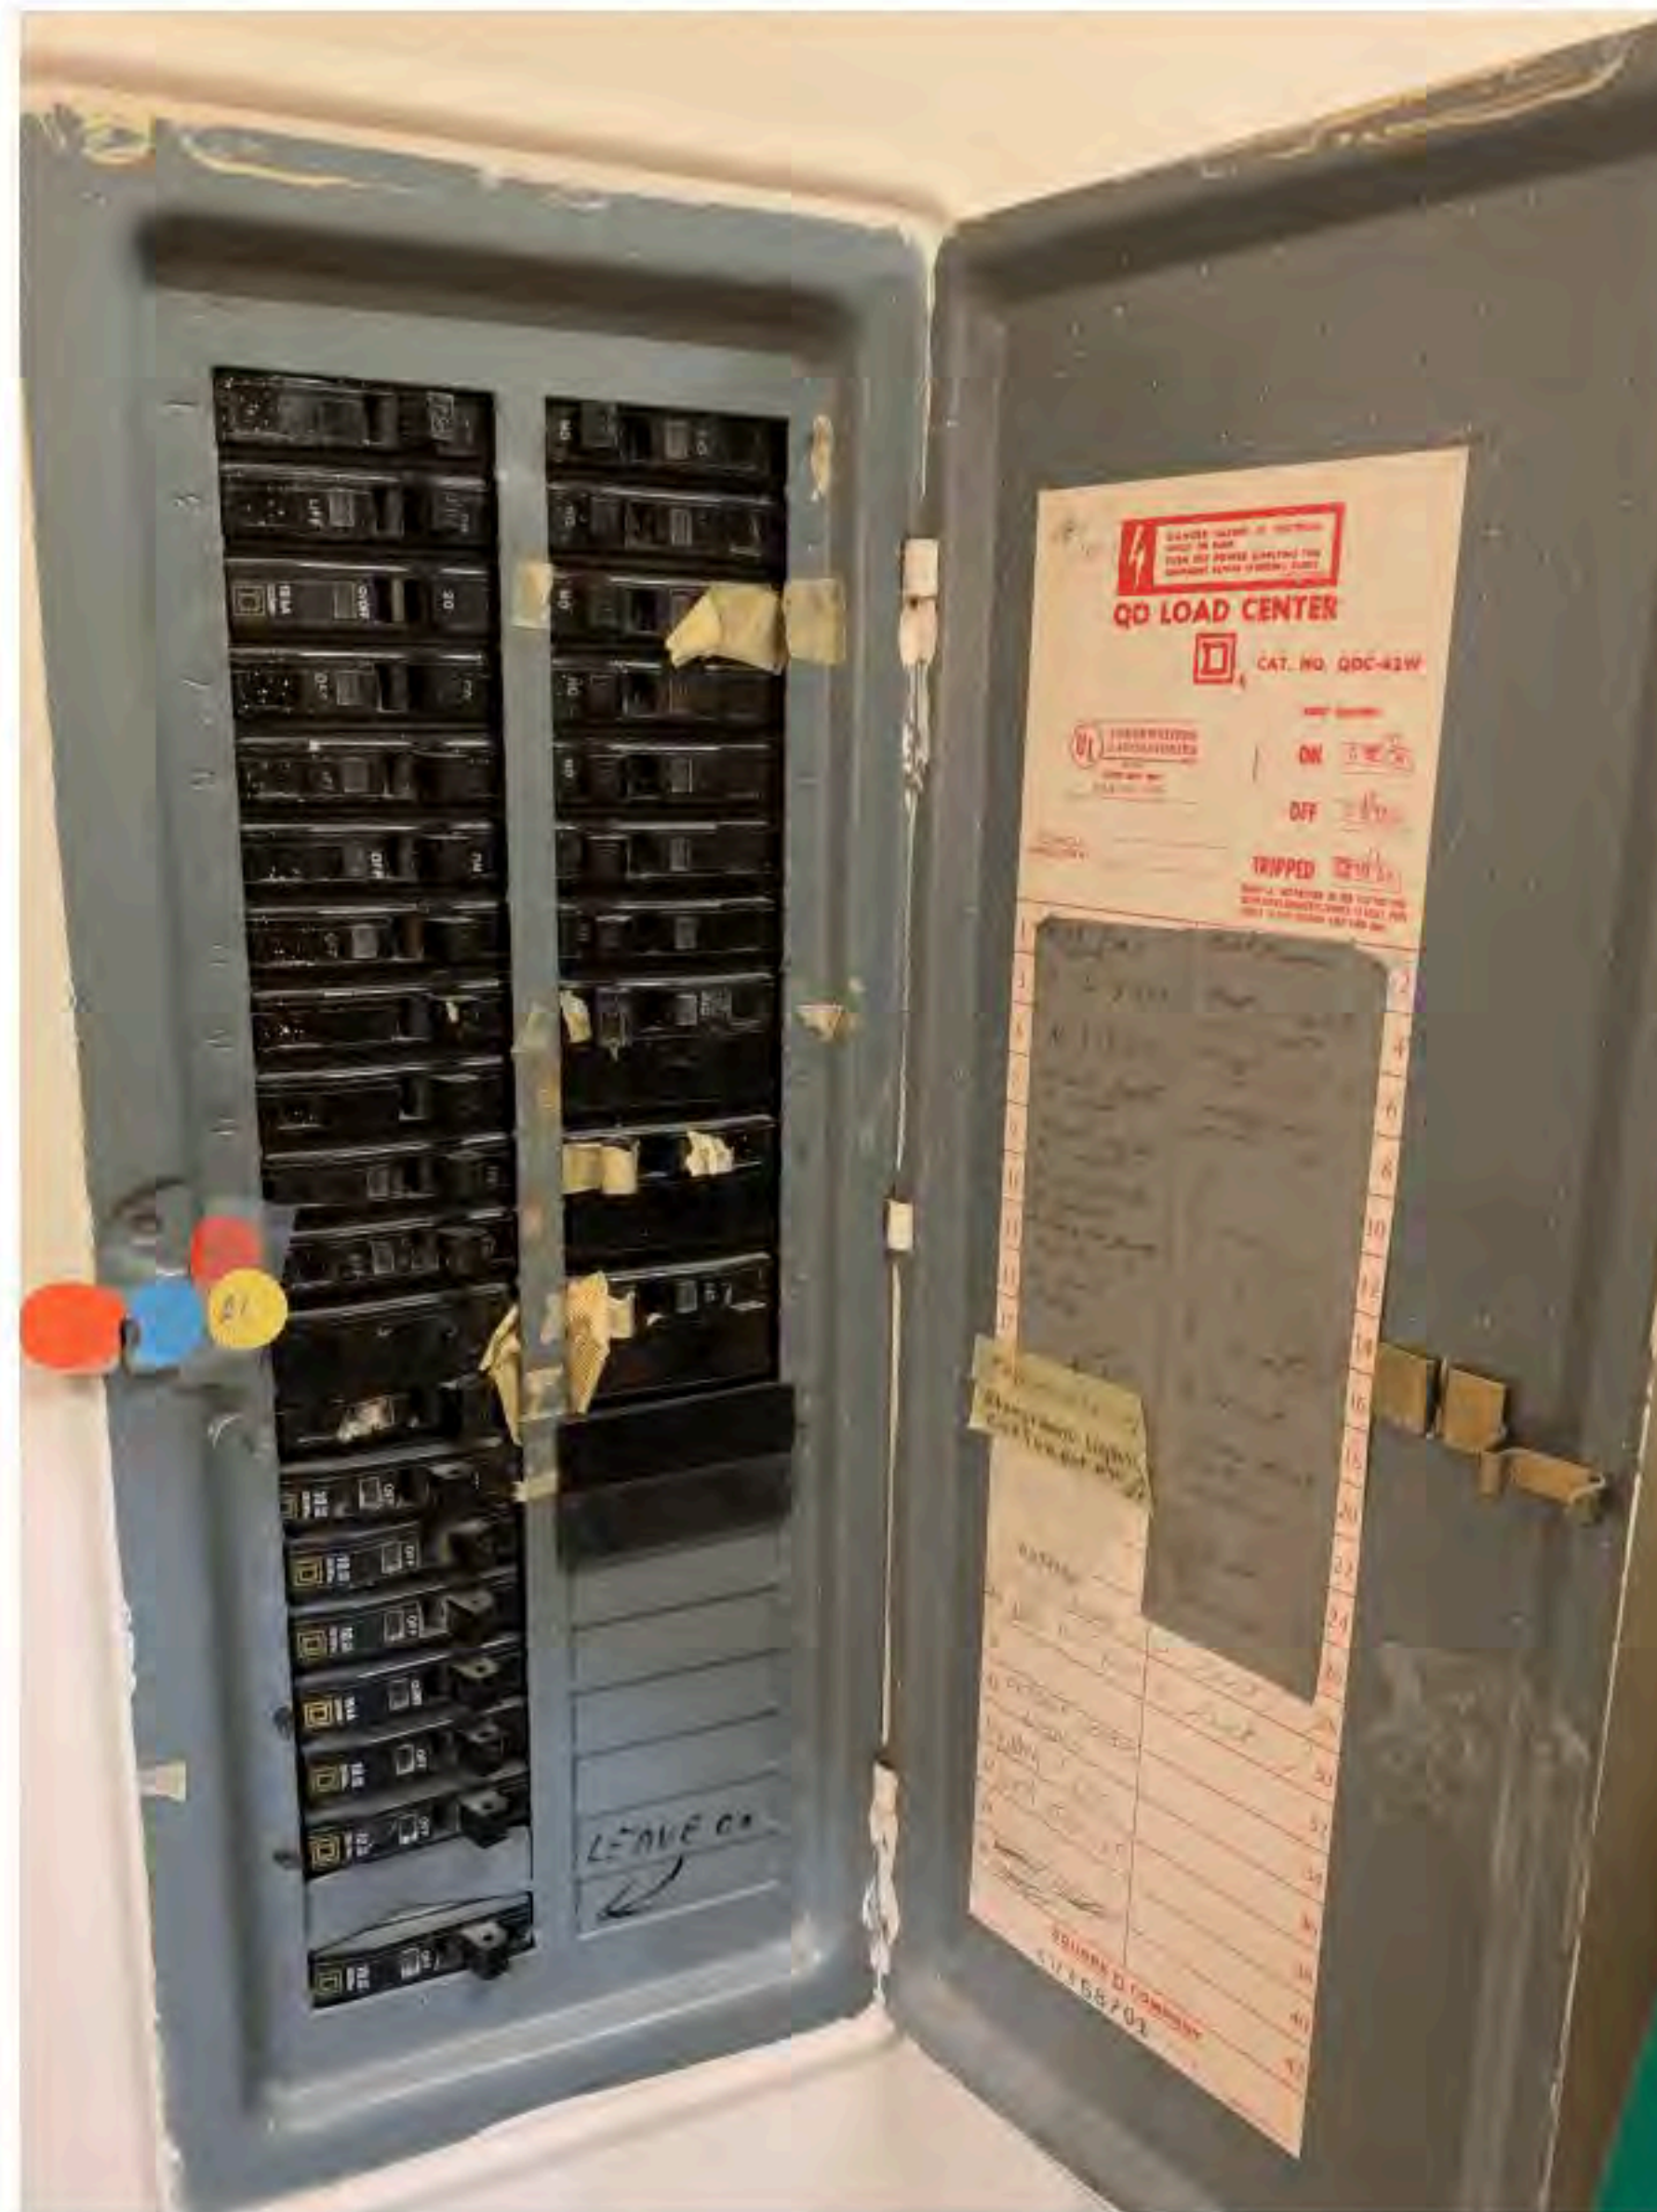
Figure 3.8-1: Main level main breaker panel

The building contains a mix of ages of wiring, panels and breakers but all of it that could be observed was of modern type, including standard replaceable circuit breakers and PVC sheathed wire, which was introduced around 1950.

While no major issues with the electrical system were observed and the system components that are observable appear to be in Good condition, the occupants state that there are circuits that frequently trip breakers so loads and circuits need to be mapped and evaluated.

A qualified electrician should inspect the entire electrical system, consult with occupants on issues, and produce a written analysis and recommendation on compliance and remedies for any issues discovered.

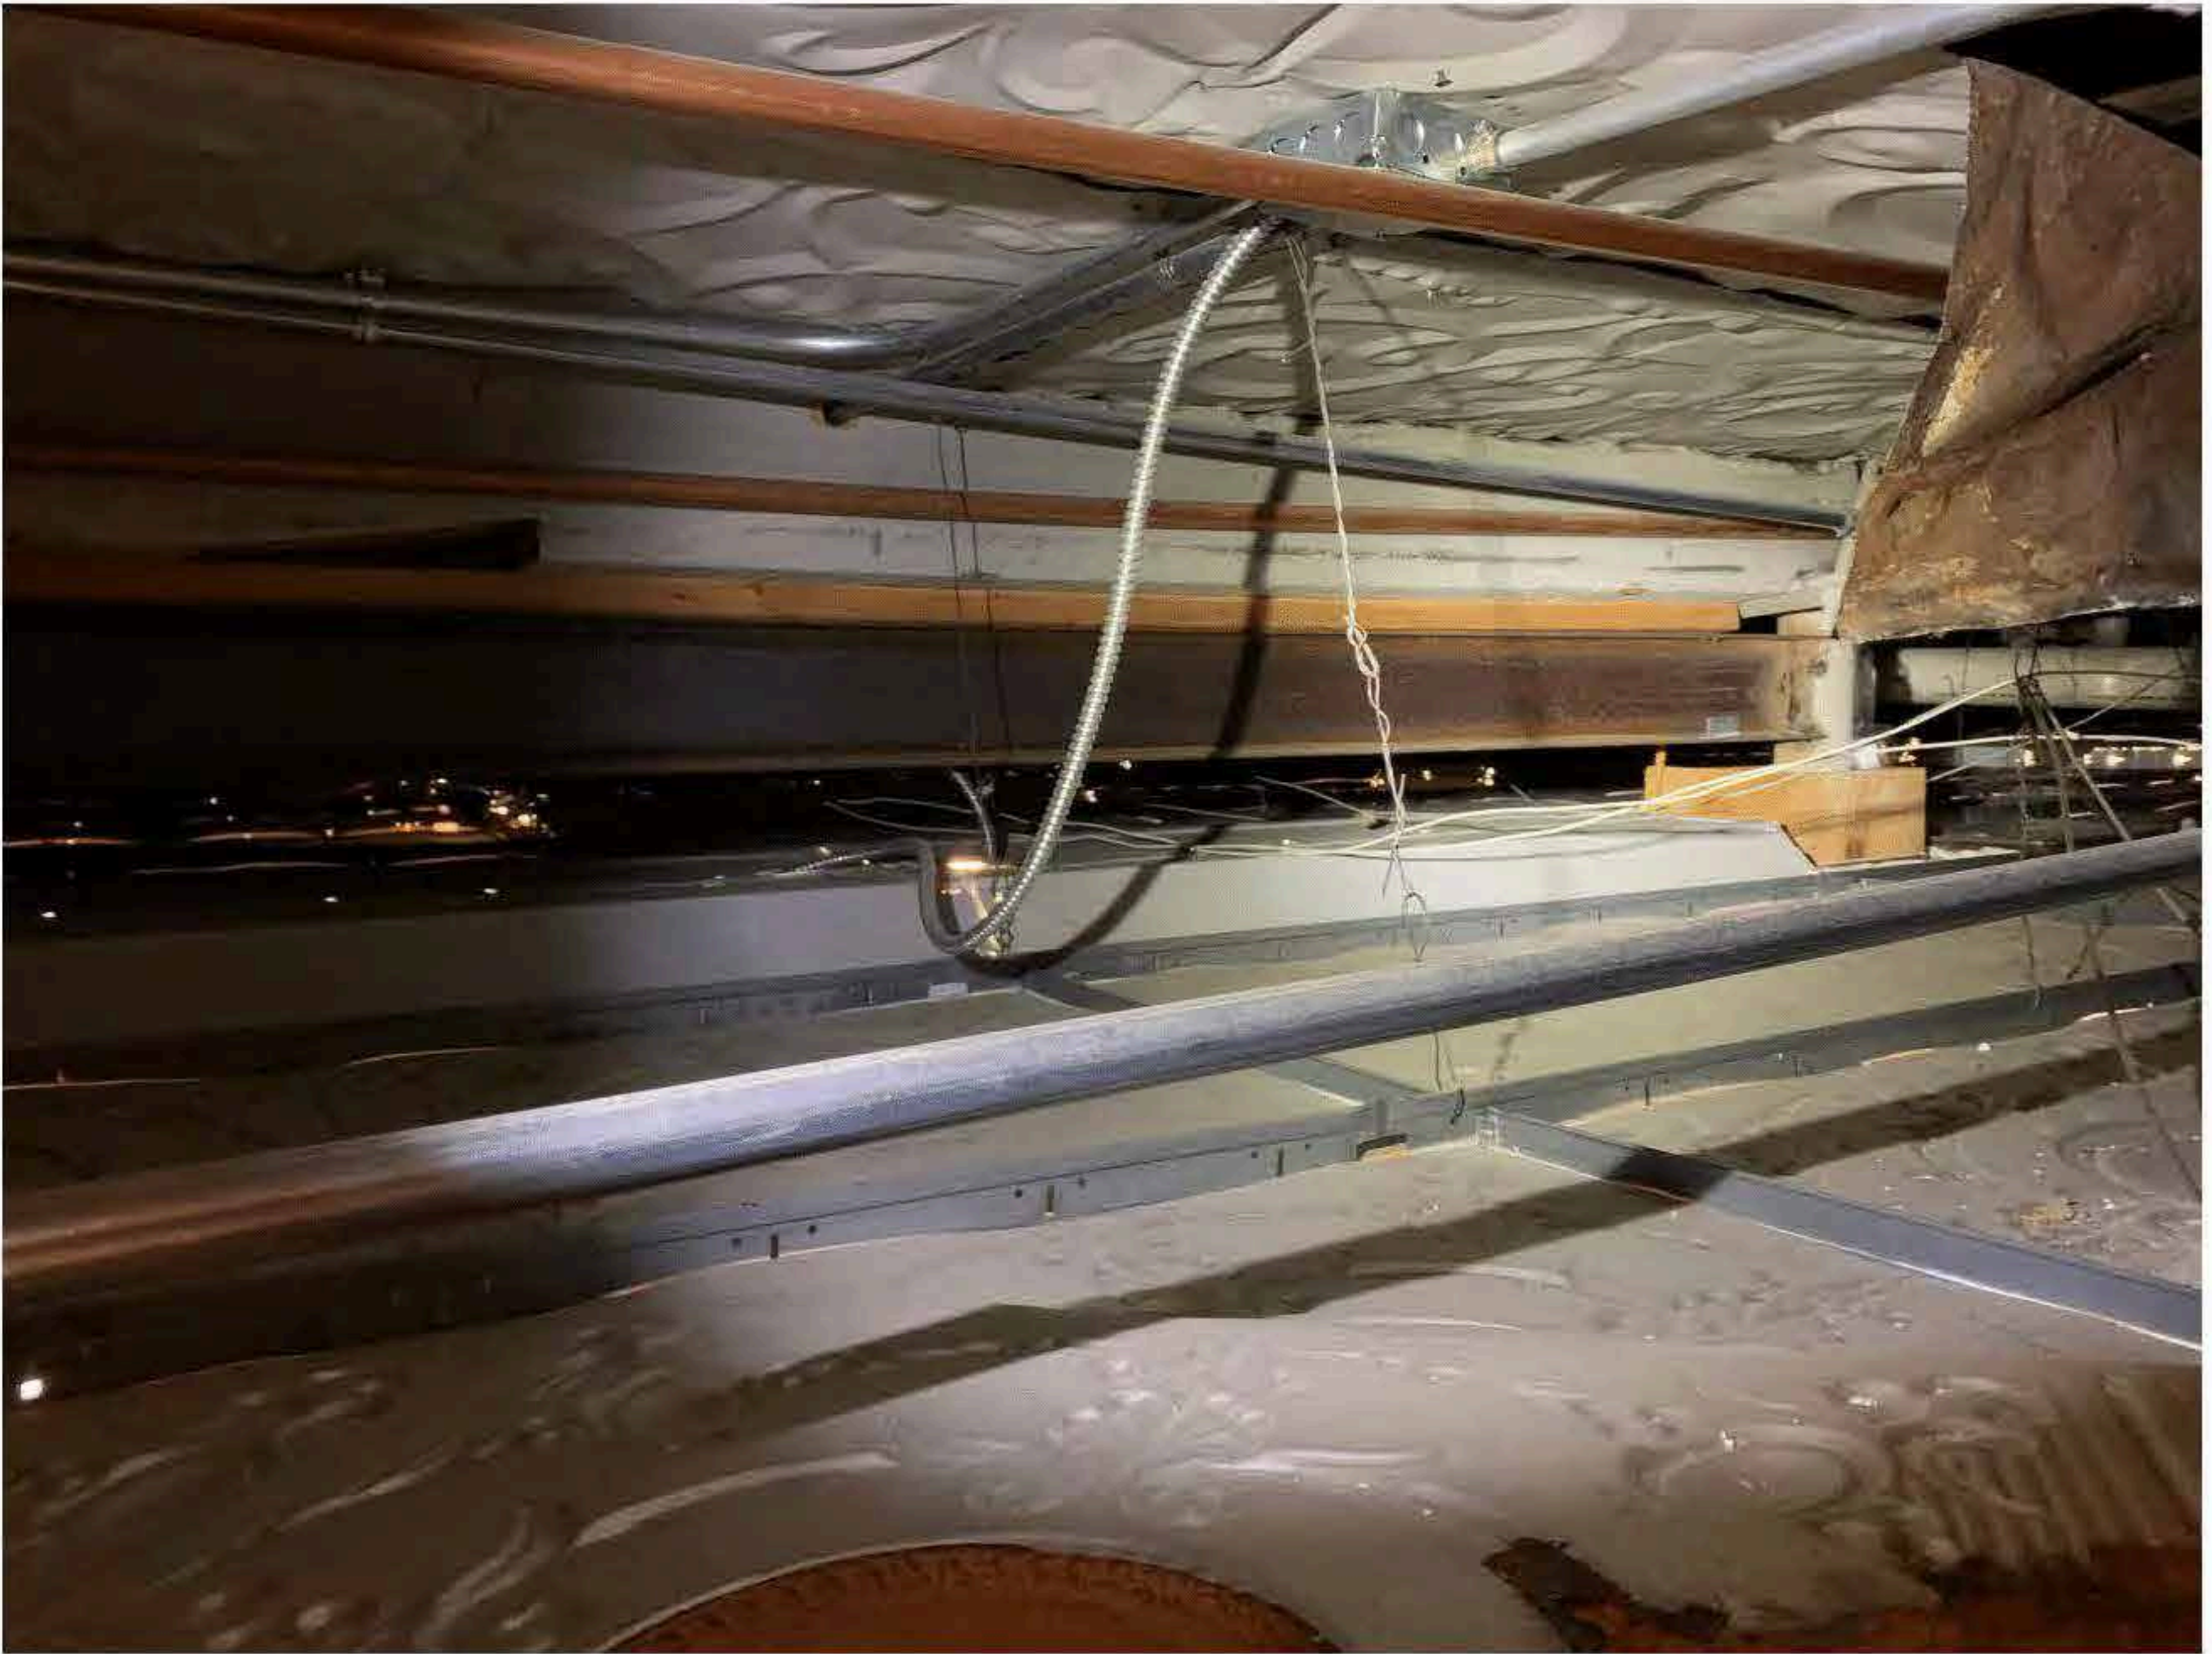
Figure 3.8-3: Main level conduit runs and lighting at dropped ceiling

Much of the renovation work that was done included running a large amount of new wiring above the new dropped ceilings. In general, this is a mess and exhibits a lack of detail and clean and professional installation methods but no obvious unsafe electrical conditions were observed. (Note that this is a general observation only, a qualified electrician or electrical inspector should be consulted for electrical code analysis.)

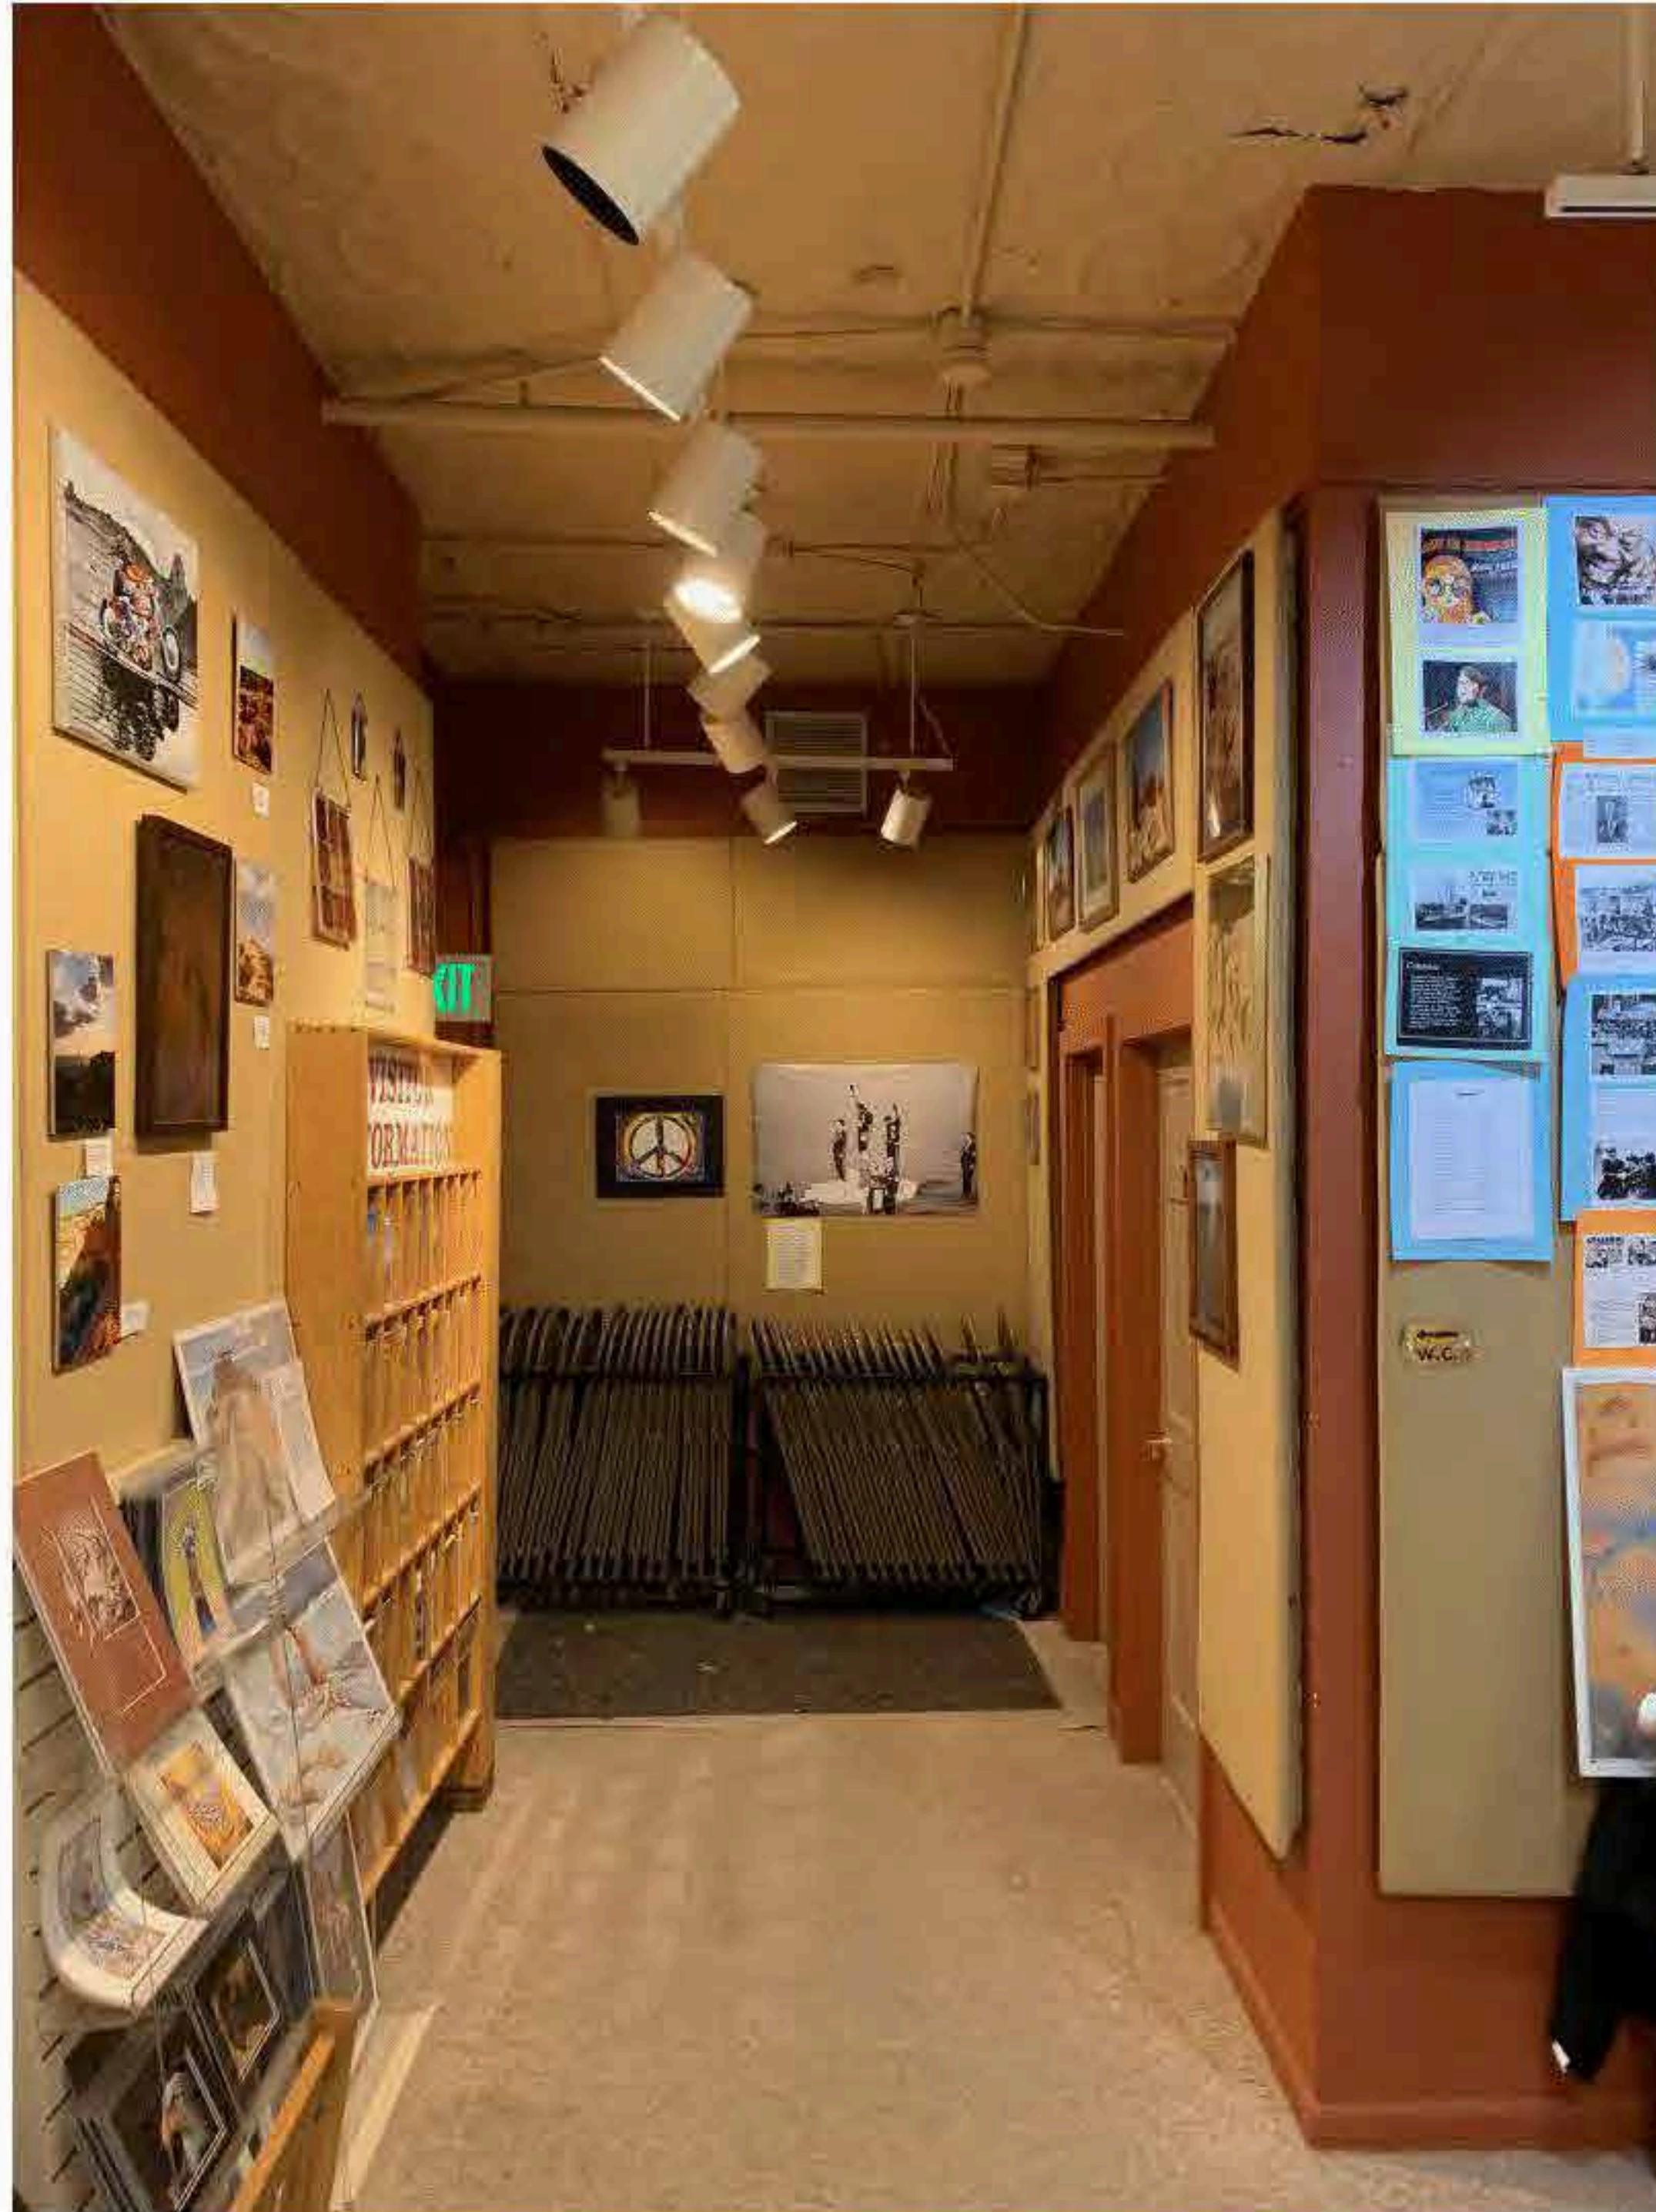
Figure 3.8-5: Main level surface mount track lighting

Interior lighting fixtures throughout are a mix of suspended, surface mount and dropped ceiling grid mounted fluorescent, and incandescent track systems.

Several of the light fixtures are either inoperable or inappropriate for their intended use. Additionally, there are issues with many of the fluorescent fixtures. Loud or failed ballasts being the most common.

An inventory of lighting fixtures and lighting needs should be conducted as part of the design process for any future work plans, this would include options to replace fixtures or groups of lights in the mean time if needed.

No indication of historic lighting fixtures was found in photos, reference material, on on site. It is recommended that all new light fixtures are modern, but simple in design and detail.
