# Historic Structure Assessment

## Cortez Cultural Center

25 N Market St., Cortez, CO 81321

SHF Project # 2019-HA-001

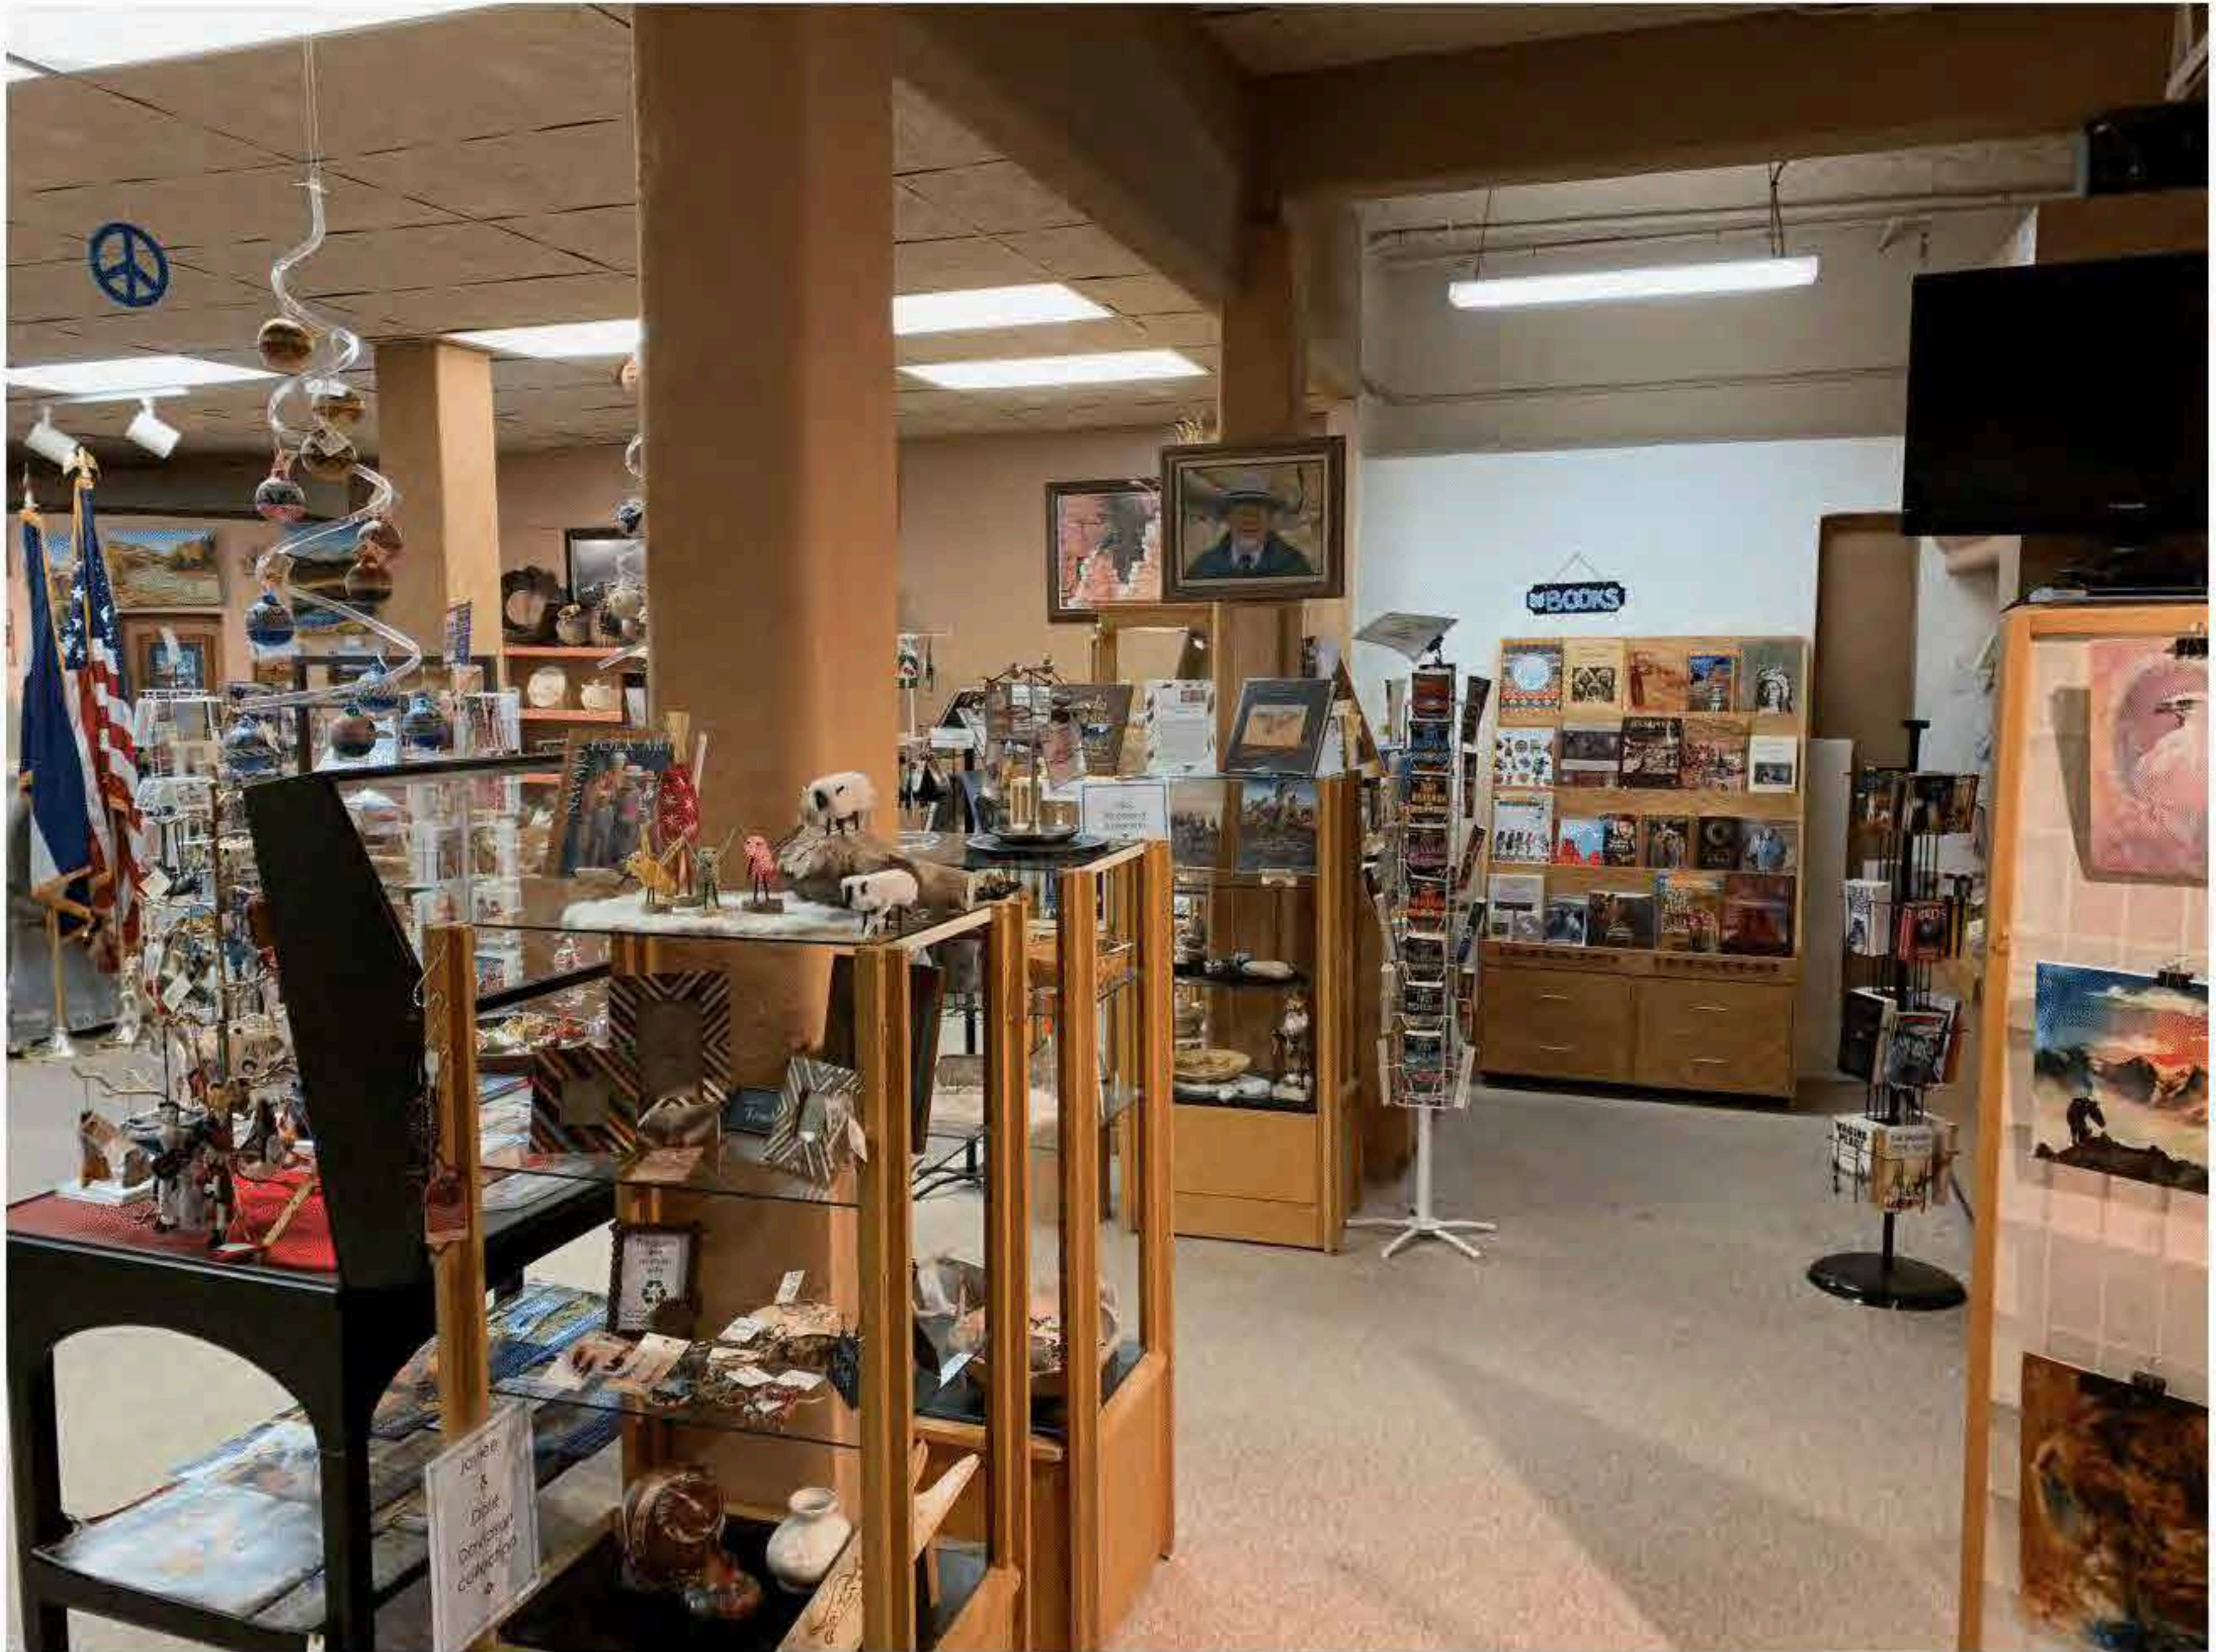
Figure 3.8-6: Main level dropped and grid mount fluorescent lighting

Several of the light fixtures are either inoperable or inappropriate for their intended use. Additionally, there are issues with many of the fluorescent fixtures. Loud or failed ballasts being the most common.

An inventory of lighting fixtures and lighting needs should be conducted as part of the design process for any future work plans, this would include options to replace fixtures or groups of lights in the mean time if needed.

No indication of historic lighting fixtures was found in photos, reference material, on on site. It is recommended that all new light fixtures are modern, but simple in design and detail.
